Property Description: Condominium
Estimated property age: Built 2000 per listing
Occupancy Status: Occupied

Inspection Date: 03/21/2017
Inspection Time: 9:00 A.M. - 10:30 A.M. +/-
Weather Conditions: Overcast, 40 deg f +/-

Hergert Inspection LLC

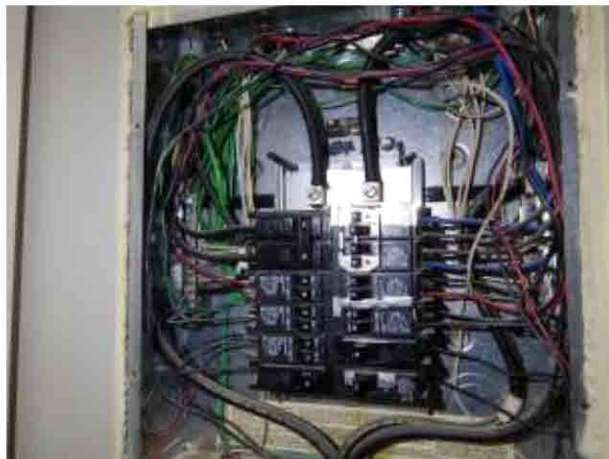
Electrical panel

Location: Bedroom
Manufacturer: Cuttler Hammer
Type: Dual bus bar
Panel Rating: Panel rating not visible
Main Disconnect: No access to the disconnect; not inspected
Serv. wire Size/ Rating: Estimated 125 AMP
Sub-panel: Yes
Grounding: To an exterior ground rod; limited visibility
Panel Clearance: 30" wide, 3' in front as required
Panel Cover: Satisfactory

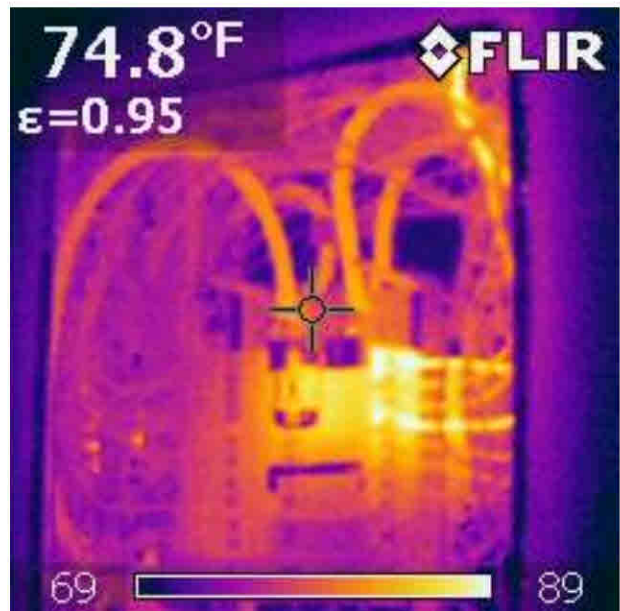
No evidence of overheating
