Property Description: (2) story townhouse style condominium
Property age/ size: 1,600 s.f., built 2004 per listing
Occupancy Status: Vacant

Inspection Date: 09/07/2011
Inspection Time: 9:30 A.M. – 11:45 A.M.
Weather Conditions: Clear 70 deg F +-

Hergert Inspection LLC

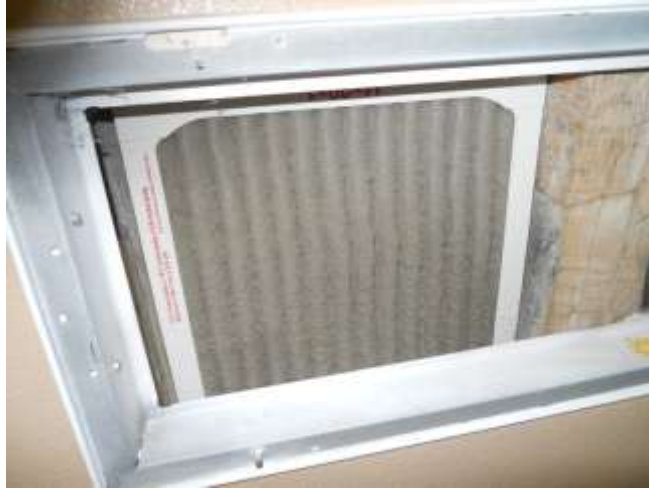
Thermostat: Programmable @ floor 1 hall
Disconnect: Switch on furnace
Combustion Air: Appears adequate
- Furnace filter is very dirty and should be replaced
- No evidence of prior servicing of furnace. Recommend service of furnace every (2) years

Furnace filter is very dirty

- Furnace filter is very dirty and should be replaced
- No evidence of prior servicing of furnace. Recommend service of furnace every (2) years

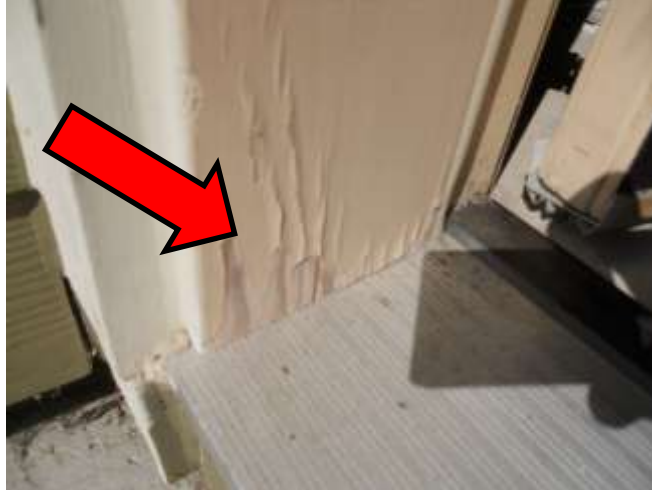
Exterior door jambs should be maintained as they are the most susceptible to wood rot

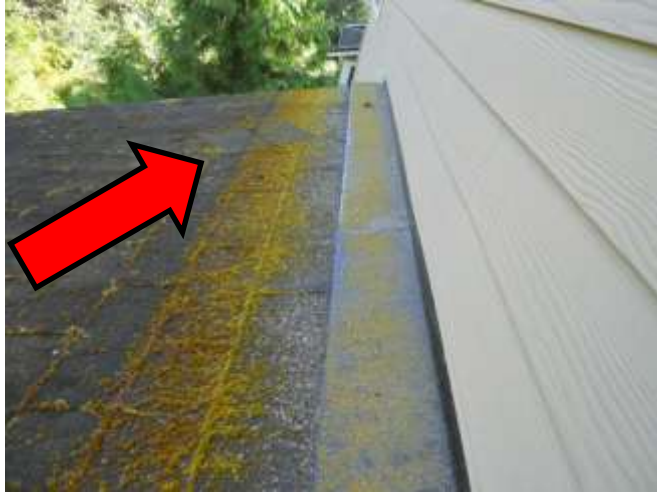
Estimated Pitch: 5:12
Material: Composition
Layers: 1+
How Inspected: From street and floor 2
Condition: - Moss build-up on North facing roof
Ventilation: Eave and ridge vent
- Ridge shingles are missing above West area of condominium. The geometry of the building is likely creating a high wind area where the shingles are missing. These shingles should be secured for high wind conditions. The attic and interior spaces are currently exposed to moisture infiltration from rain
Plumbing Vents: Satisfactory
Flues: Satisfactory
Flashing: Satisfactory

Moss build up on roof
Shingles are lying on roof blown from other areas
(see arrow)

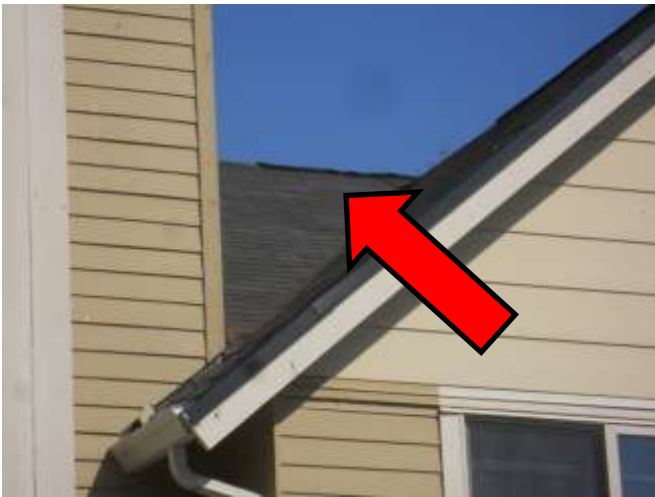
- Moss build-up on North facing roof
- ***Ridge shingles are missing above West area of condominium. The geometry of the building is likely creating a high wind area where the shingles are missing. These shingles should be secured for high wind conditions. The attic and interior spaces are currently exposed to moisture infiltration from rain***

Ridge shingles missing

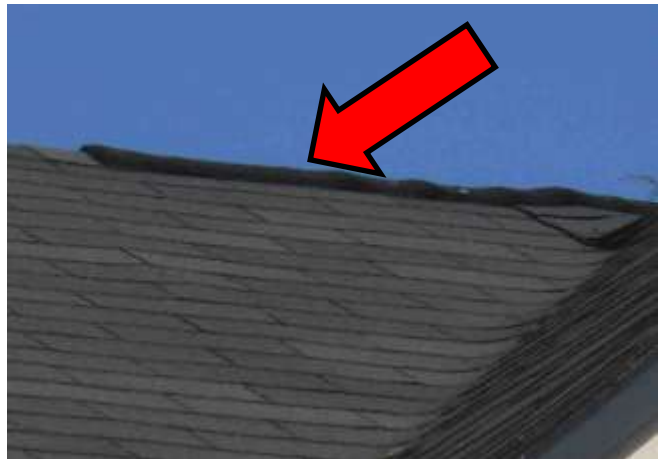
Ridge shingles missing (same area)
Dark black area is plastic ridge vent

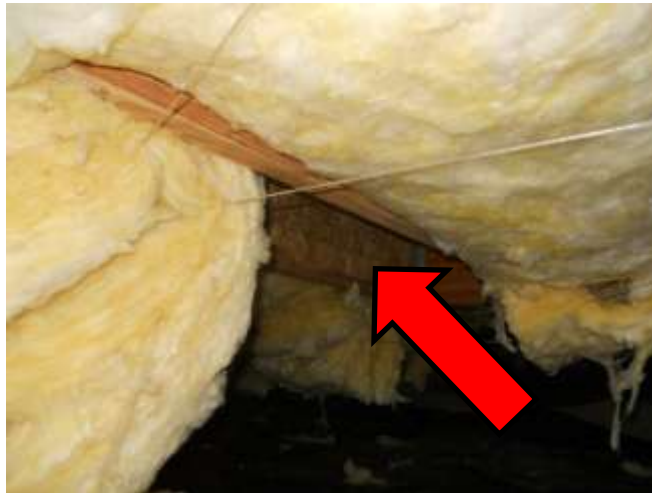
Minor area of insulation detached beneath Kitchen

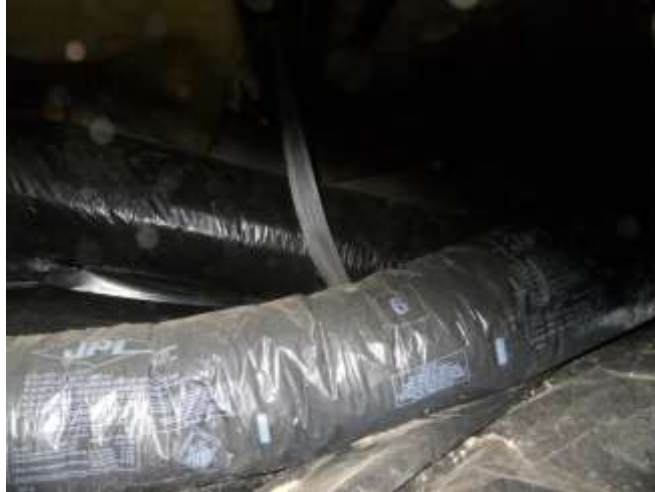
- Duct Work: - Several heat ducts are not properly secured to floor joists above
Ventilation Ducts: No visible defects
Gas Piping: No visible defects

Heat ducts lying on ground

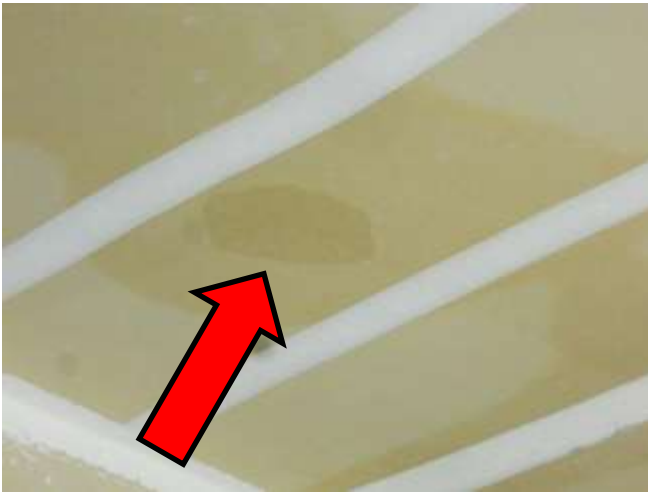
Visibility: Space is vacant
Structural Movement: No visible evidence
Moisture Infiltration: - *Evidence of prior moisture at ceiling. Domestic water was run in all fixtures, including washer drain, were run for at least 30 minutes. No evidence of current moisture intrusion. See Building Exterior section*
Walls: Satisfactory
Ceiling: Satisfactory
Slab: Satisfactory

Moisture stains at ceiling

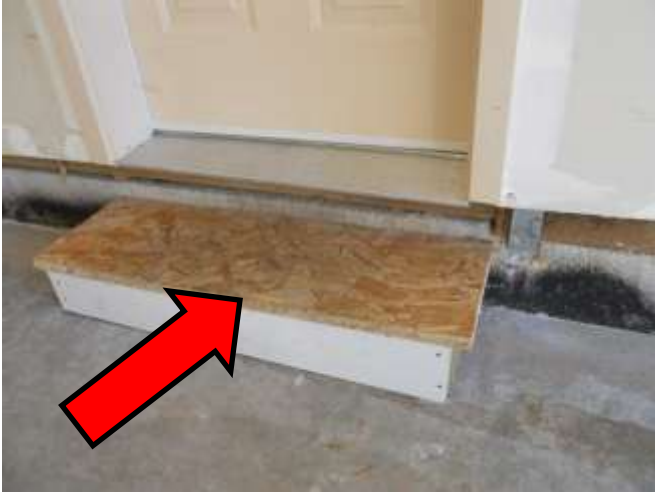
Fire separation: As required where visible
Ignition point > above FF: In compliance
Safety barricade to mech.: In compliance
Step to house: - Step from garage to house should have risers within 3/8" of each other. Recommend support door threshold and at same time reduce the threshold overhang which may result in a trip hazard (catch shoe under threshold)
- *Unknown load support rating of plywood above garage door. Use caution when moving objects near fire control heads to prevent accidental activation*

Unequal step risers

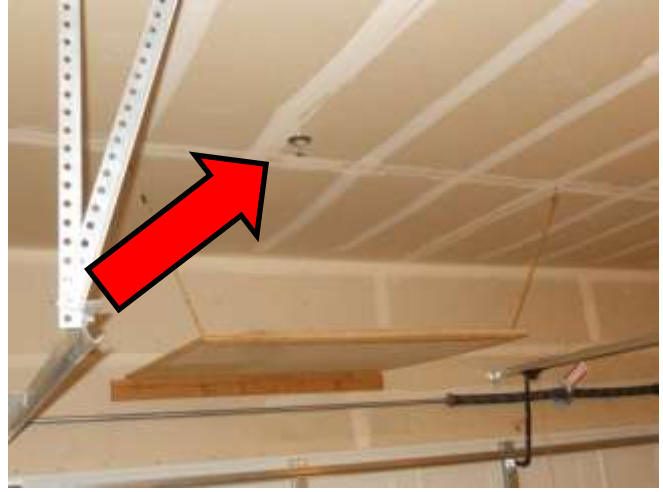
Storage above garage door near fire control head

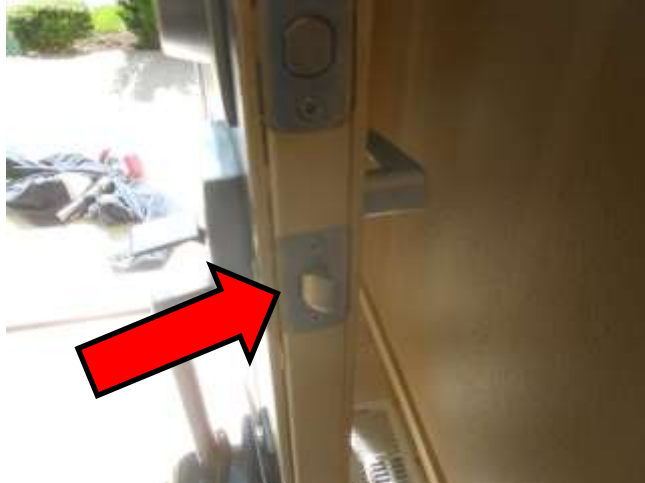
Operation/latching: Tested
- Entry latch is not properly adjusted; door stop missing at front door
Door condition: Satisfactory
Millwork condition: Satisfactory

Door latch is not properly adjusted
(sticks)

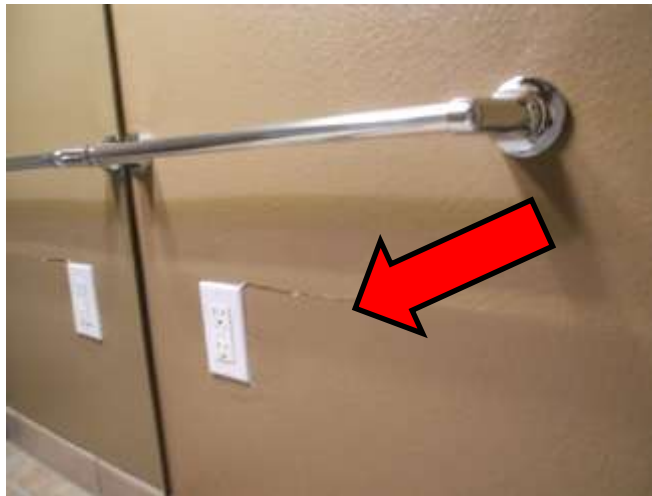
Visibility: Room is vacant
Structural Movement: No visible evidence
Moisture Infiltration: - *Evidence of moisture intrusion. See Building Exterior section*
Walls: - *Drywall damage from moisture intrusion as noted above*
Ceiling: Satisfactory
Flooring: Satisfactory
Cabinets: Satisfactory
Countertops: Satisfactory
Mirrors: Satisfactory

Minor drywall and backsplash damage
from apparent moisture intrusion from attic.
See Building Exterior section

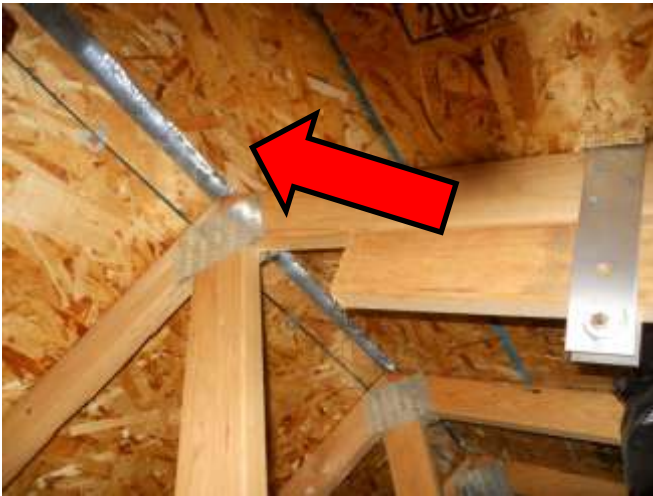
Roof Ventilation: Appears adequate
Moisture Intrusion: - *Moisture intrusion at ridge vent. Shingles are missing. See Building Exterior section*
- *Dryer vent is not properly secured to roof jack. Minor evidence of mold like substance and wood rot at roof sheathing*
Bath/Kitchen fans : All vent to outside

Light visible straight up at ridge vent

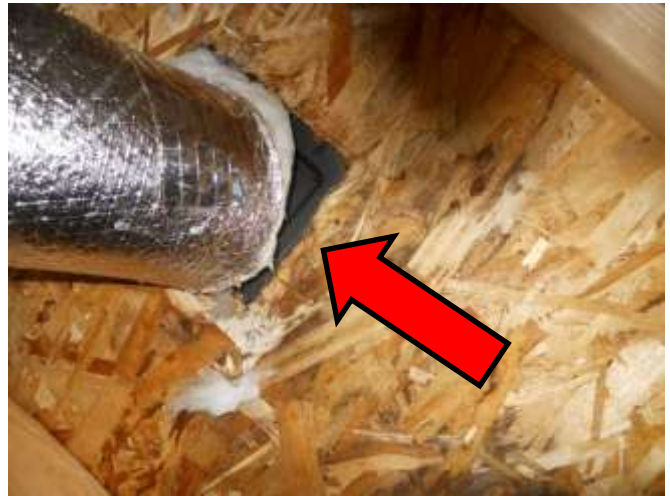
- Dryer vent is not properly secured to roof jack. Minor evidence of mold like substance and wood rot at roof sheathing

Dryer vent not properly secured
