Property Description: (2) story single family home (daylight style)  
Property age/ size: Built 1974, 2,308 s.f. per listing  
Occupancy Status: Occupied

Inspection Date: 11/10/2011  
Inspection Time: 8:30 A.M. – 11:30 A.M. +-  
Weather Conditions: Clear, 55 deg F +-

Hergert Inspection LLC

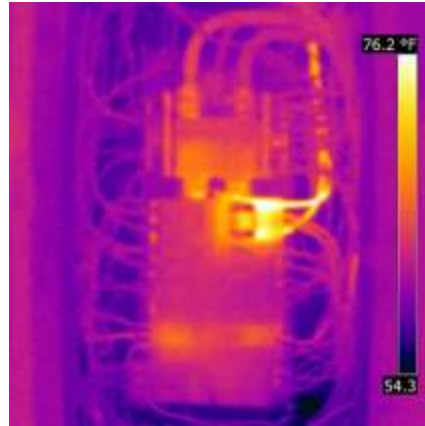
No evidence of over heating

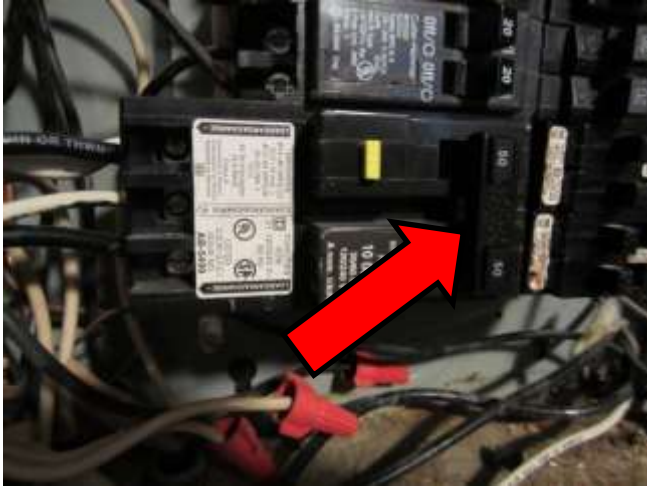
Type: Copper romex  
Breakers: No visible defects  
- Unable to reset Dock GFCI breaker. Re-test GFCI once functioning  
- White wires to breakers should be properly re-identified

Dock GFCI will not reset  
Test GFCI once operational

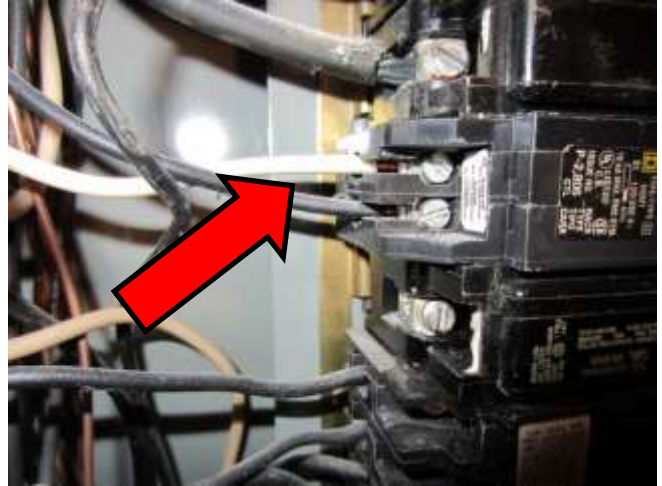
White wires are to be re-identified with electrical tape

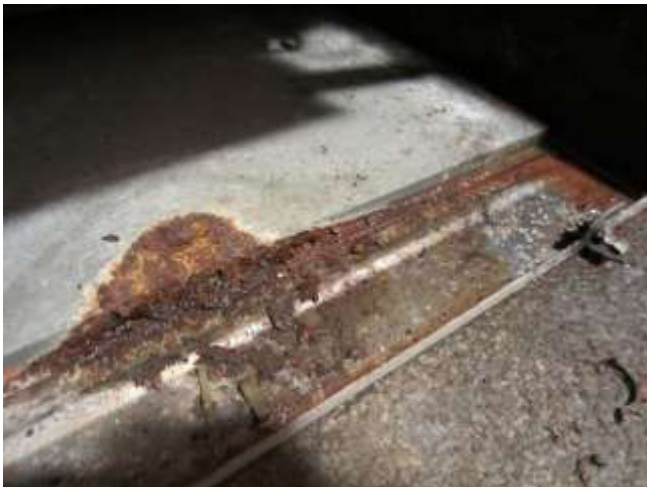
- Condensation line is not connected to pump and also leaks into furnace. Rust at base of furnace

Rust at base of furnace

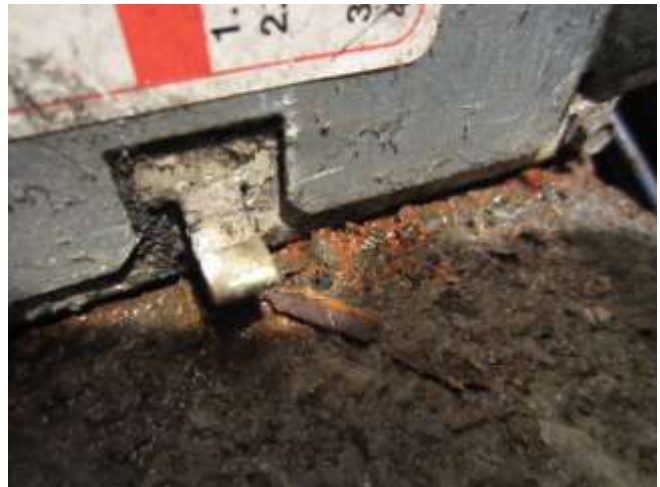
Moisture from base of furnace

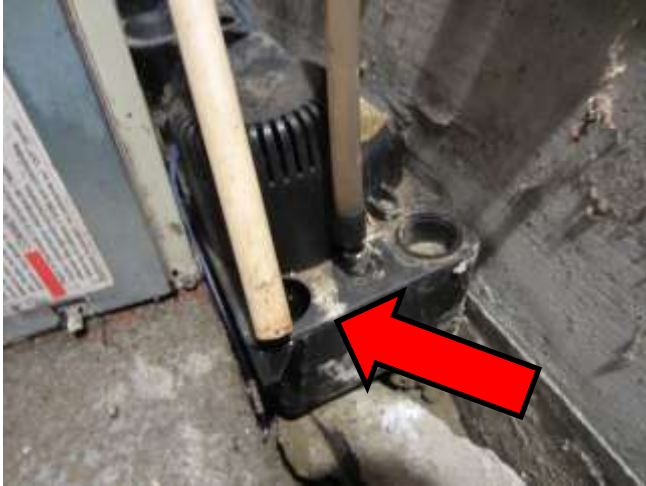
Condensation line not connected to pump

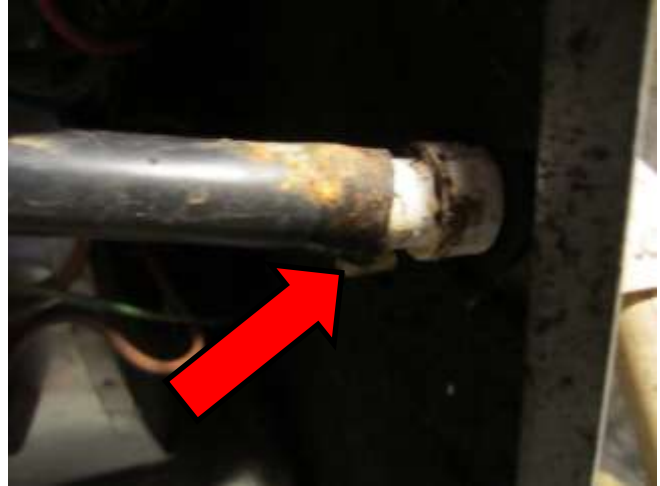
Leak at condensation line

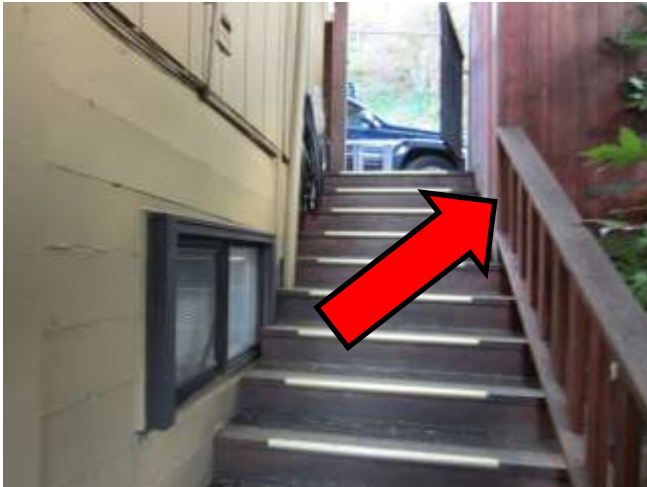
Graspable handrail not installed

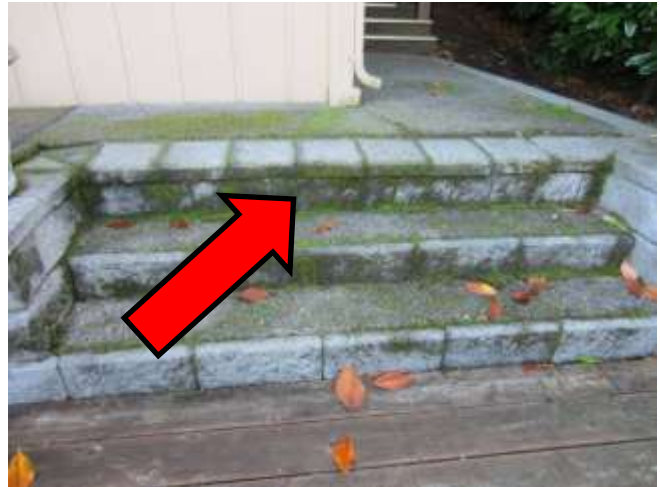
Unequal riser height

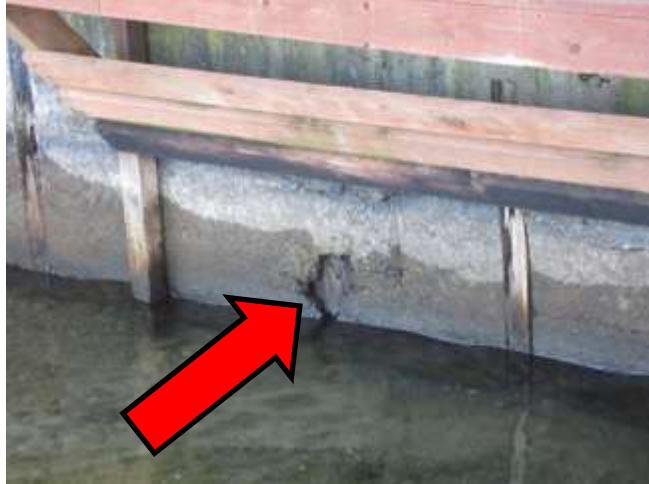
Overhead Power Lines: N/A  
Retaining Walls: - Unable to view rear side of lake bulkhead. Recommend seal deterioration at concrete  
Underground Oil Tank: No visible evidence  
Irrigation System: None visible

Deterioration at bulkhead

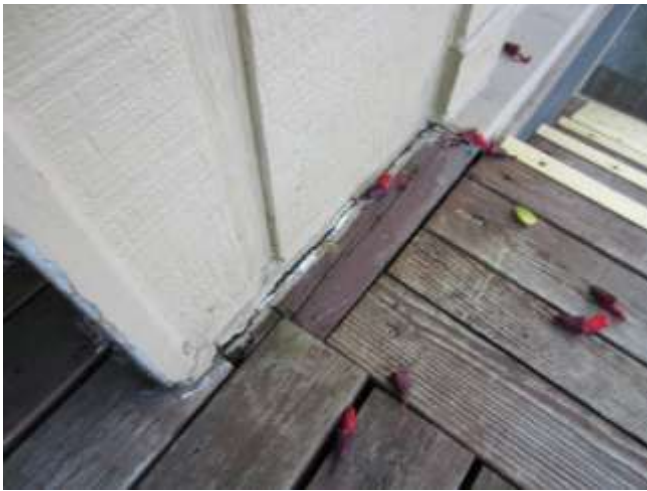
Wood rot at ½ wall

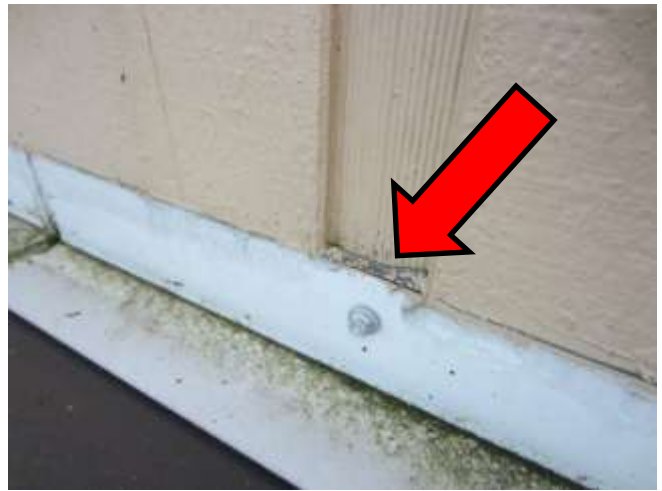
Caulking at vertical grooves must be maintained

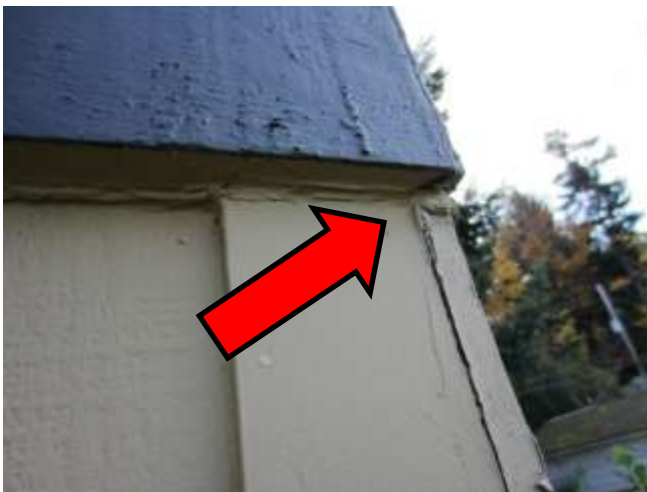
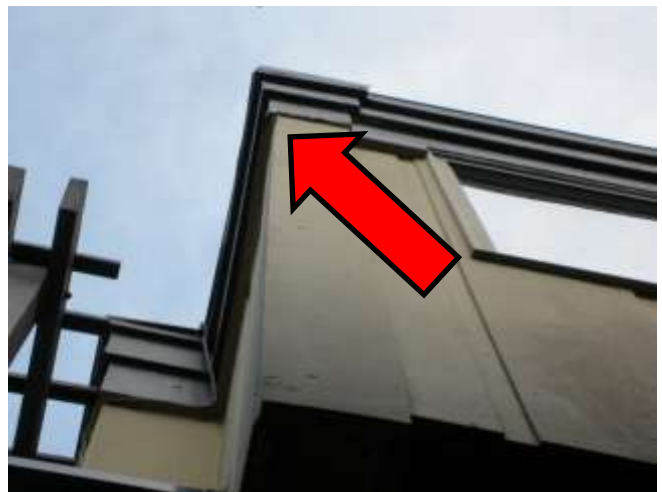
Impropr flashing at S.W coner of Master bedroom

See image to left

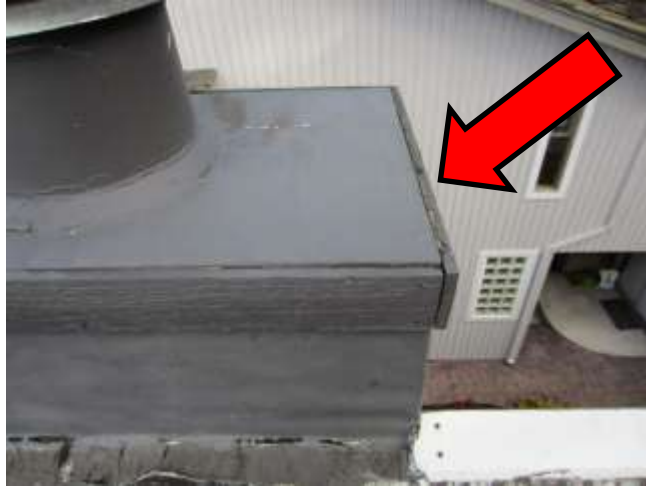
Flashing not installed at chimney cap trim

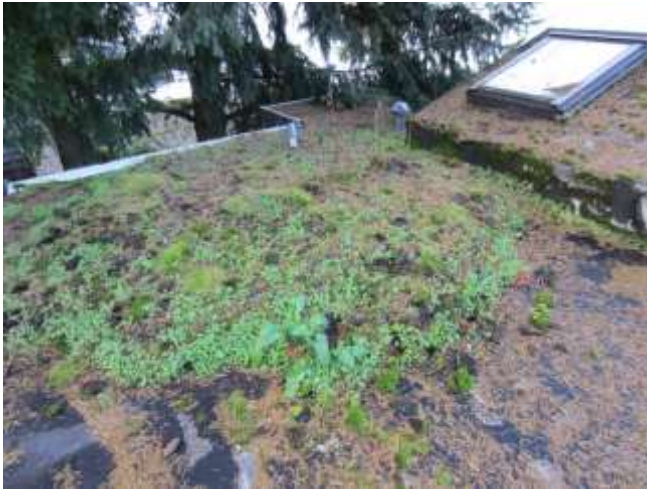
Estimated Pitch: Near flat  
Material: Rolled  
Layers: 1+  
How Inspected: Traversed roof  
Condition: ***- Roof is in marginal condition. There is a substantial build-up of moss, mud, and debris, deterioration of coating, and ponding water. Recommend review by a licensed roofing contractor***  
Ventilation: Eave and ridge vent  
Plumbing Vents: Satisfactory  
Flues: Satisfactory  
Flashing: Satisfactory

8" + of debris on roof

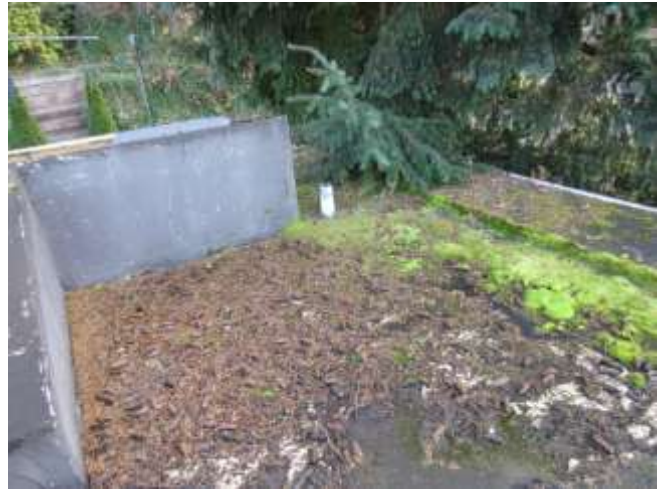
Debris on roof

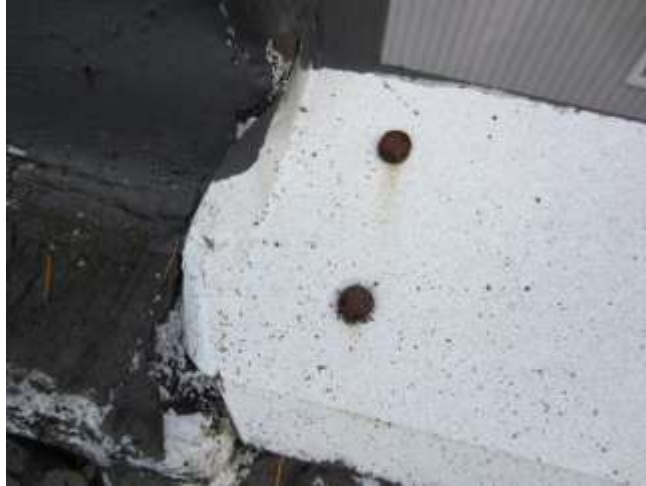
Rusting flashing nails  
These nails should be coated  
to prevent moisture intrusion

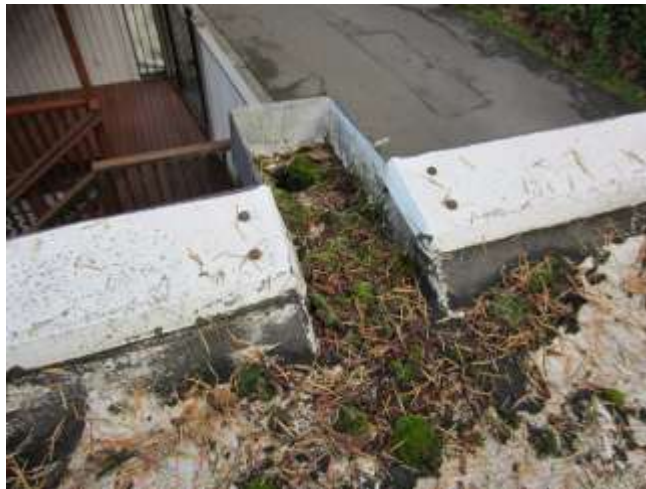
Debris in scuppers

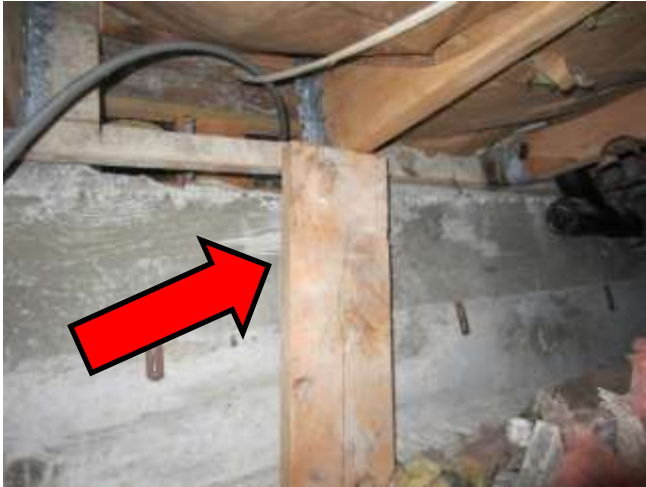
Foundation: No visible defects  
Mudsill: No visible defects  
Joists: No visible defects; limited visibility  
Post-Beams: - Joist support near middle area of home should be properly supported with 4 x 4 pressure treated wood  
Structural Movement: No visible evidence

Joist supported with 2 x 8 non treated wood

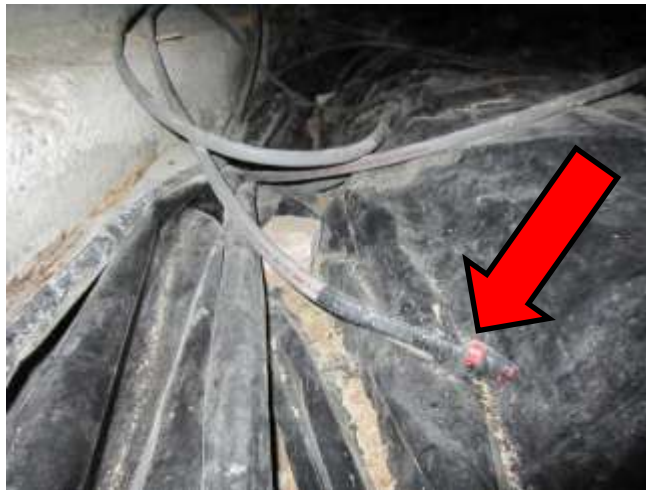
- Outlets: None visible  
Wiring/ junction boxes: - Electrical wire at middle area of crawlspace should be properly secured and terminated in an electrical junction box

Loose wire in crawlspace

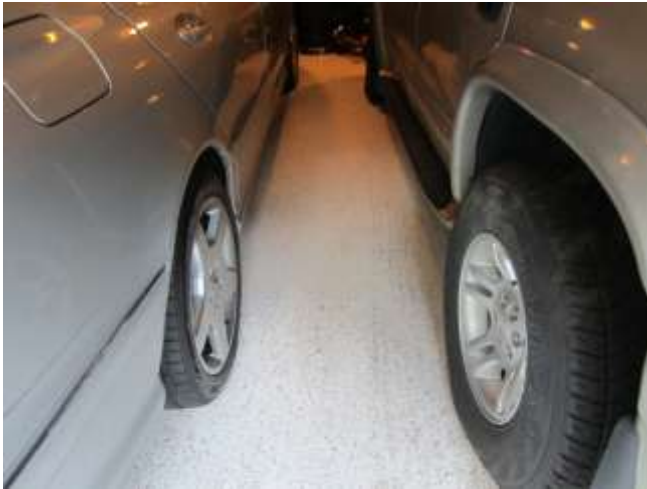
Visibility: Space is occupied  
Structural Movement: No visible evidence  
Moisture Infiltration: No visible evidence  
Walls: Satisfactory  
Ceiling: Satisfactory  
Slab: Satisfactory  
- Recommend seal gap at inside corner of garage slab  
- Verify the slope of the slab once vacant. A moisture barrier may be necessary at the outer edges of the slab adjacent to the living spaces of the house

Garage slab appears to slope towards the house

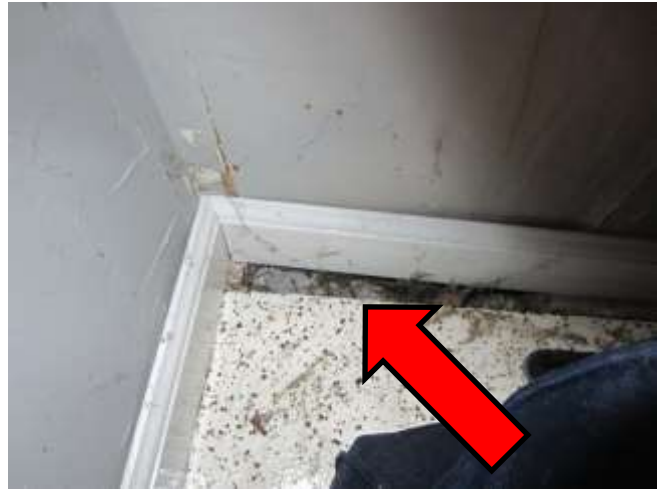
Gap at garage slab adjacent to house

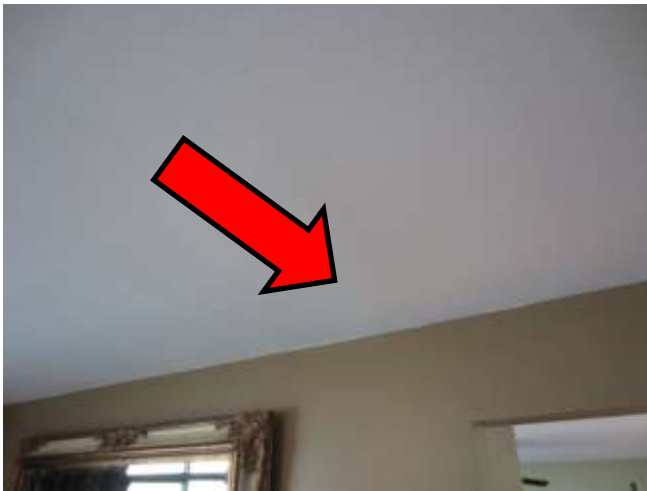
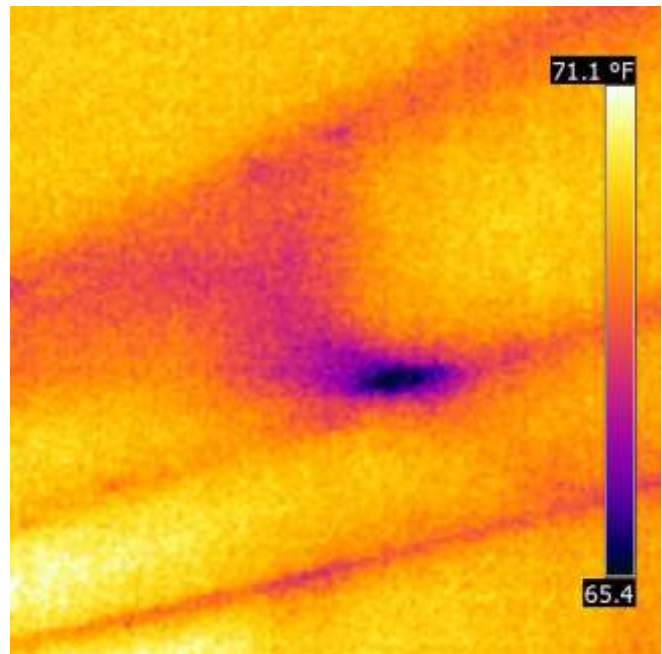
See image to right

Evidence of moisture intrusion

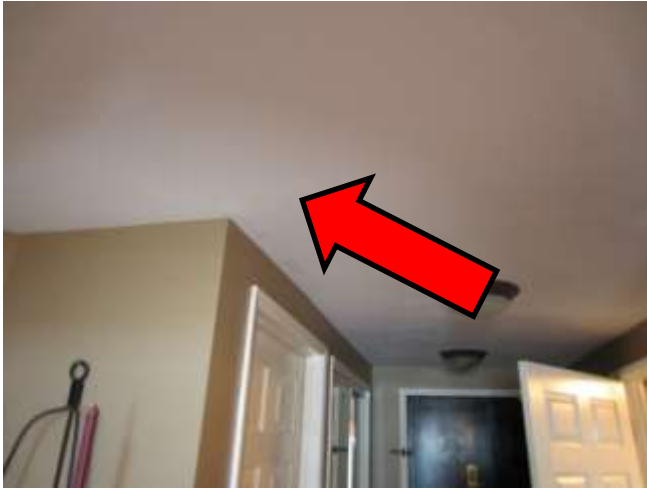
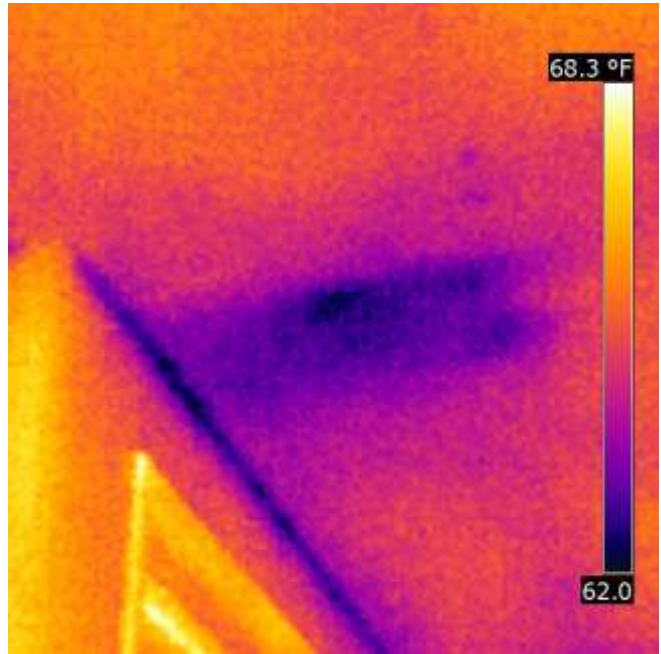
See image to right

Evidence of moisture intrusion

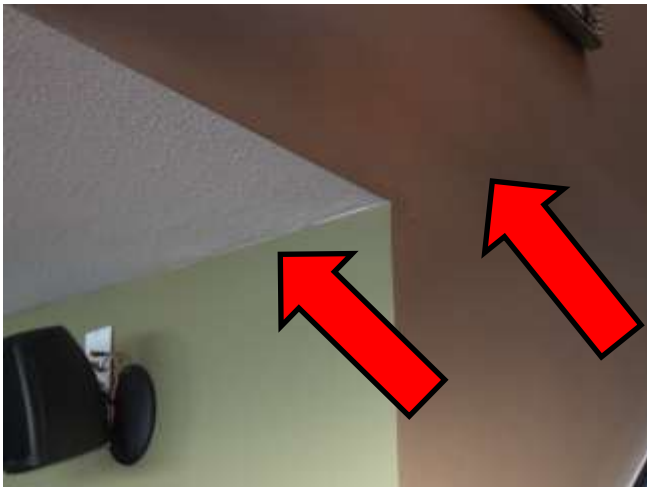
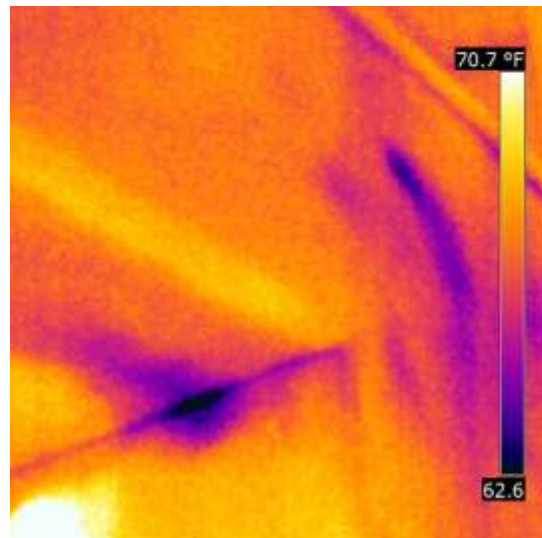
See image to right

Air or moisture intrusion at stairwell  
May be related to gap at garage slab  
See comments in garage section

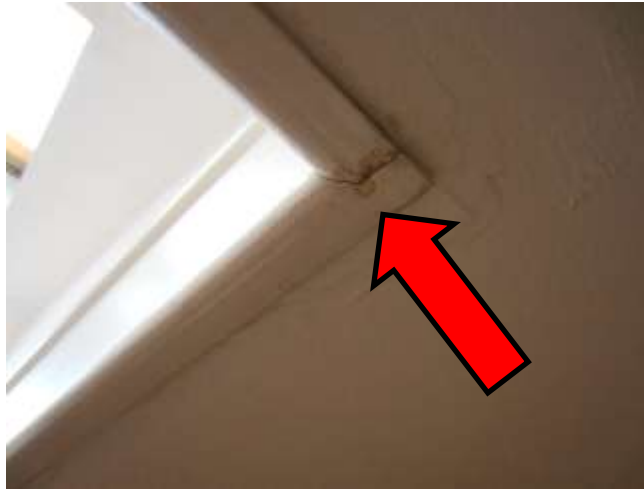
Moisture stains at skylight well trim

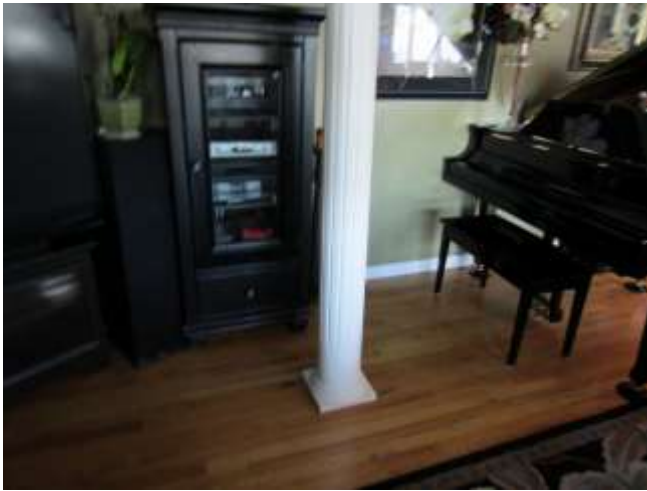
Visibility: Room is vacant  
Structural Movement: No visible evidence  
- Question to Seller: Is the column a structural support ? If so, can it be shifted to the left or right (is the beam split above) ?  
Moisture Infiltration: No visible evidence  
Walls: Satisfactory  
Ceiling: Satisfactory  
Flooring: Satisfactory

Column in Living Room

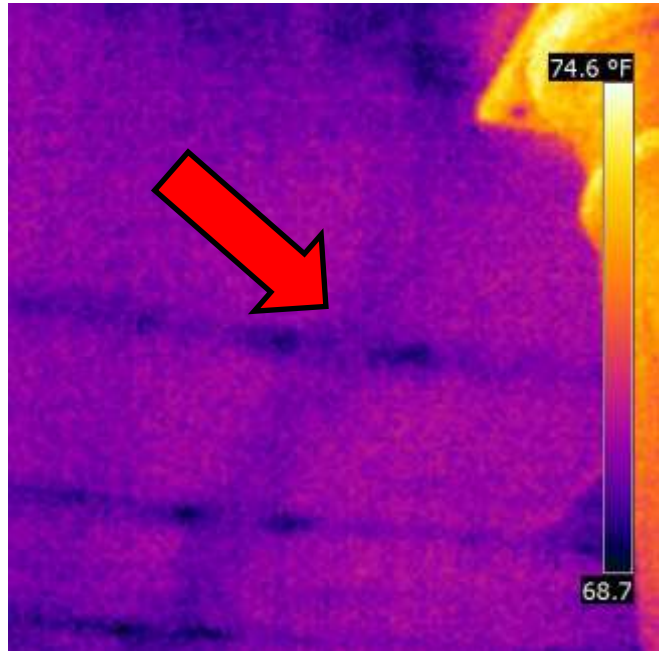
Image indicated joist hangers and a beam in line with the column

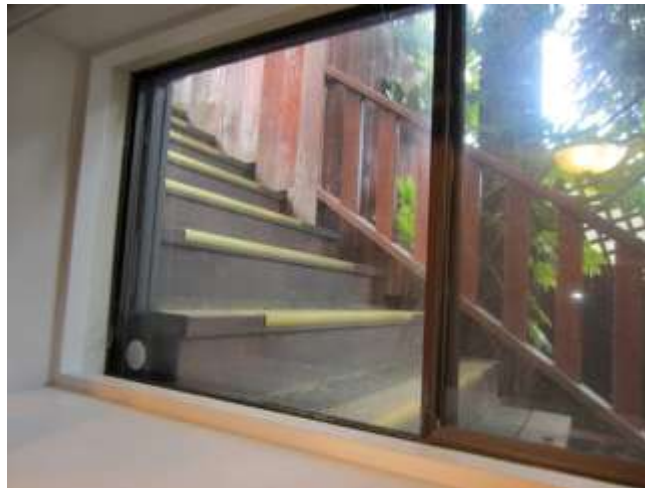
Glazing: - Failed window seal at N.E. bedroom  
Tempered: - Window adjacent to stairs typically would be tempered due to height of adjacent exterior grade and potential of a bed placed below this area  
Operation: Tested  
Egress: - *Egress appears reasonable (would not comply with current code requirements)*  
Screen: - *Some screens not installed*

Window is recommended to be tempered  
due to exterior grade
