(425) 652-6515  
Kevin@Hergert.com  
Wa. Home Inspector 619  
WSDA Inspector 79988  
WSDA Control # 1295AQ-043

Property Description: Tri-level single family home  
Property age/ size: Built 1991, 4,670 s.f. per listing  
Occupancy Status: Occupied

Inspection Date: 11/12/2011  
Inspection Time: 1:00 .M. – 3:50 P.M. +-  
Weather Conditions: Heavy rain and wind, 37 deg F +-

Hergert Inspection LLC

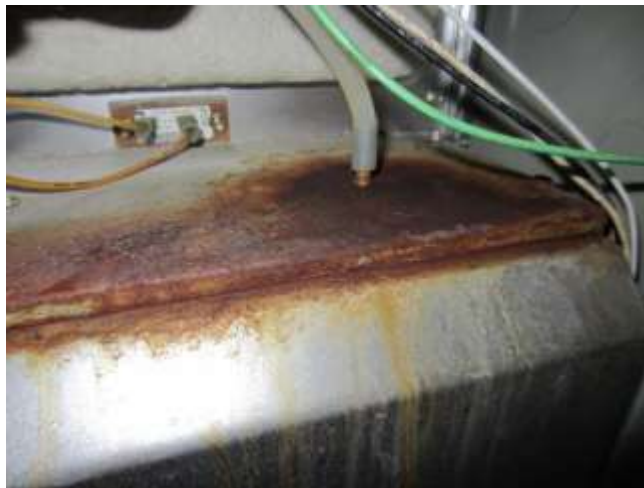
Est. Useful Life new: 25 years  
Est. age of furnace: 20 years +-  
- Recommend service of furnace and every (2) years thereafter. Evidence of rust on top of combustion compartment

Rust on top of combustion compartment

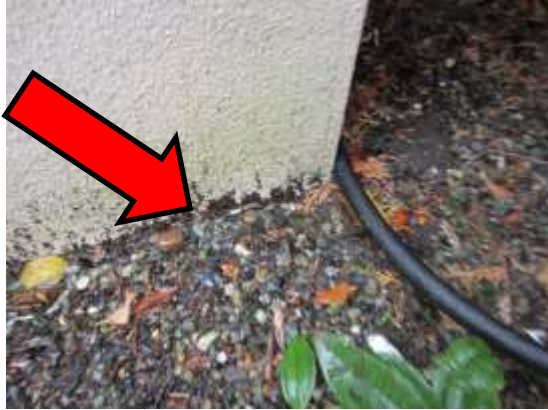
Siding in contact with ground

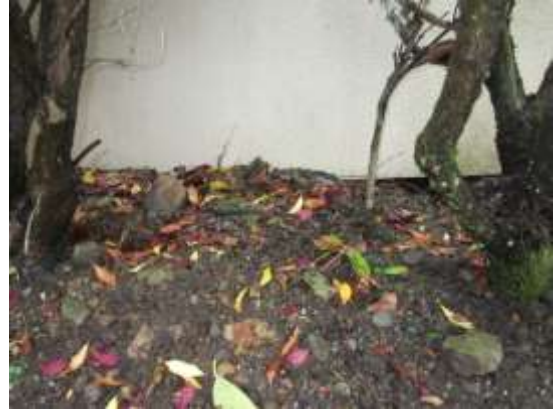
Dirt piled up in contact with living room cantilever

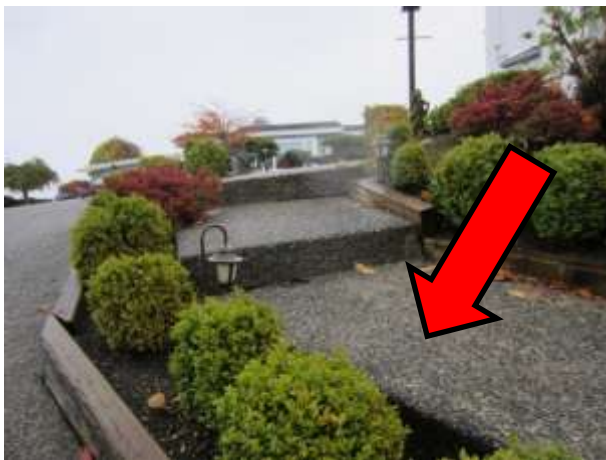
Walkway leans towards driveway

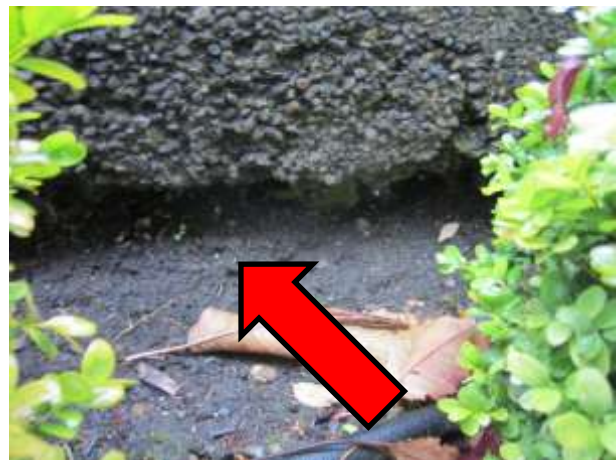
- Type: Concrete  
Condition: - Significant settlement of front walkway. Walkway is not supported by ground below in certain areas. Slip hazard when wet or icy conditions exists as walkway leans towards the driveway  
Trip Hazard: - See comment above

Walkway is not supported in certain areas

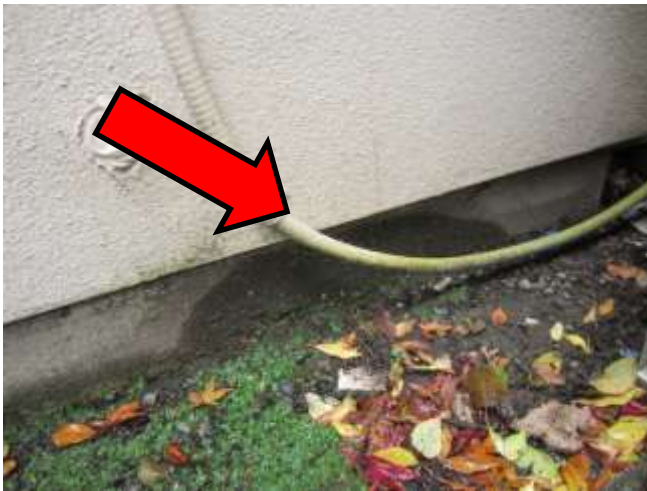
Moisture stain at foundation wall  
Stain is located beneath rear stair stringer  
This moisture may be ground “splash-back” related as the top of the stain is arced (not vertical)

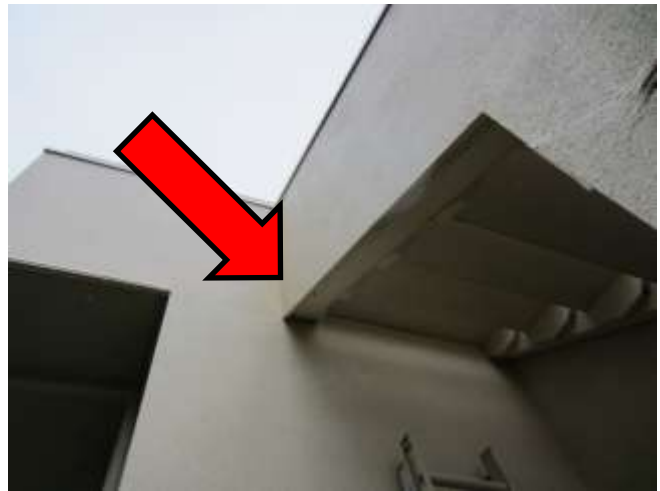
See image to left  
Stain is located beneath this area

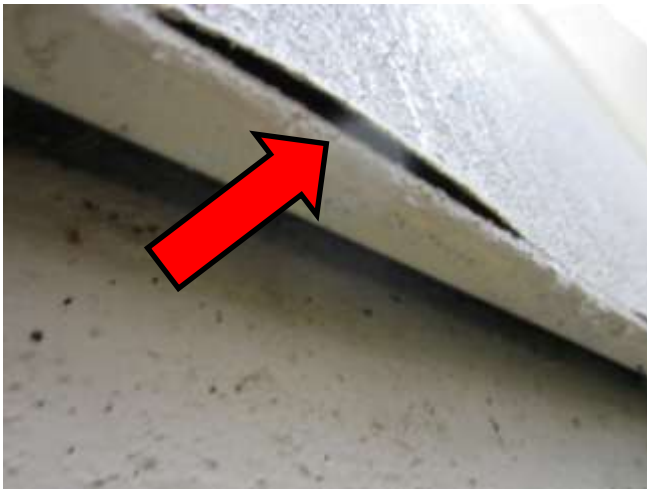
Separation of stucco finish

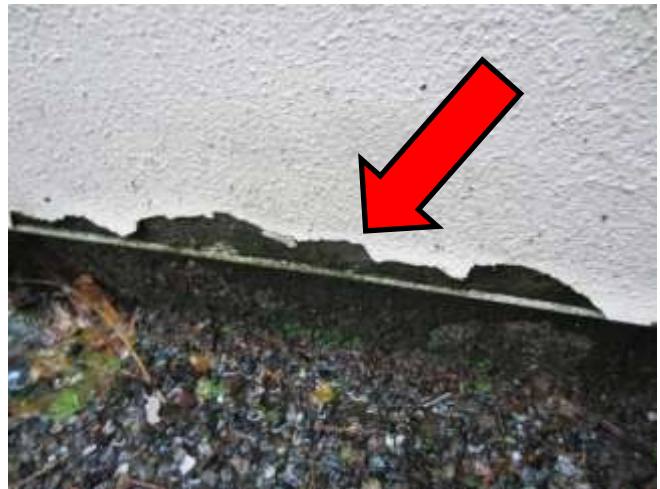
Deterioration of stucco at base

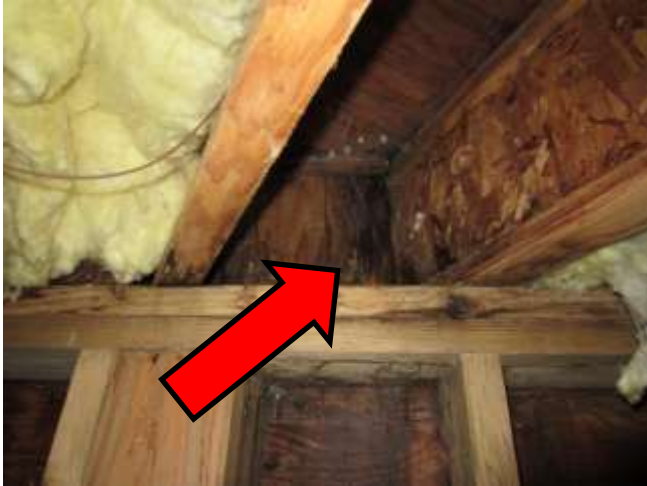
Moisture stains and (wet) wood rot below the rear deck

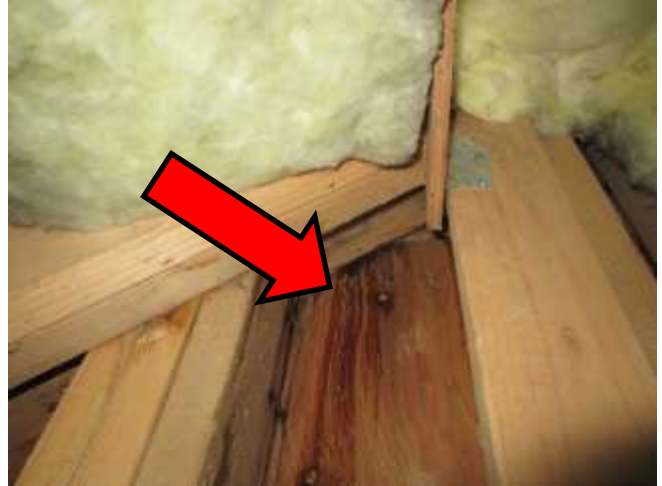
Moisture (wet) below stairs to game room

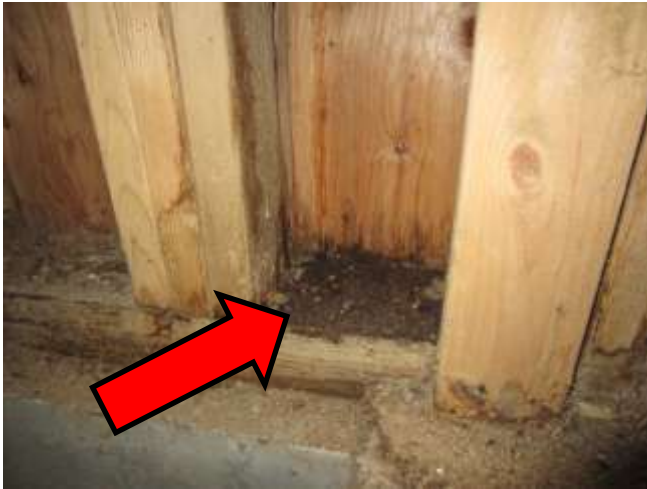
Moisture (wet) below stairs to game room

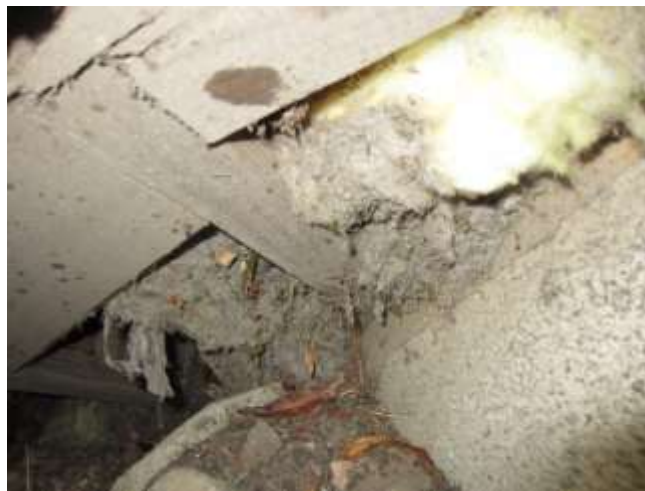
Exposed insulation below Living Room cantilever

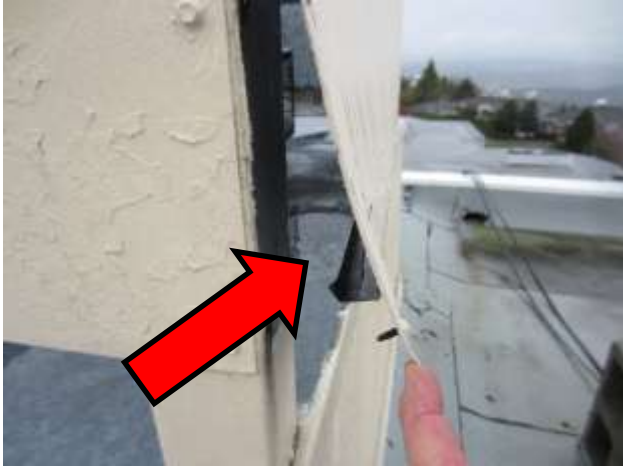
Separation at fireplace shroud

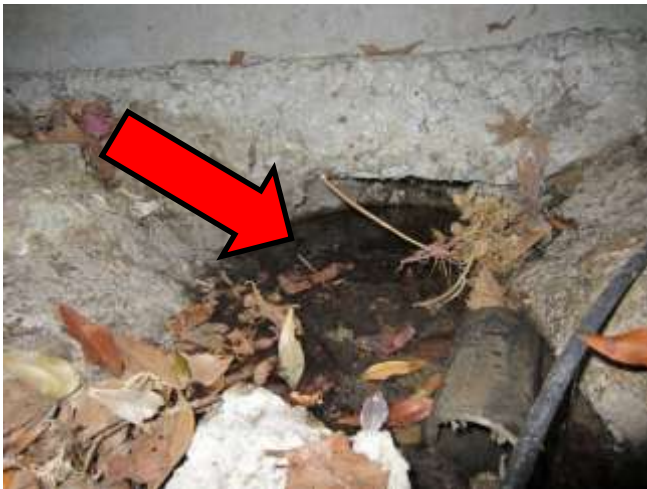
Ventilation: Appears adequate  
Vapor Barrier: - Vapor barrier missing at several areas  
Moisture Intrusion: - *Moisture intrusion detected at (3) locations. There is a significant flow of moisture from beneath garage slab. This may be related to the repair of the channel drain by the right side garage bay. Moisture could lead to potential settlement and/or failure of the garage slab. Another source is the gap around the sewer discharge pipe*  
Sump Pump: Yes

Moisture intrusion (flowing water) from behind the garage. Water flows to a sump pump

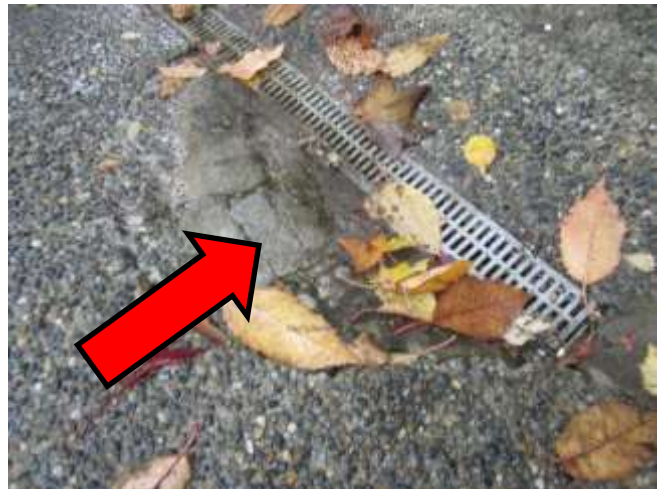
Concrete repair at driveway channel drain

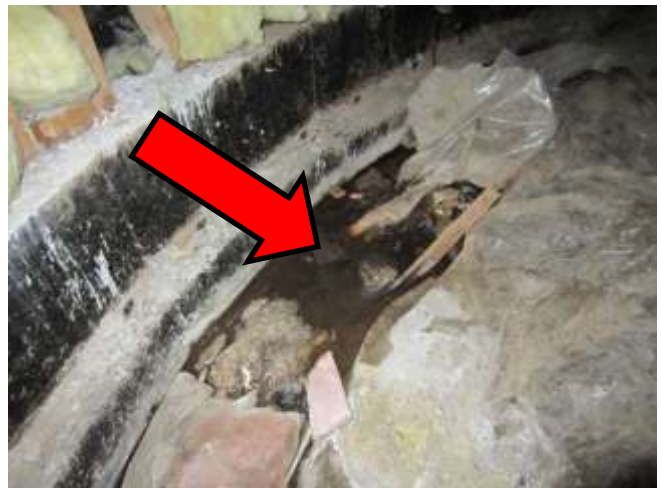
Moisture above game room

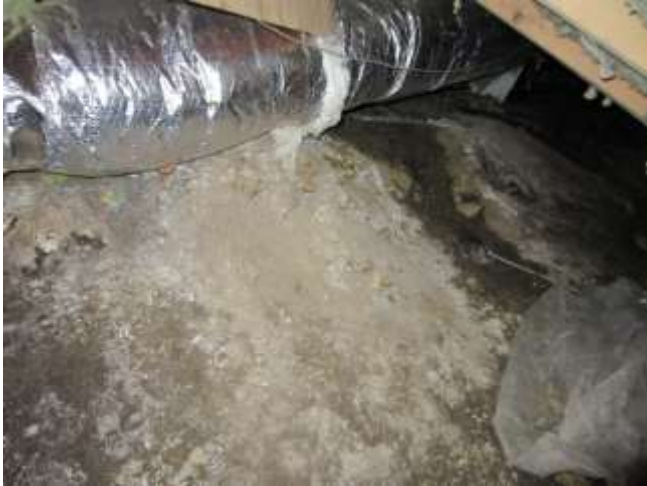
Exposed ground (no vapor barrier)

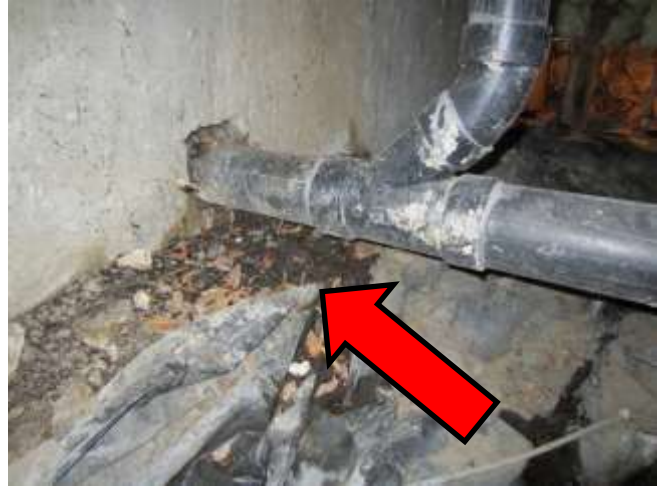
Moisture intrusion at sewer discharge pipe

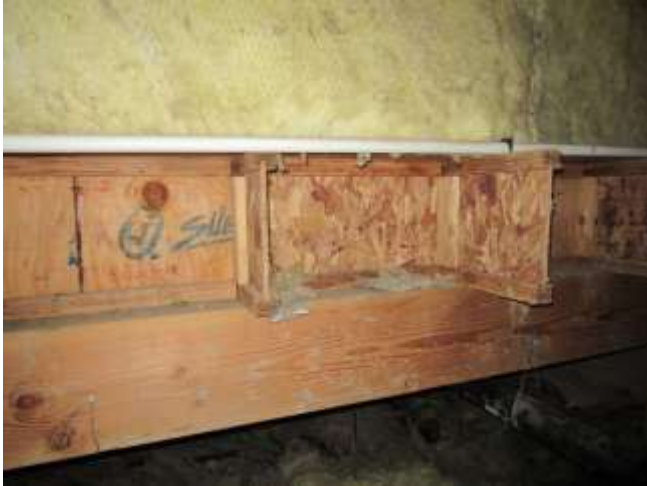
- Under-floor: - Numerous areas are not insulated. Primary areas are the rim joists
- Domestic Water Pipes: Satisfactory
- Heating Supply: Satisfactory

No insulation at rim joist

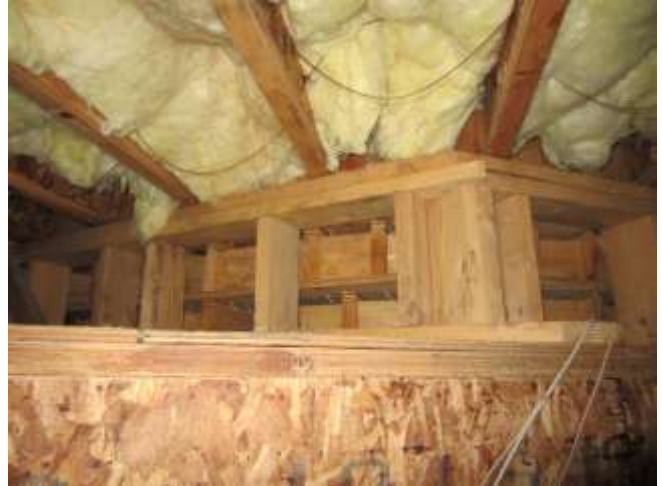
No insulation at rim joist

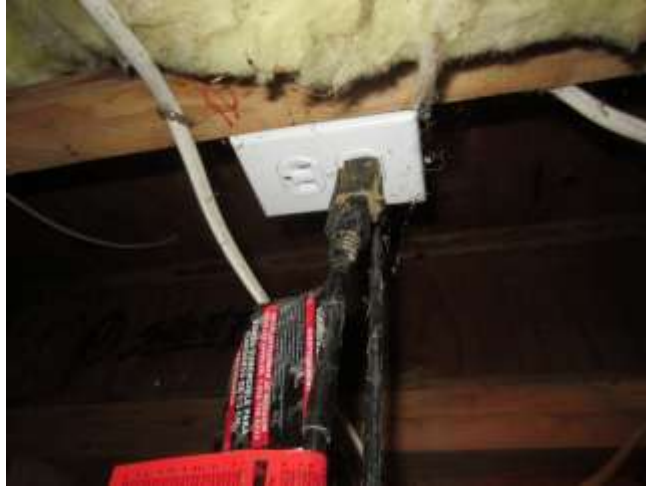
Sump pump should be GFCI protected

- Recommend verification that the sump pump is connected to a GFCI protected outlet

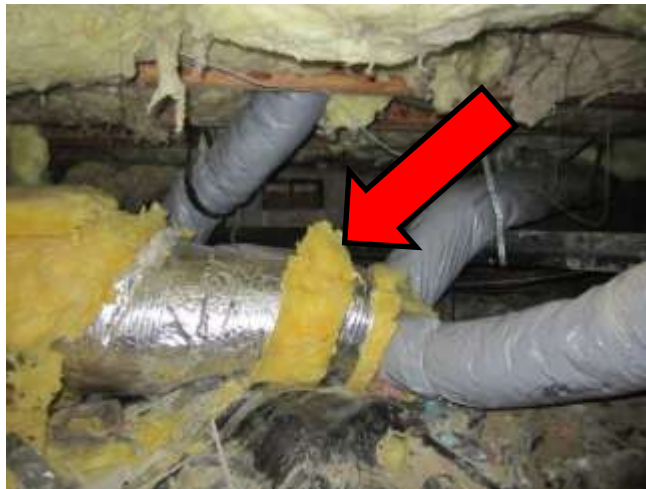
- Duct Work: - Heating ducts below bedrooms 2 and 3 are not secured to joists above (laying on the ground)
- Ventilation Ducts: No visible defects
- Gas Piping: No visible defects

Heat ducts are not secured to floor joists above

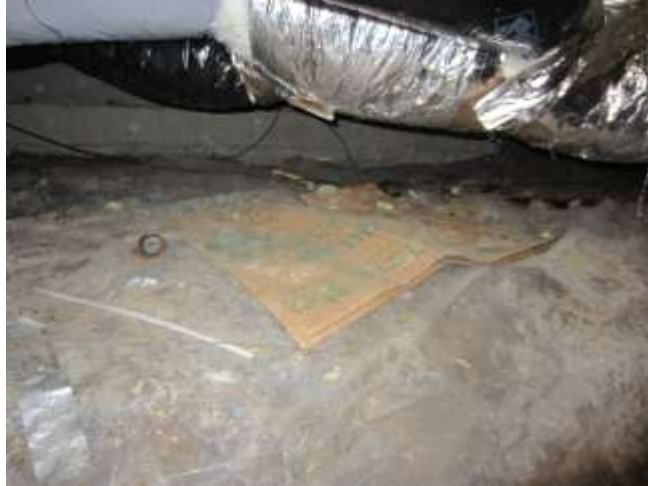
- Conductive Material: - Crawlspace should be clean of wood and cardboard debris (WDO conducive condition)
- Visible Evidence: No visible evidence

Cardboard debris in crawlspace

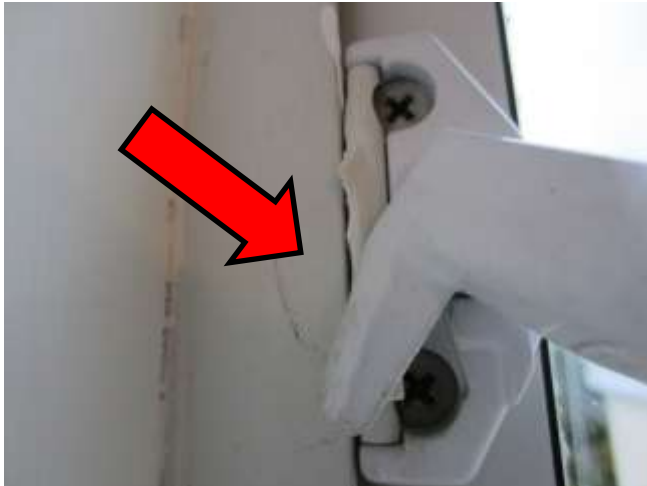
Deteriorated window hardware

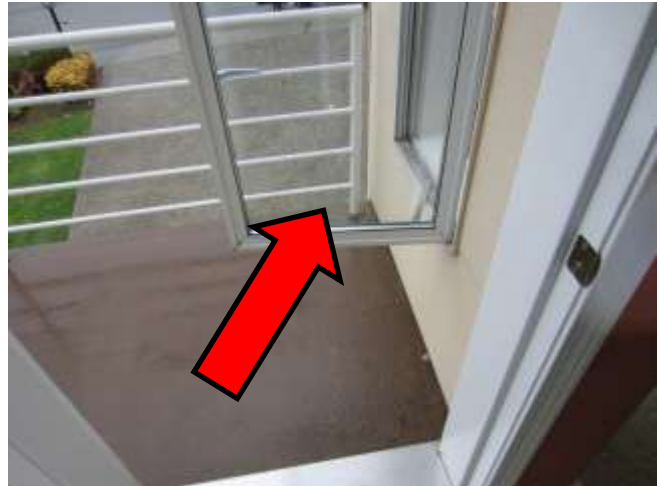
Casement window swings in front of deck walking path

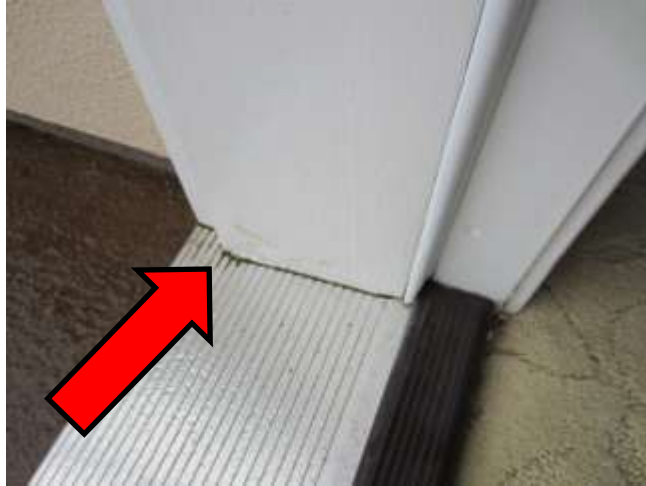
Operation/latching: Tested  
Door condition: Satisfactory  
- Minor wood rot at deck door jamb. Recommend maintain to prevent further deterioration  
Millwork condition: Satisfactory

Minor wood rot at door jamb

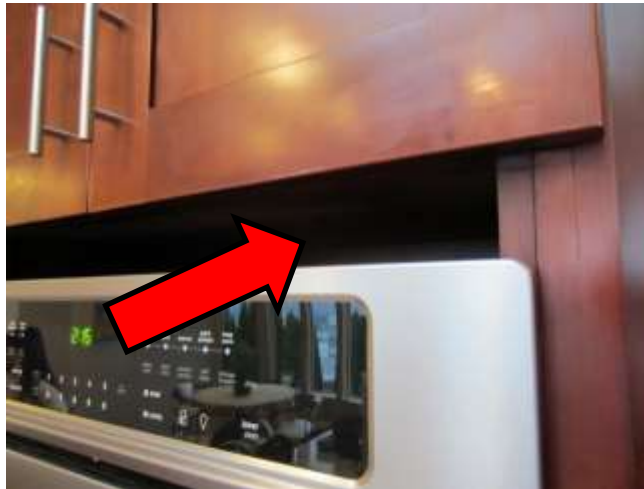
Large gap above oven

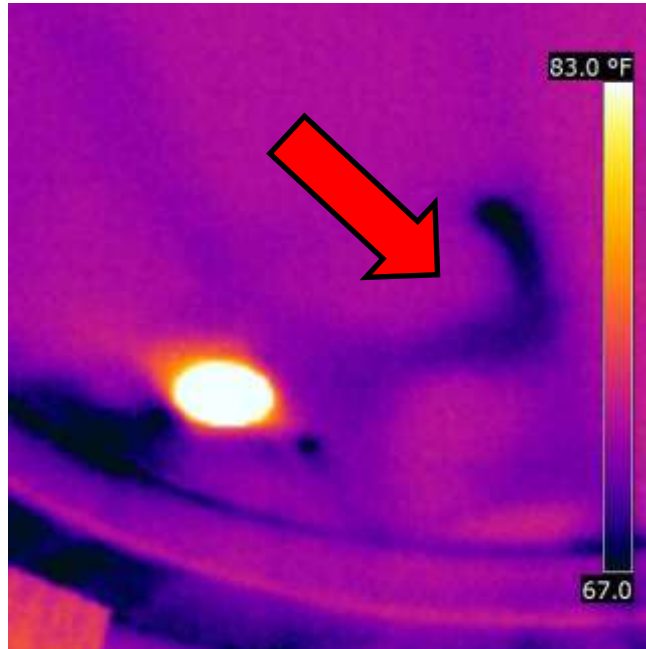
Visibility: Rooms are occupied  
Structural Movement: No visible evidence  
Moisture Infiltration: - Infrared image shows evidence of possible moisture intrusion at ceiling. Recommend continue to monitor  
Walls: Satisfactory  
Ceiling: Satisfactory  
Flooring: Satisfactory

Pattern suggests moisture leak at ceiling

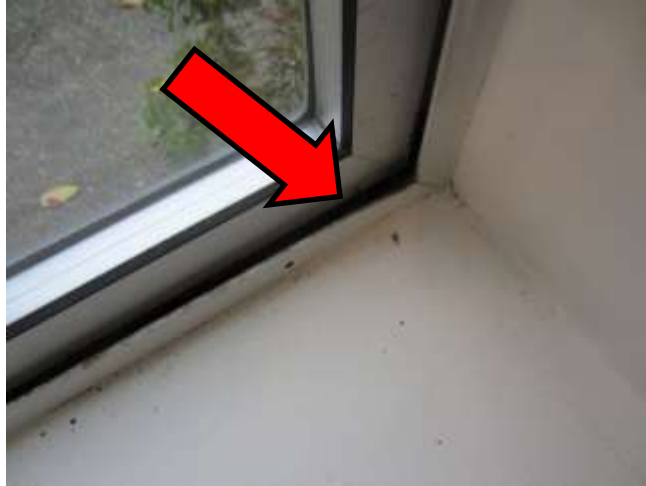
Large gaps at base of casement windows

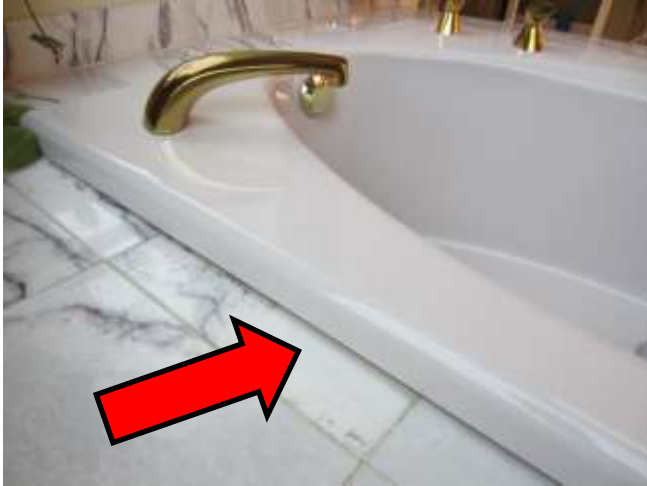
Tub should be caulked to tub deck

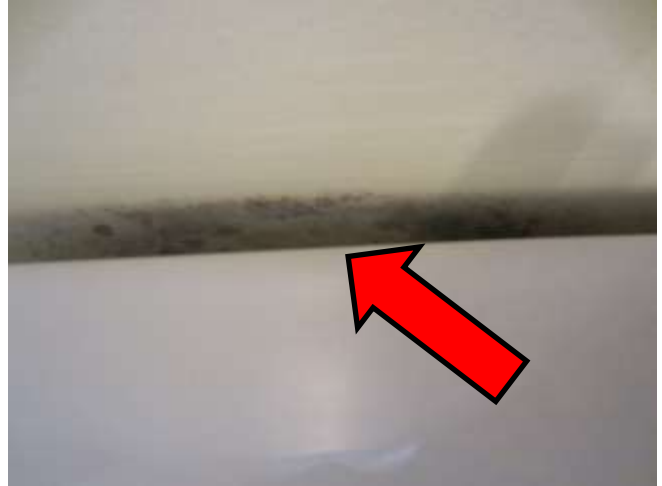
Evidence of microbial growth behind toilet lid

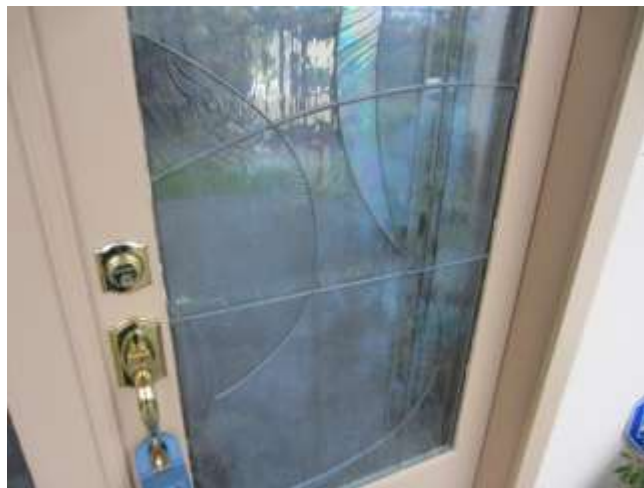
Failed from door glazing (fogging)

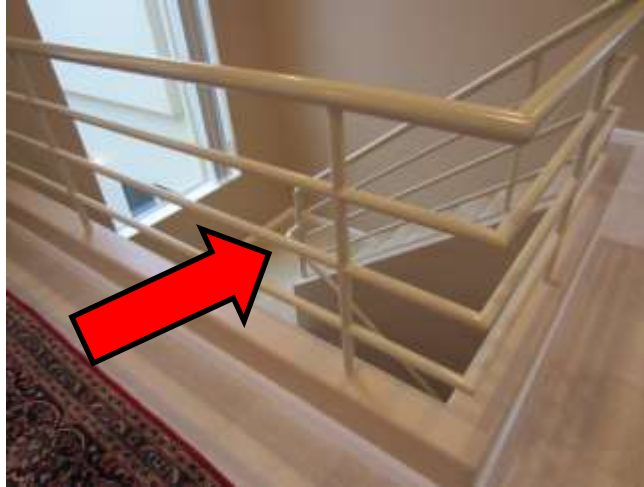
Horizontal balusters create a ladder and subsequent fall hazard for children

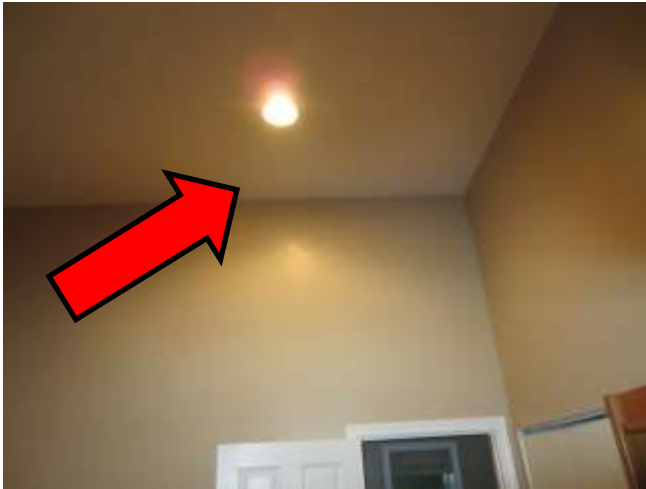
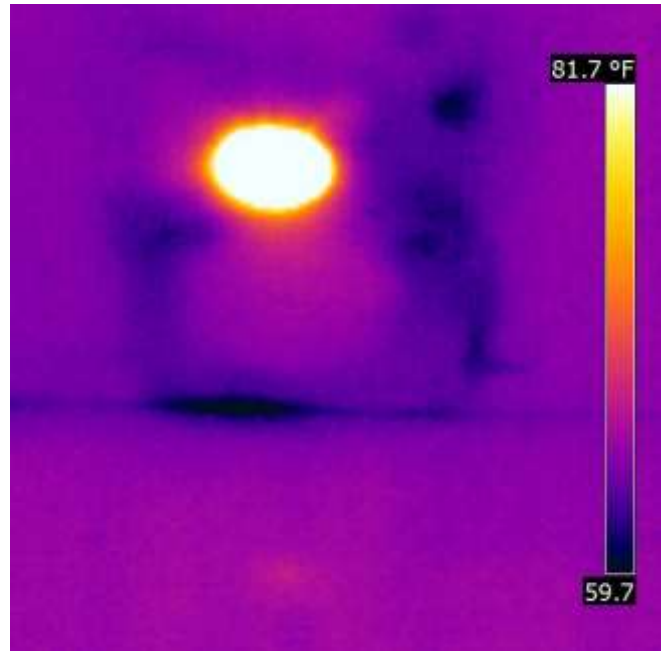
Visibility: Room is occupied  
Structural Movement: No visible evidence  
Moisture Infiltration: - *Evidence of moisture intrusion below deck above. See comment in Siding section*  
Walls: Satisfactory  
Ceiling: Satisfactory  
Flooring: Satisfactory  
Cabinets: Satisfactory  
Countertops: Satisfactory  
- *Recommend re-caulk countertop to backsplash*  
Mirrors: Satisfactory

Evidence of possible moisture intrusion below deck above bedroom

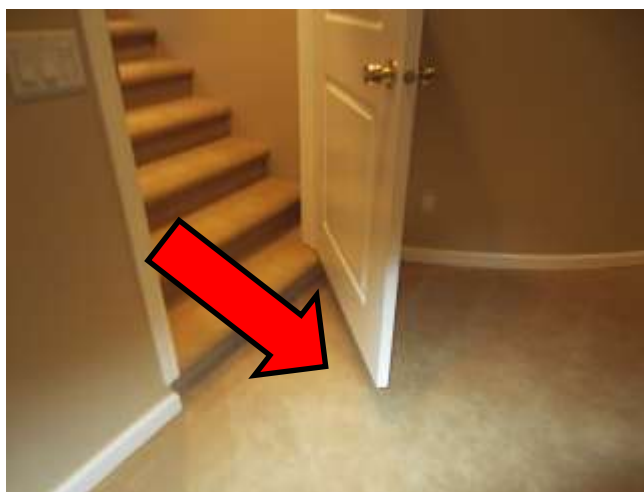
Door should swing over a 3' x 3' landing

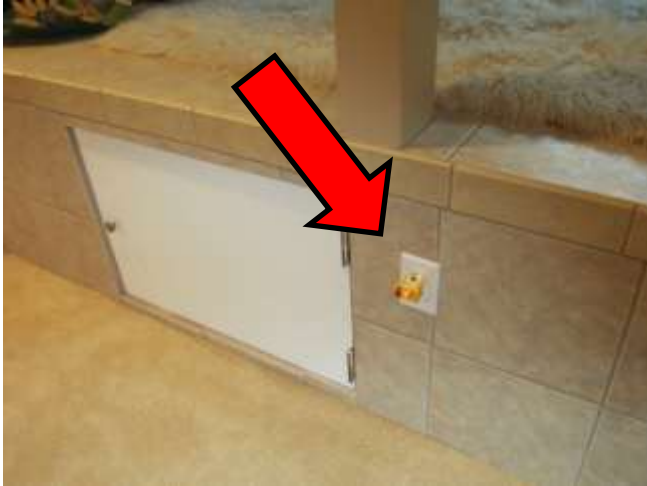
Ungrounded outlet

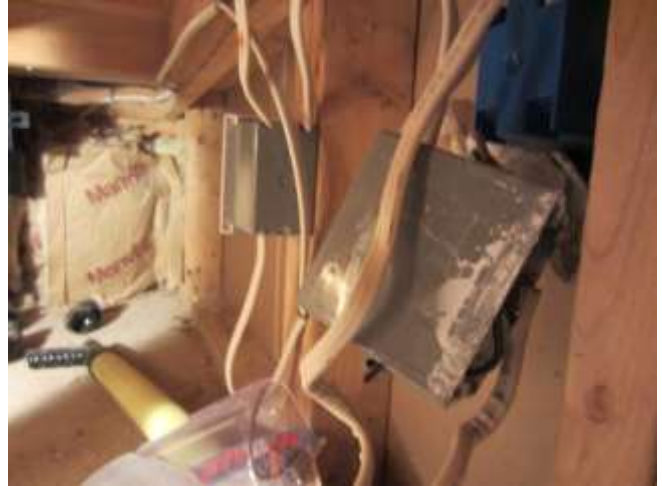
Unsecured wires and boxes at spa access

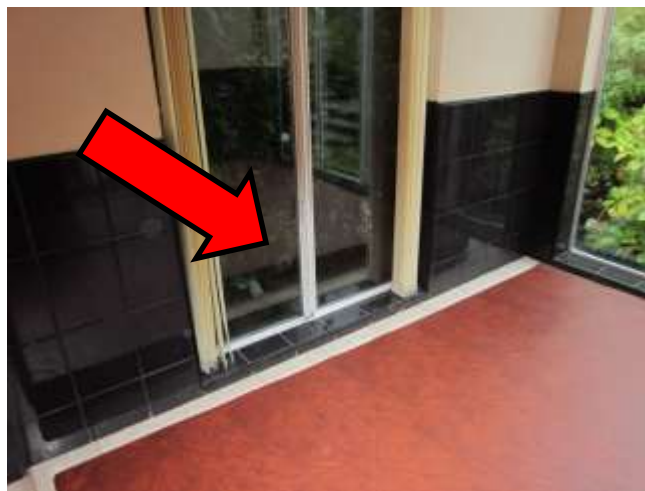
Windows adjacent to spa are not tempered
