Property Description: (1) level condominium in a multi-story building  
Property age/ size: Built 2006, 1,137 s.f. per listing  
Occupancy Status: Vacant

Inspection Date: 12/10/2011  
Inspection Time: 9:00 A.M. – 11:00 A.M.  
Weather Conditions: Overcast, 40 deg F +-

Hergert Inspection LLC

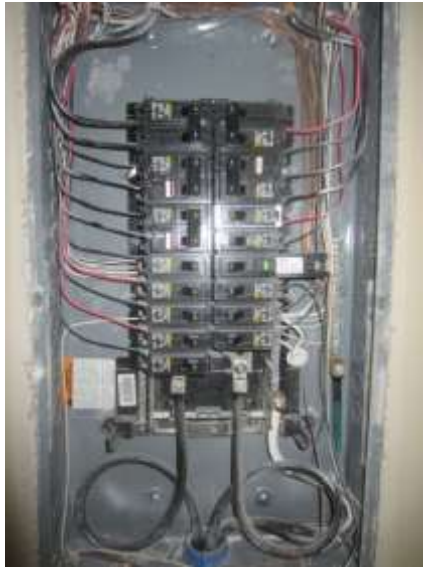
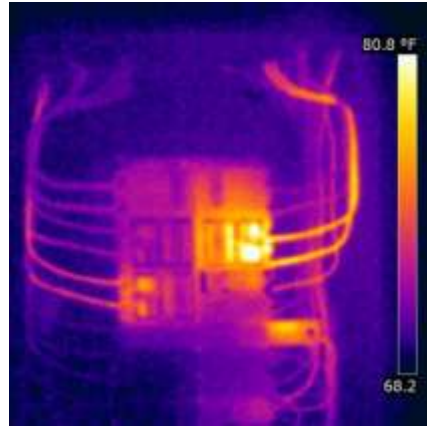
No evidence of over heating

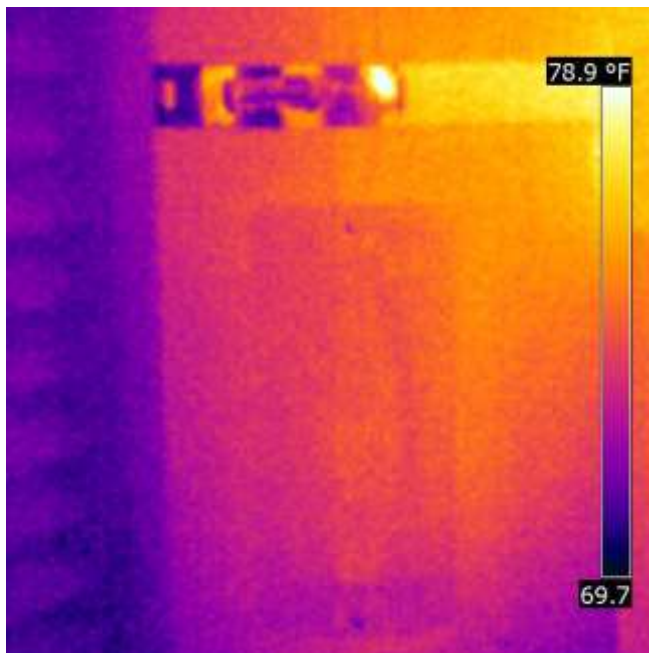
Heat from upper heating element

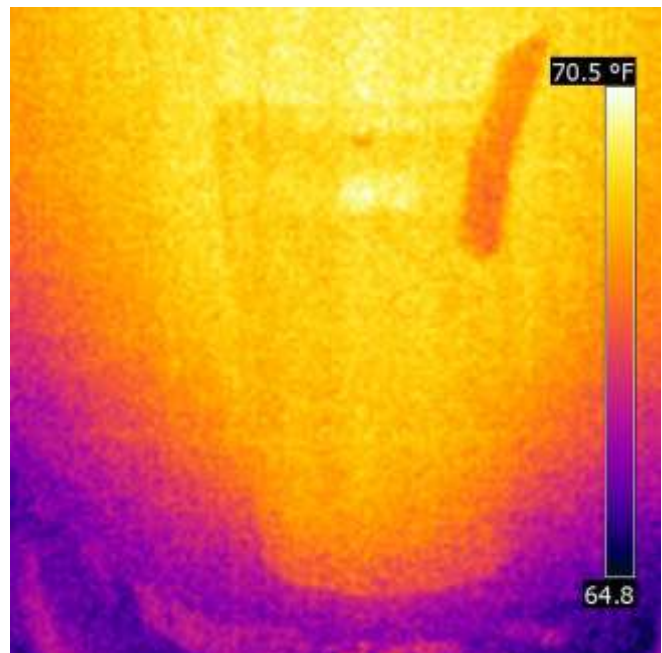
Hear from lower heating element

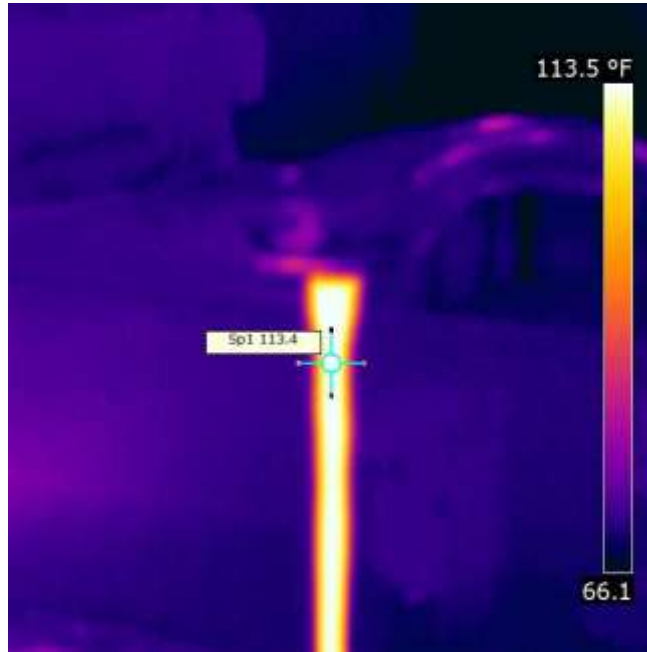
TMP valve: As per required  
Earthquake Straps: Installed  
Safe water temperature: 120 deg F per industry standards  
Measured temperature: 113 deg F

Water temperature @ kitchen

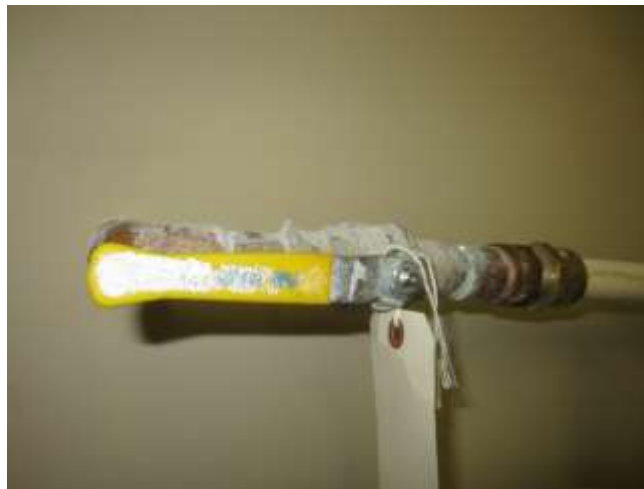
Shut off: - *Utility closet. This valve will not shut off the fire control system*

Domestic water shut off

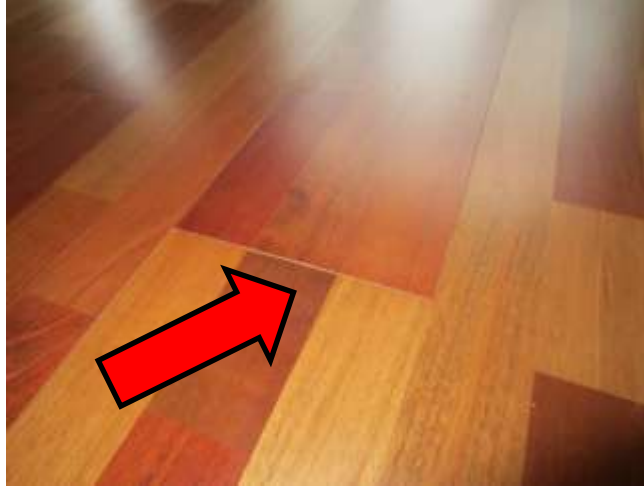
Visibility: Room is vacant  
Structural Movement: No visible evidence  
Moisture Infiltration: No visible evidence  
Walls: Satisfactory  
Ceiling: Satisfactory  
Flooring: - Hardwood flooring does not lay flat at various areas of the Living room. Sharp edges of the boards are not flush to the adjacent boards

Edges of laminate hardwood are not flush

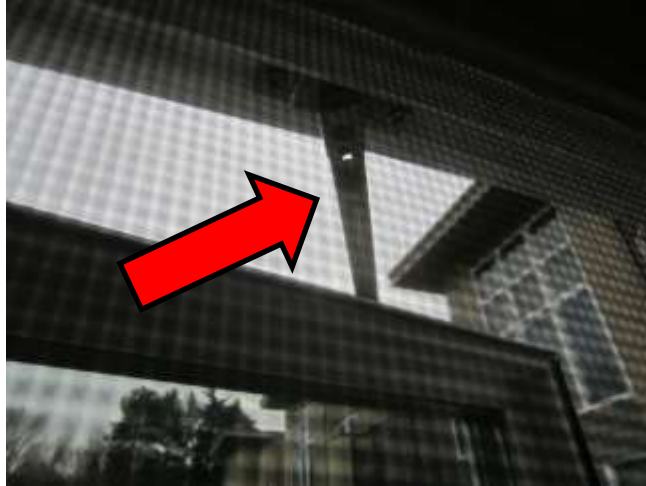
Glazing: No visible defects  
Tempered: Not required  
Operation: Tested  
*- Window opening limiter has been removed from (1) window. Fall hazard as window sill are approximately 12" above the floor*  
Screen: No visible defects

North window has limiter installed  
All others have been removed

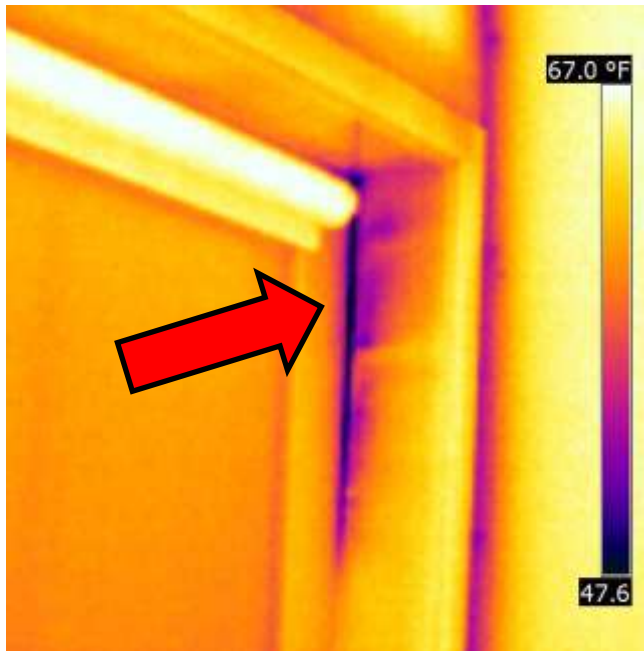
- Substantial air leakage at door to deck. Recommend replacement of weather-stripping and/or adjustment of the door

Air leakage at the door to the deck

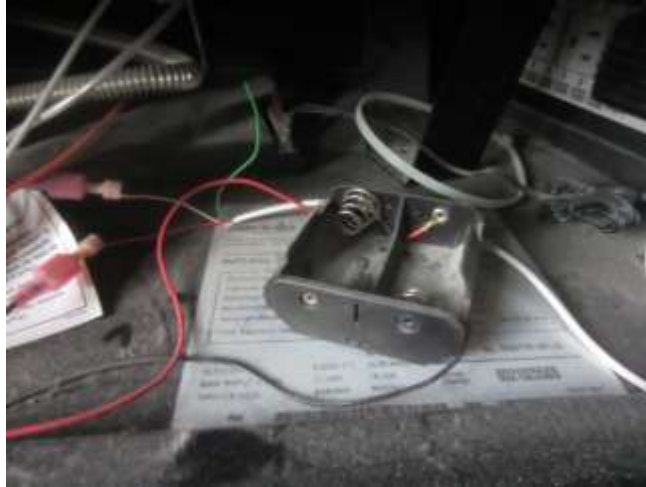
Battery compartment in lower compartment of fireplace (2) D batteries

*- Install D batteries at fireplace for ignition of the fireplace during a power outage*

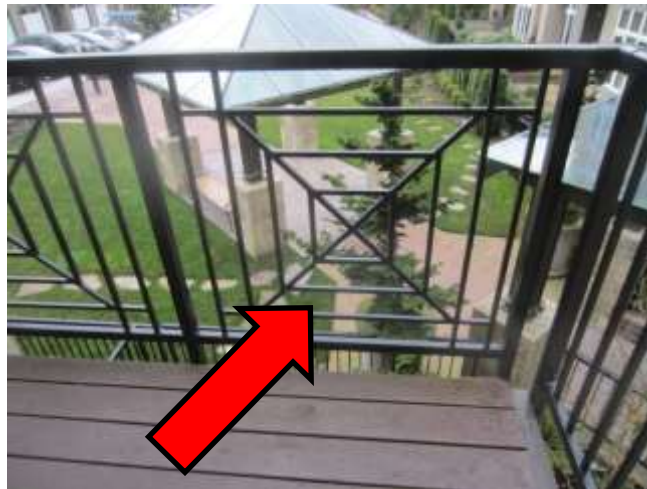
Barricades: *- Deck barricade is a "ladder style" railing. This style of barricade is a potential fall hazard. Recommend cover barricade if small children are present.*

Ladder style barricade

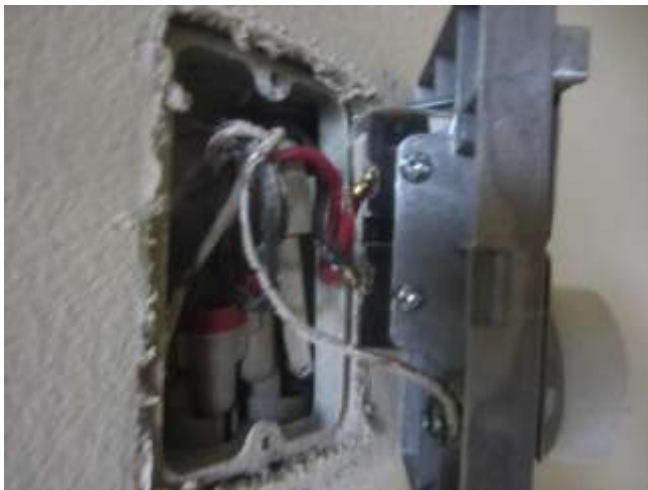
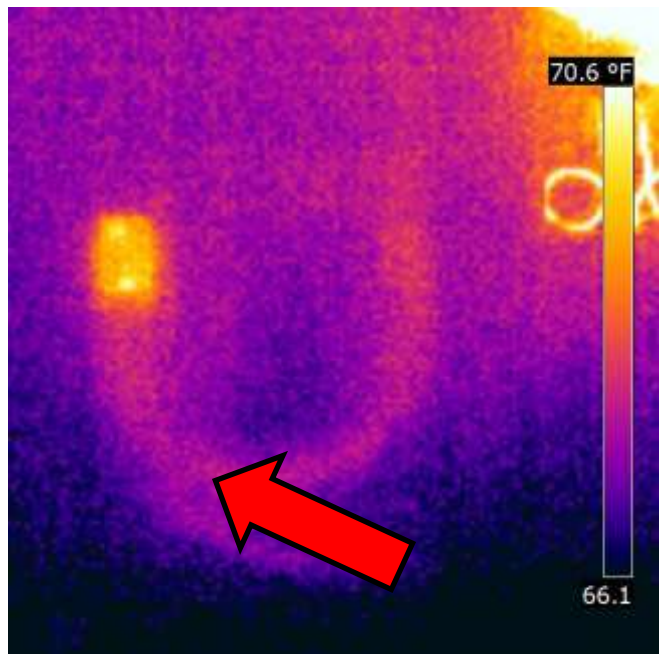
Electrical wires to thermostat

Source: Electric baseboard  
*- If heating system is moved, recommend that this work be completed by a licensed electrician*  
Air Flow/ Heat Gain: Satisfactory

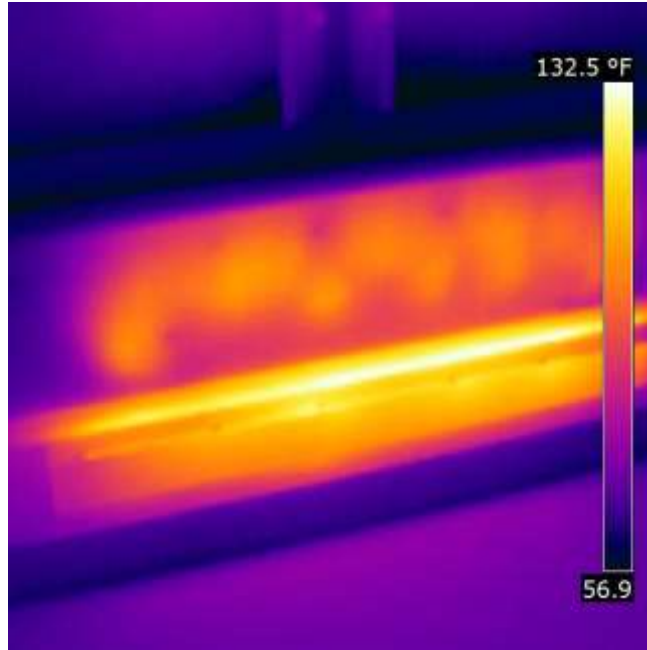
Maintain proper clearances to combustibles

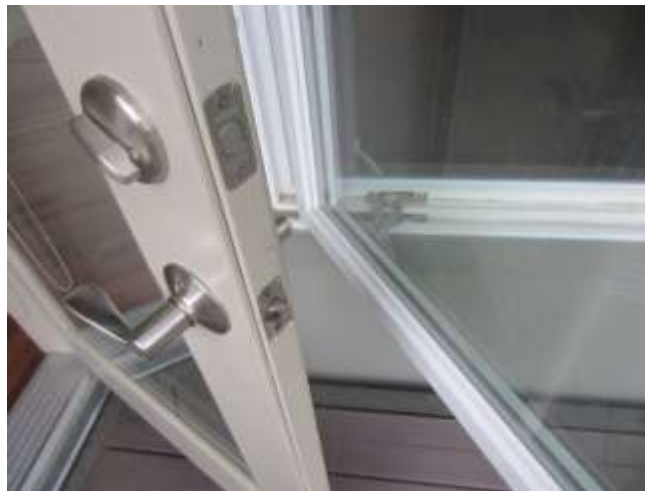
Window conflicts with deck door

- Glazing: No visible defects
- Tempered: Not required
- Operation: Tested
  - Recommend install limiter on South window as this window conflicts with the exterior deck door
- Egress: Appears to meet current egress standards
- Screen: No visible defects

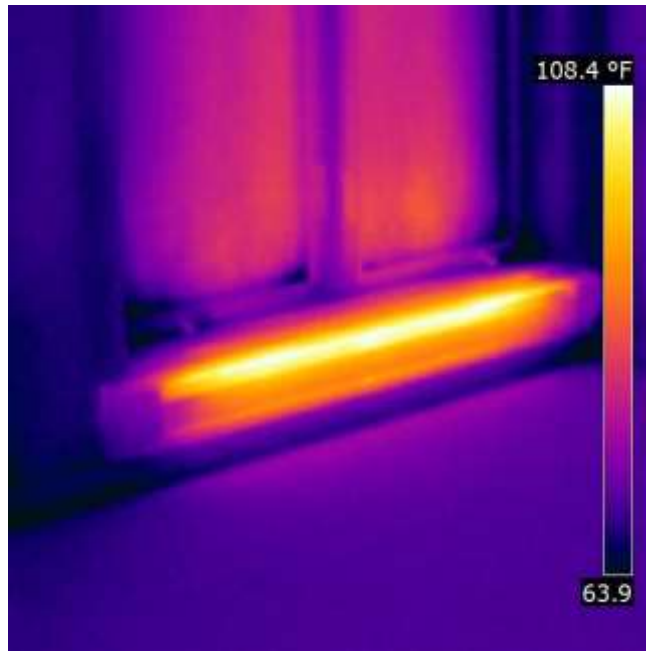
Maintain proper clearances to combustibles

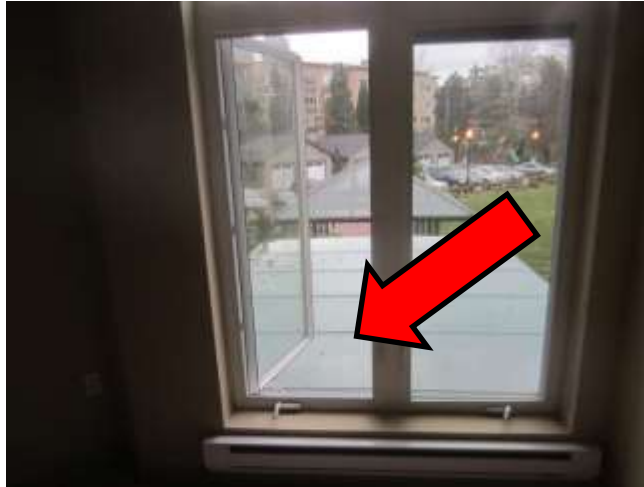
*- Window opening limiters have been removed. Fall hazard as window sill are approximately 12" above the floor*

Casement windows can fully open  
Condominium is on the 3<sup>rd</sup> floor
