Property Description: (1) story single family home with detached garage w/apt  
above

Property age/ size: 1,942 s.f, built 1999 per listing

Inspection Date: 09/03/2011

Hergert Inspection LLC

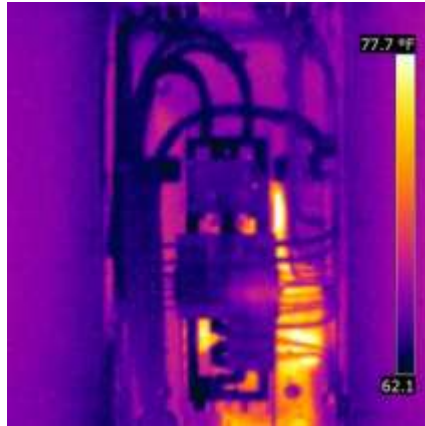
No evidence of over heating

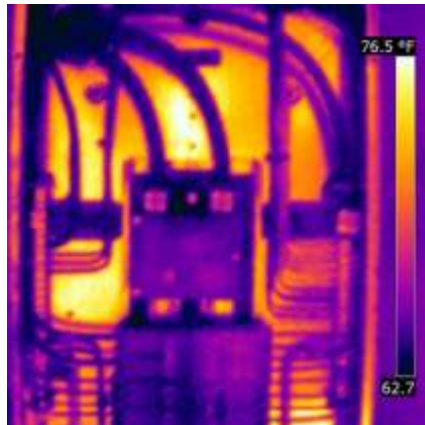
No evidence of over heating

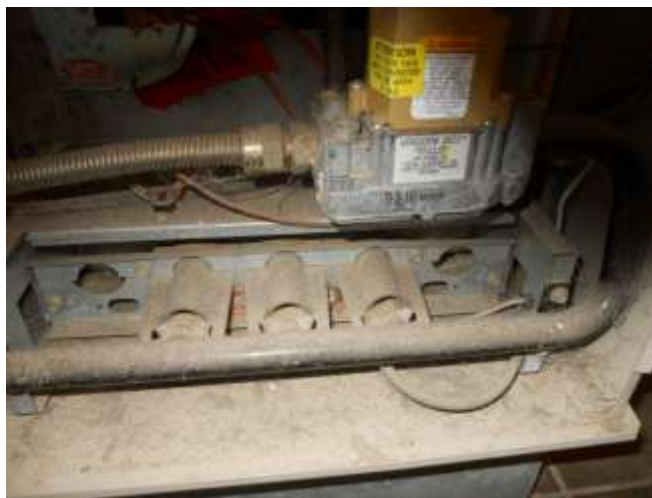
Est. Useful Life new: 25 years  
Est. age of furnace: 12 years +-  
- Furnace not tested due to lack of propane. Blower fan operated and furnace when thru ignition cycle. Furnace is extremely dirty. Recommend service and cleaning by a licensed furnace technician

Dust and lint in burner area

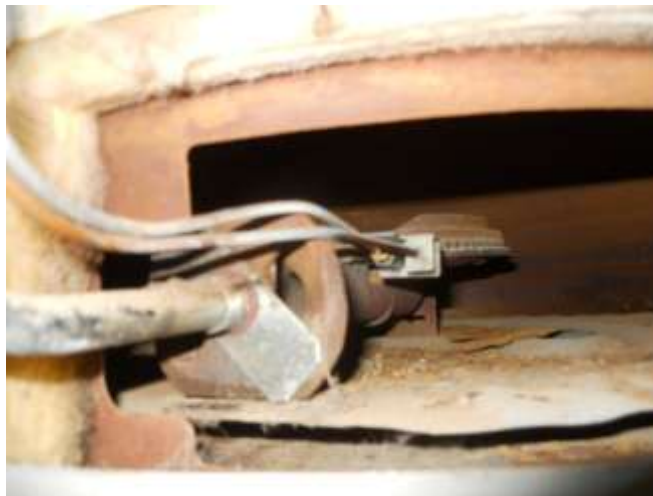
- Water heater not tested due to lack of propane. Substantial rusting inside burner area of tank. Both water heaters are beyond their anticipated useful life expectancy

Rust in burner compartment

Earthquake Straps: Installed  
Expansion Tank: Installed  
Flame Rollout: Yes, burn marks on front of compartment

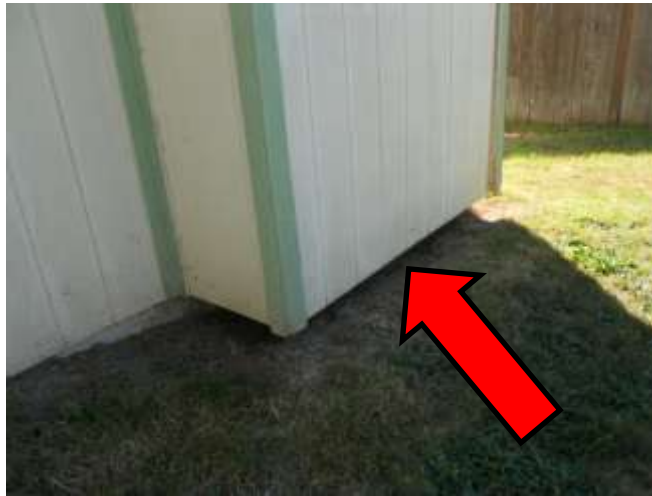
Type: Composite  
Condition: Satisfactory  
- Insulation and soffit not installed at cantilever (rear of addition)  
Window/Door Flashing: Satisfactory  
Caulking: Satisfactory

Insulation and soffit not installed

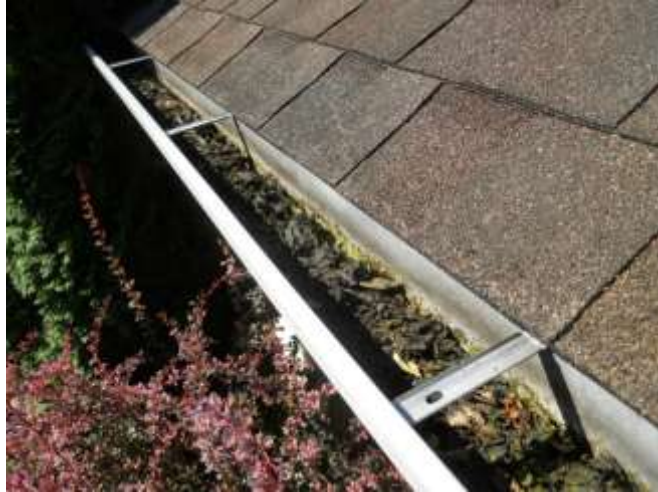
Type: Continuous metal  
Condition: Satisfactory, minor debris in gutters

Debris in gutters (typical)

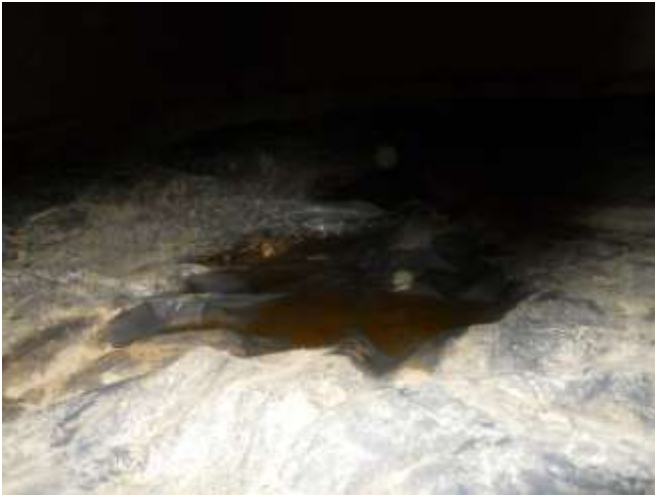
Ventilation: - Ventilation is not provided at addition area of house. Foundation vents at original area of house are blocked by insulation  
Vapor Barrier: As required  
Moisture Intrusion: - Evidence of moisture intrusion (standing water) primarily in addition area. Minor amount of standing water beneath Dining area  
Sump Pump: None visible

Standing water in addition area

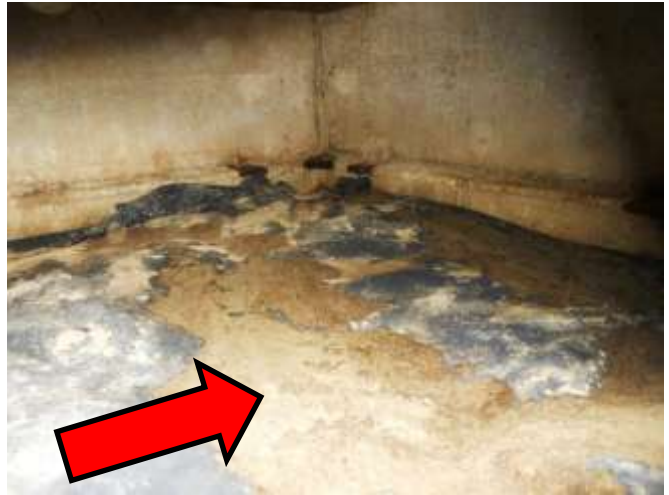
Mud trail beneath corner of addition by deck

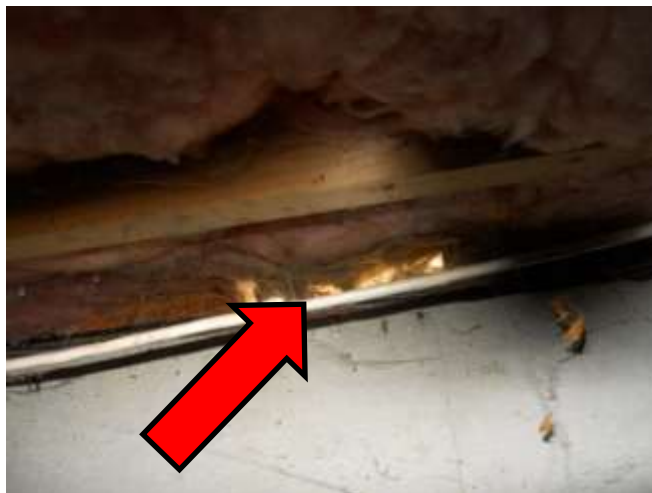
Partially obstructed foundation vent at original house

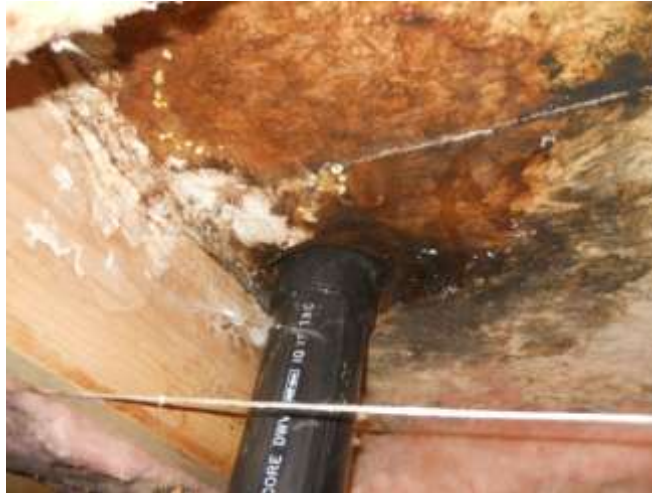
Condition: *- Substantial plumbing leak at Master bathroom area. Subfloor is damaged far beyond repair and should be removed. Evidence of mold like substance on sub floor. Standing water on vapor barrier below*  
Valves/ Other: None visible

Moisture damage below Master bathroom

Visibility: Room is vacant  
Structural Movement: No visible evidence  
Moisture Infiltration: No visible evidence  
Walls: Satisfactory  
Ceiling: Satisfactory  
Flooring: - Substantial moisture damage to bathroom flooring  
- See comment in Crawlspace section  
Cabinets: Satisfactory  
Countertops: Satisfactory  
Mirrors: Satisfactory

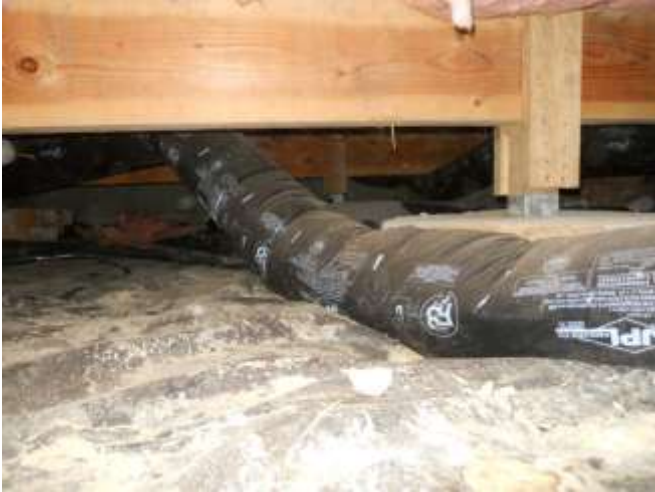
Duct Work: *- Several heating ducts are not properly secured; some have pulled loose from trunk line*  
Ventilation Ducts: *- Substantial lint near crawl access area by clothes dryer. Recommend verify integrity of dryer vent ducting and move wall exhaust jack away from access and crawl vents*  
Gas Piping: No visible defects

Heating duct lying on ground

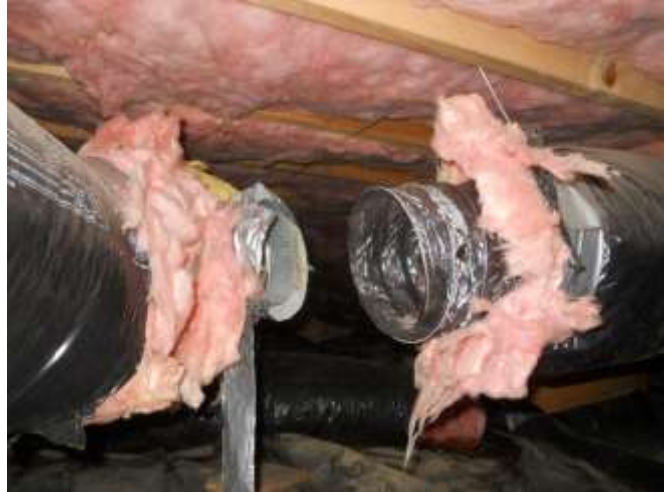
Heat duct disconnected from trunk line

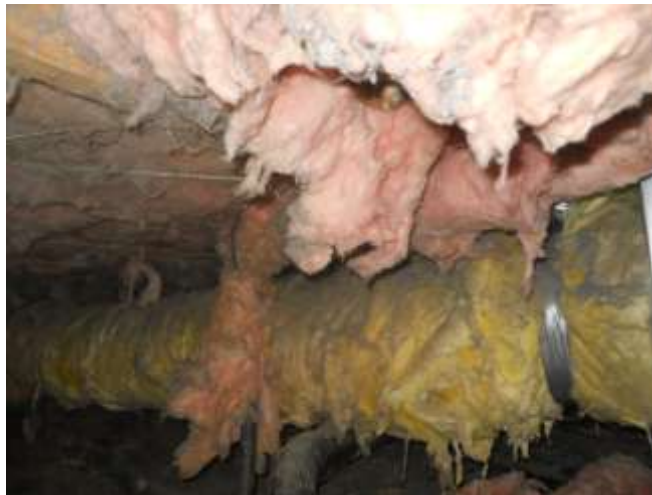
Substantial lint in crawlspace near dryer vent

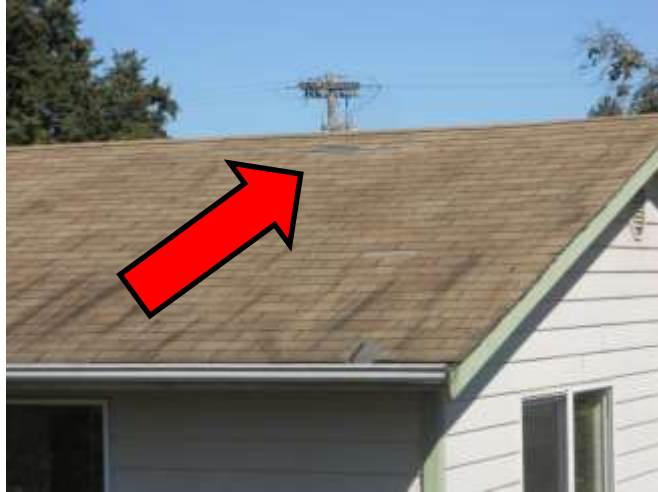
Estimated Pitch: 4:12  
Material: Composition  
Layers: 1+  
How Inspected: From roof of main house and eave  
Condition: - Shingles are missing at apartment roof. Possible moss on apartment roof that is not visible from house. Recommend full inspection of this roof when repairs are made  
- *See comment in Attic section*  
Ventilation: Eave and ridge vent  
Plumbing Vents: Satisfactory  
Flashing: Satisfactory

Shingles missing at roof

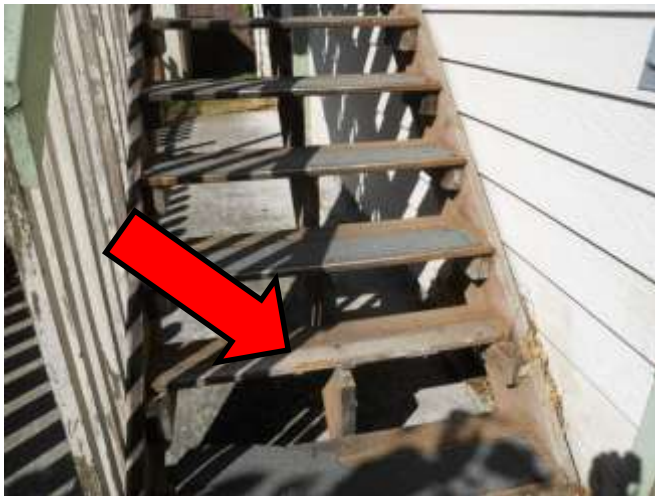
Structure: Pressure treated joists  
Decking: Cedar  
Condition: - Deck stair treads are deteriorated and barricades are not secure at apartment  
Connection to Structure: Lag bolts  
Trip Hazard: None  
Handrails: - Graspable handrail not installed at apartment stairs  
Barricades: As required. *See comment above*

Broken stair tread (typical)

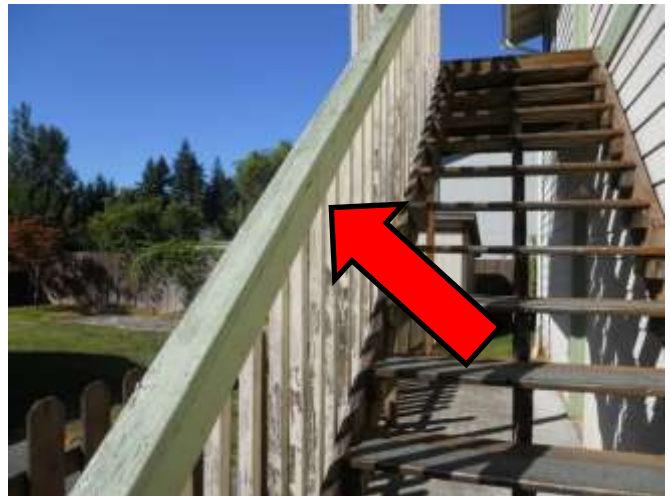
No graspable handrail

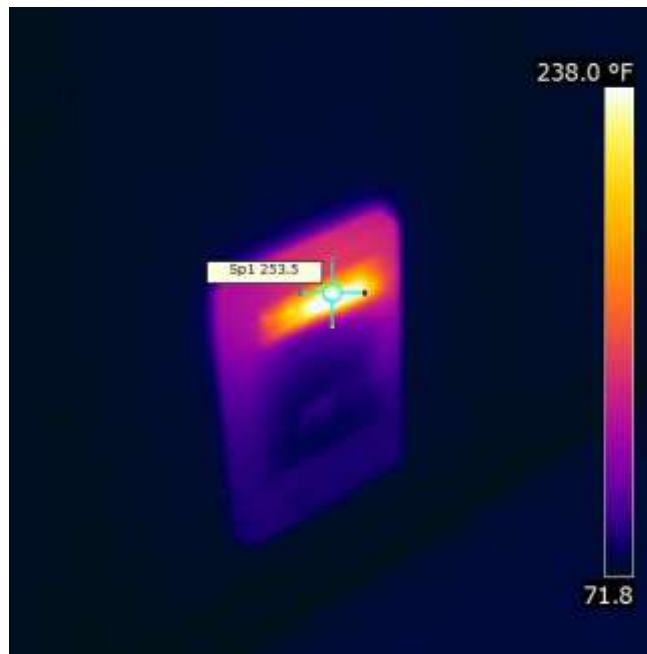
Maintain proper clearances to wall heaters

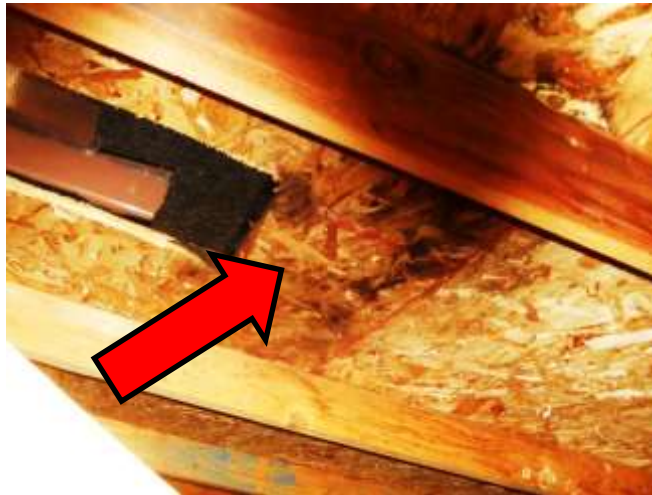
Visibility: Rooms are vacant  
Structural Movement: No visible evidence  
Moisture Infiltration: - *Evidence of prior moisture intrusion at ceiling. See attic section*  
Walls: Satisfactory  
Ceiling: Satisfactory  
Flooring: Satisfactory

Roof Ventilation: Appears adequate  
Moisture Intrusion: - Evidence of moisture intrusion at roof vent near attic access. Wood rot at sheathing. Recommend verification of proper flashing at roof jack by a licensed roofing contractor  
Bath/Kitchen fans : All vent to outside

Wood rot at sheathing below roof jack
