Property Description: Split level house  
Property age/ size: Built 1961, 2,100 s.f. per listing  
Occupancy Status: Occupied

Inspection Date: 07/13/2011  
Inspection Time: 3:30 P.M. – 6:30 P.M.  
Weather Conditions: Scattered Clouds, 65 deg F +-

Hergert Inspection LLC

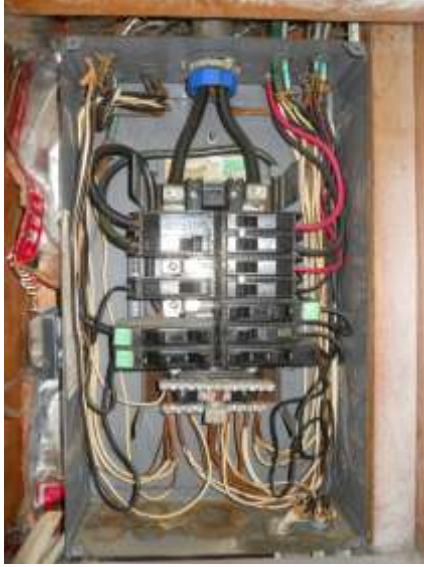
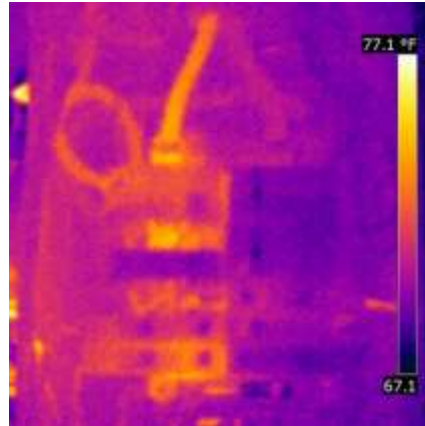
No evidence of overheating

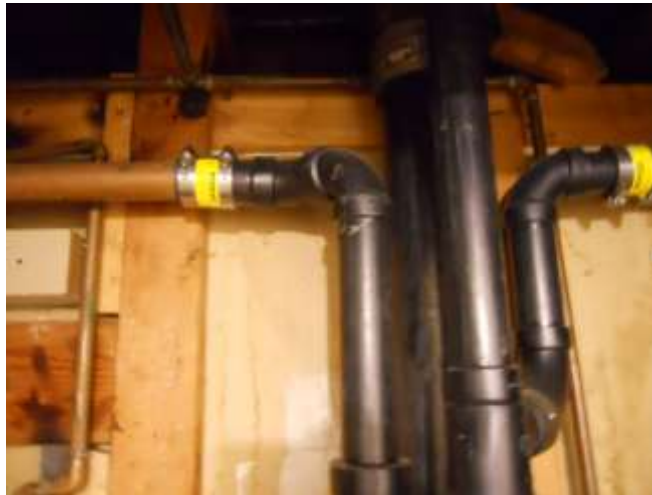
Prior repair to plumbing pipes in Utility room area

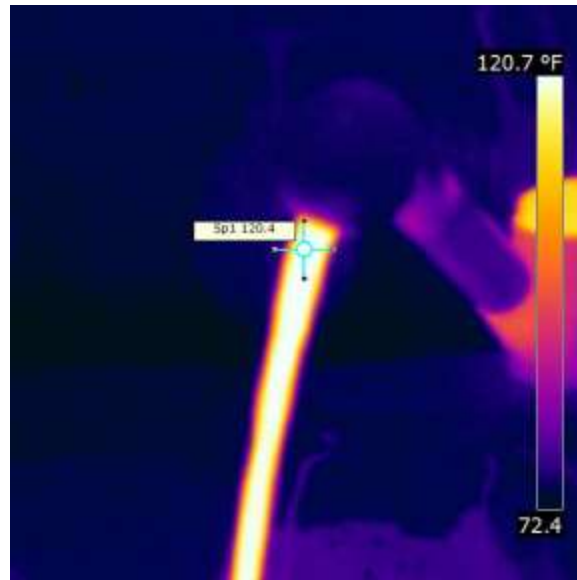
Safe water temperature: 120 deg F per industry standards  
Measured temperature: 120 deg F

Water temperature @ kitchen

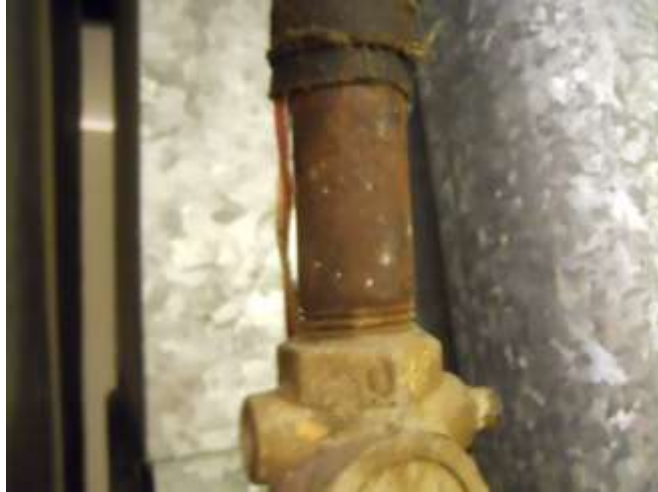
Extensive rust at gas pipes

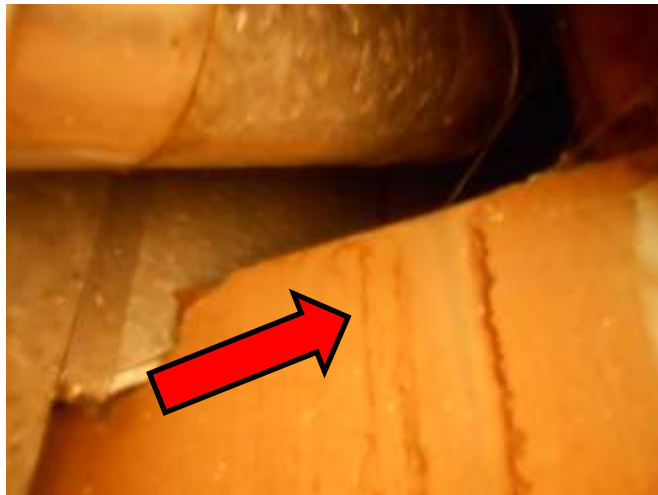
Thermostat: Programmable @ floor 1 hall  
Disconnect: - None  
Combustion Air: *- Combustion air and draft is drawn from the Living space of the house. Staining on walls indicates inadequate combustion and draft hood air. When furnace is replaced, recommend provide exterior combustion air for furnace. See comment above*

Moisture stains below flue indicate inadequate air for draft hood (condensation in flue)

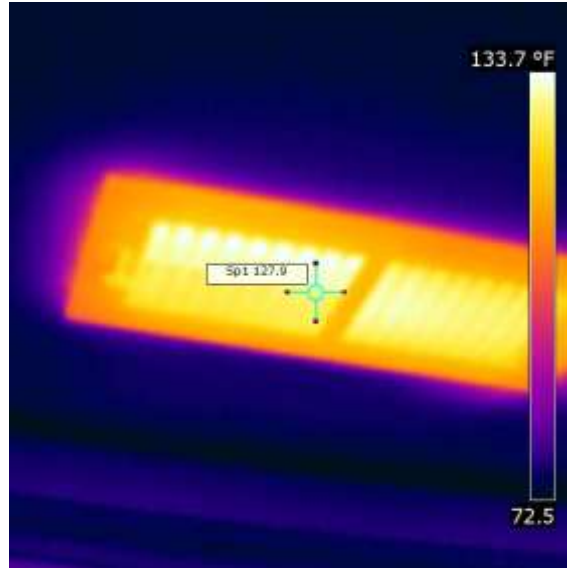
Rating: 70-105 deg F  
@ return air: 70 deg F  
@ nearest register: 133 deg F  
Heat Gain: - 63 deg F. *Heat gain is below the specifications of furnace*

Temperature measured at heat register

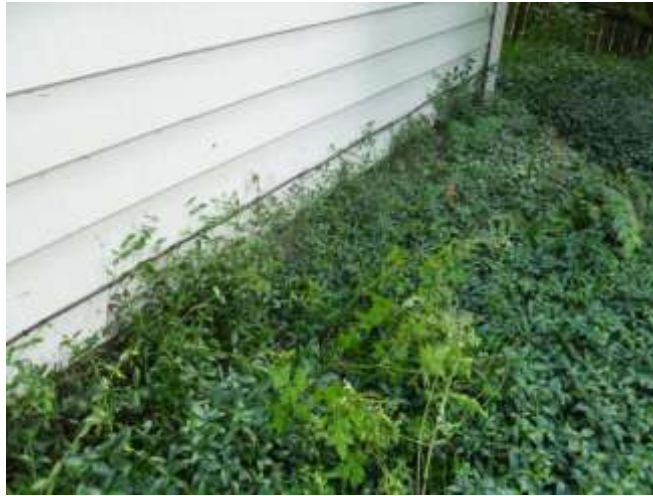
Grade at structure: Adequate grade away  
Earth to wood contact: Clearance as required  
Vegetation contact: - Vegetation in contact with house at several locations (WDO Conducive condition)  
Roof drain discharge: Surface discharge

Vegetation should not be in contact with the house  
(including the roof)

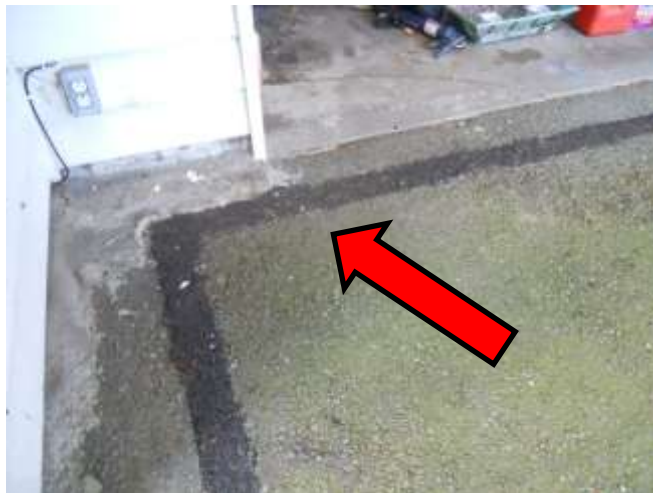
Unknown purpose of repair to driveway near garage

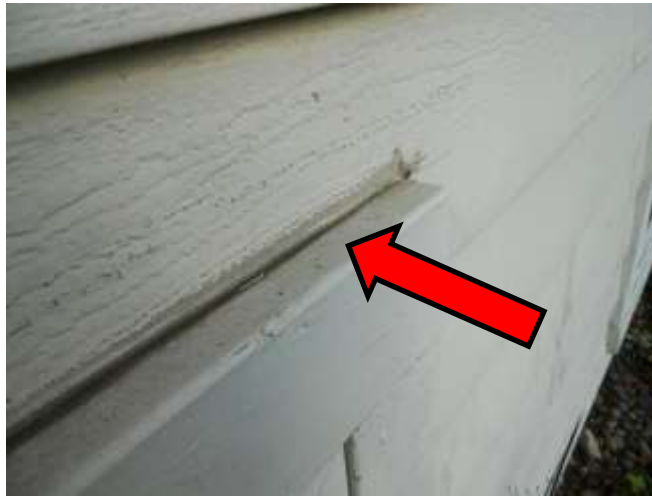
Type: Cedar  
Condition: Satisfactory  
Window/Door Flashing: - *Head flashing is not installed above window trim. These areas must be maintained in order to prevent wood rot and/or leakage behind the trim*  
Caulking: Satisfactory

Flashing not installed at window trim

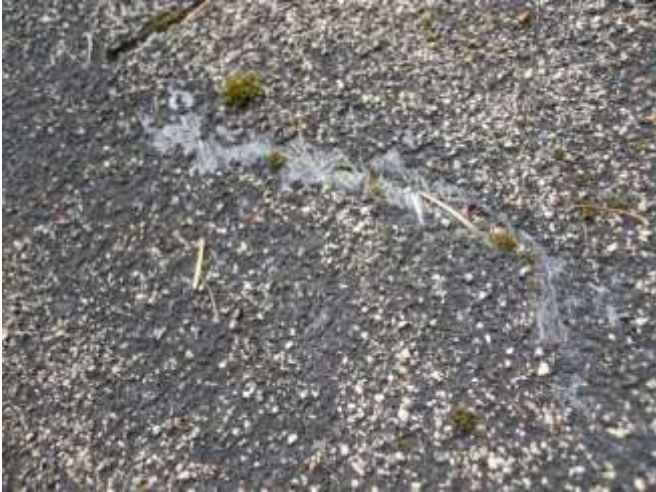
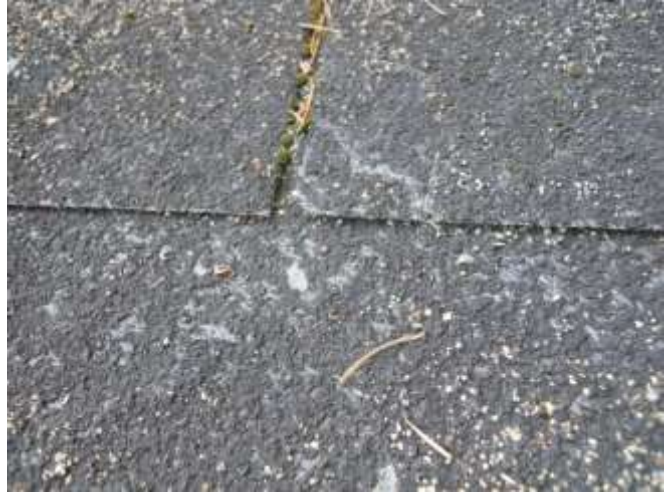
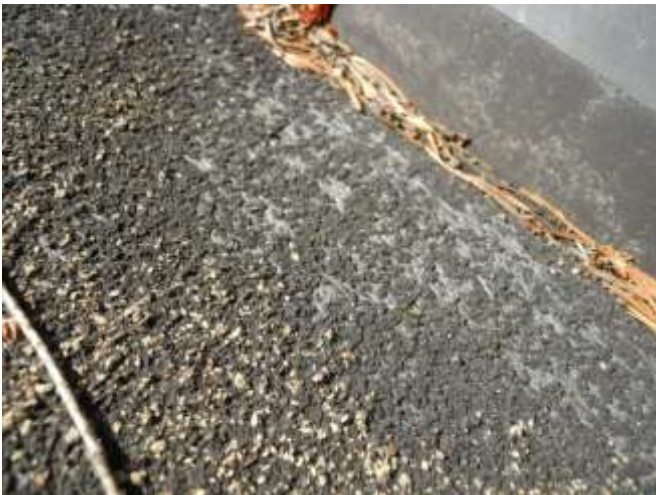
Estimated Pitch: 5:12  
Material: Composition  
Layers: 1+  
How Inspected: - Traversed roof  
Condition: - *Roofing is in very poor condition. All shingles are substantially worn (no granules remaining). Many shingles are damaged or missing. Evidence of leakage into the ridge beam in attic. Recommend removal and replacement of shingles. Plywood sheathing should be replaced as needed. There is a visible sag in the sheathing above the Living room*  
Ventilation: Eave and roof vent  
Plumbing Vents: Satisfactory  
Flues: - Recommend repair of worn and missing mortar at chimney  
Flashing: - Flashing above garage at chimney is improperly installed. A gap exists which will trap moisture and debris

Worn shingle (typical)

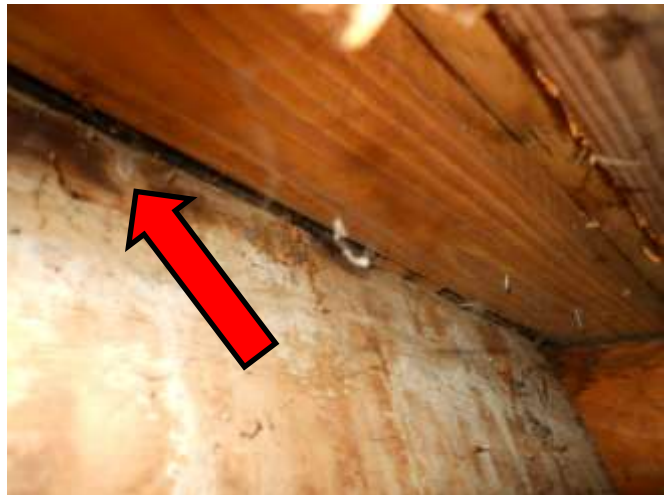
Moisture at attic ridge beam

Roof Ventilation: Appears adequate  
Moisture Intrusion: - *Moisture stains at ridge beam. See Building exterior section*  
Bath/Kitchen fans : All vent to outside where visible

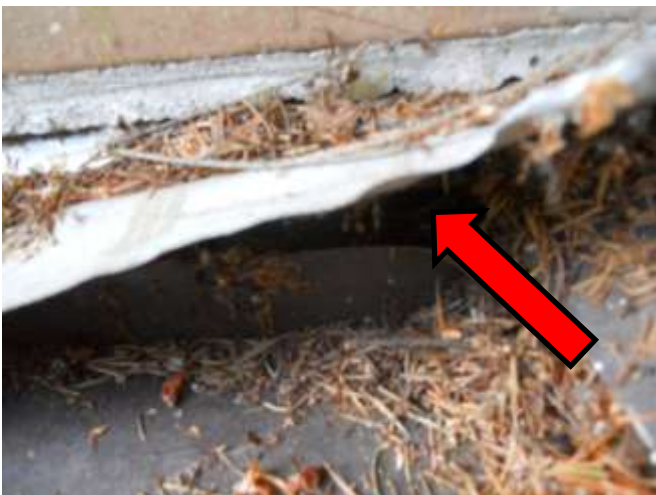
Gap at chimney flashing

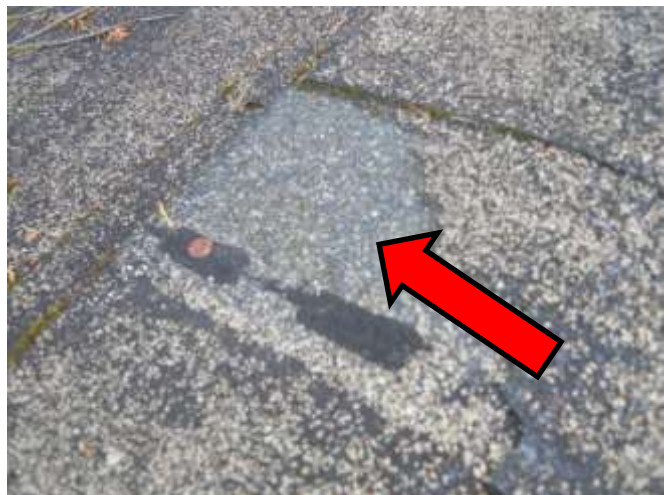
Missing shingle (typical)

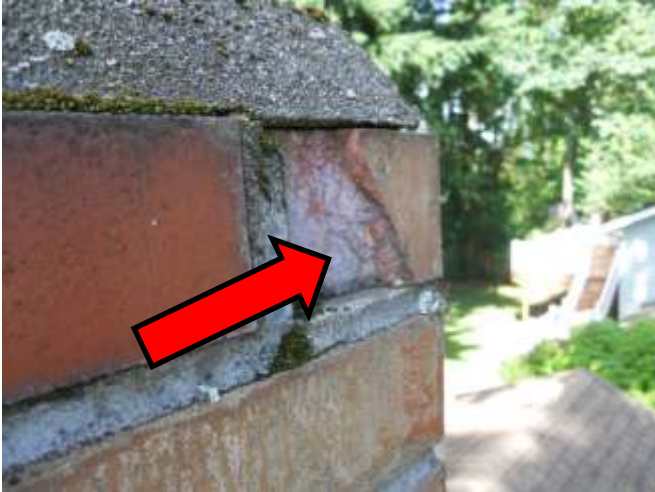
Cracked chimney brick

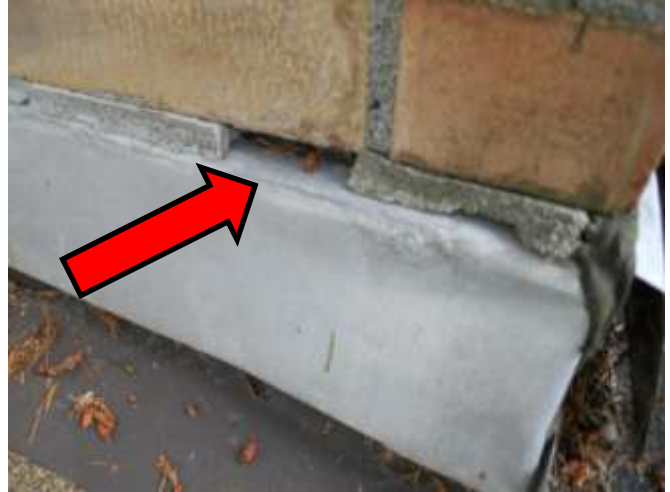
Missing mortar at chimney

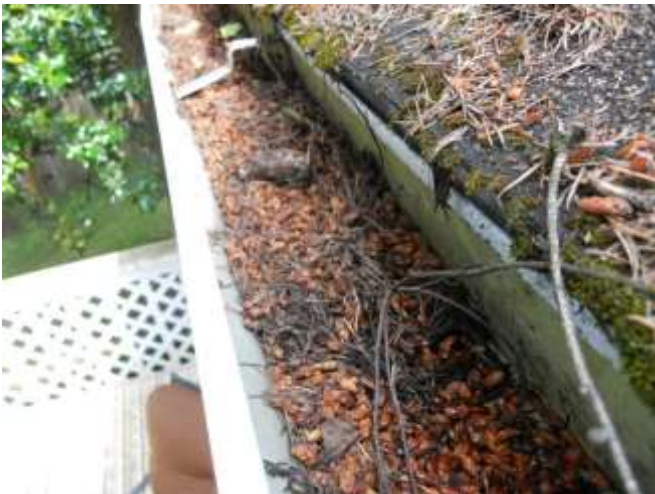
Type: Continuous metal  
Condition: - Gutters are filled with debris. Evidence of gutter leaks in various locations

Debris in gutter

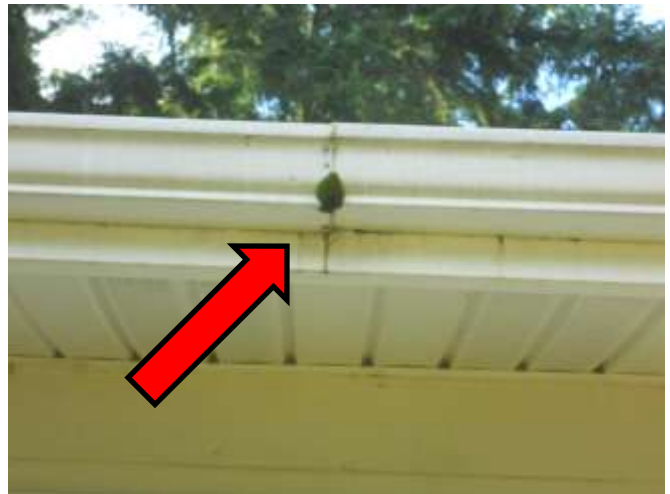
Evidence of gutter leak

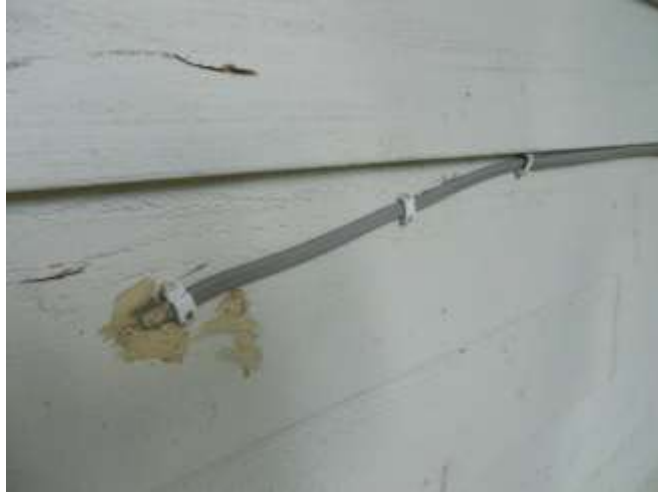
Outlets: *Tested, not GFCI protected as recommended*  
Switches/Lights: Tested  
- Electrical supply to garage should be installed in conduit

Power supply to garage should be in conduit

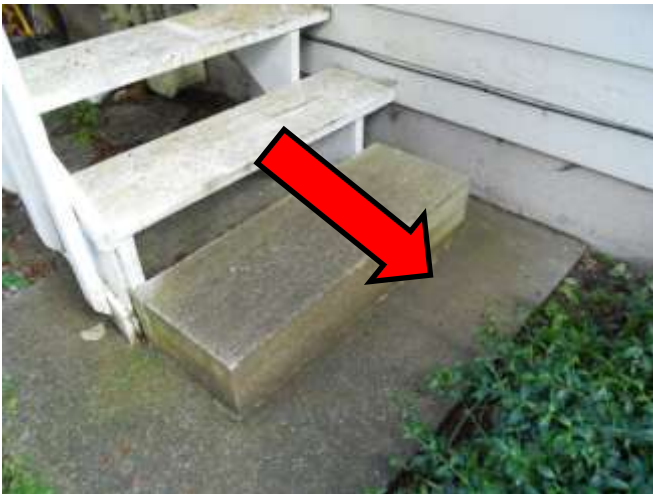
Landing should be 3' in front of last tread

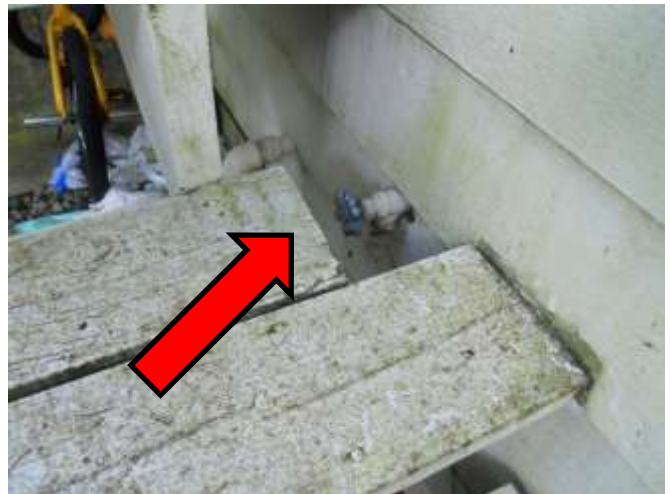
Trip hazard at hose bib

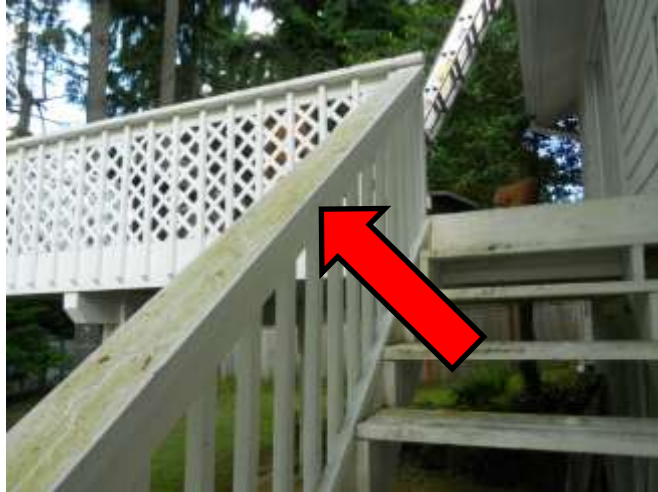
Graspable handrail not installed

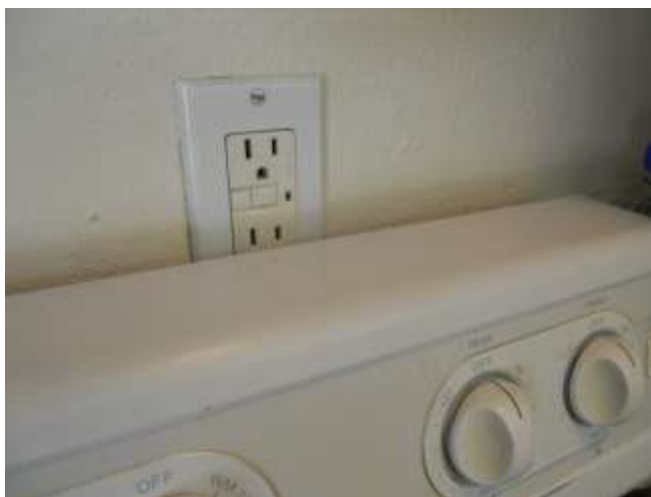
Switches/Lights: All visible tested  
Outlets: - *Outlets adjacent to sink are not GFCI protected as recommended. Outlet above range is a safety hazard due to potential contact of electrical cord with burners*

Electrical outlet above range is a safety hazard

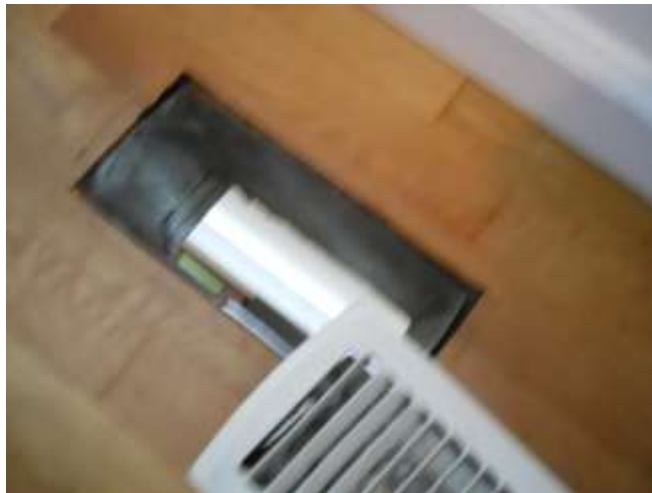
Heat registers are open to rooms below  
(joint heat runs)  
Sound and light will travel from room to room

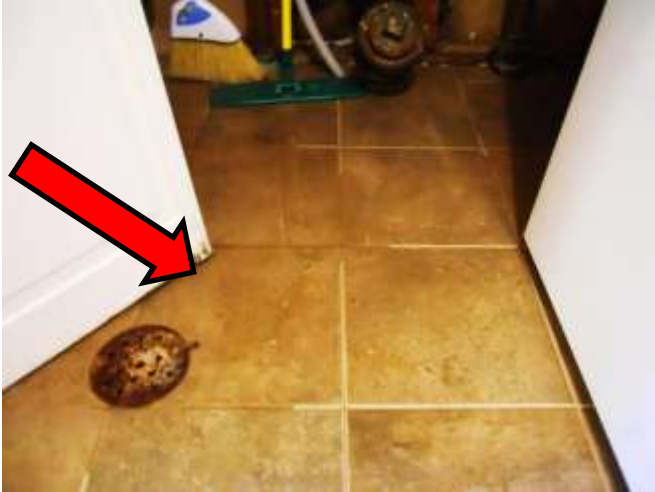
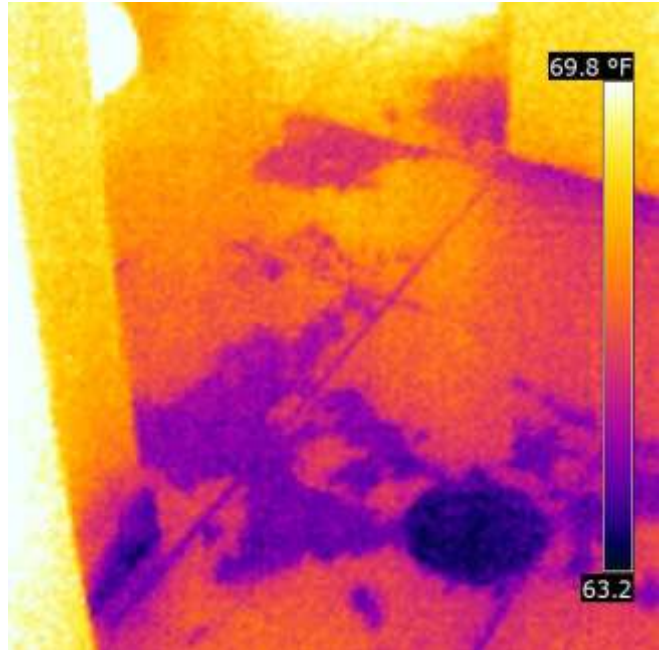
Functional flow: Appears adequate  
Hot/ Cold: Tested  
Drainage: - ***Floor drain is overflowing when plumbing fixtures are operated for several minutes at floor 2. Waste water overflow has damaged the cabinet, baseboards, and drywall in the Utility room (all areas of the room). This drainage issue is likely a clogged waste line in the basement floor or at the exterior discharge system to the septic, or a failed septic system. Plumbing system is not functional in this condition.***  
Visible leaks: - *See comment above*  
Caulking: Satisfactory  
Fixtures: No visible defects

Waste water flowing out of floor drain

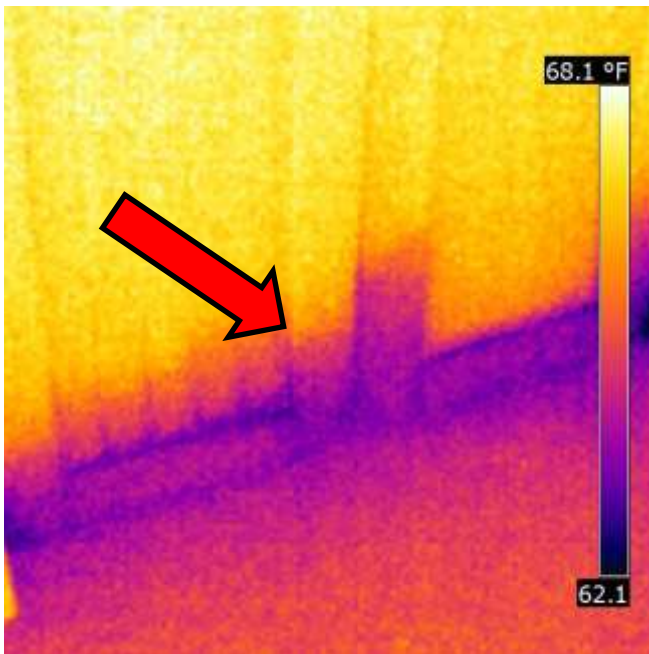
Moisture wicking up into cabinet

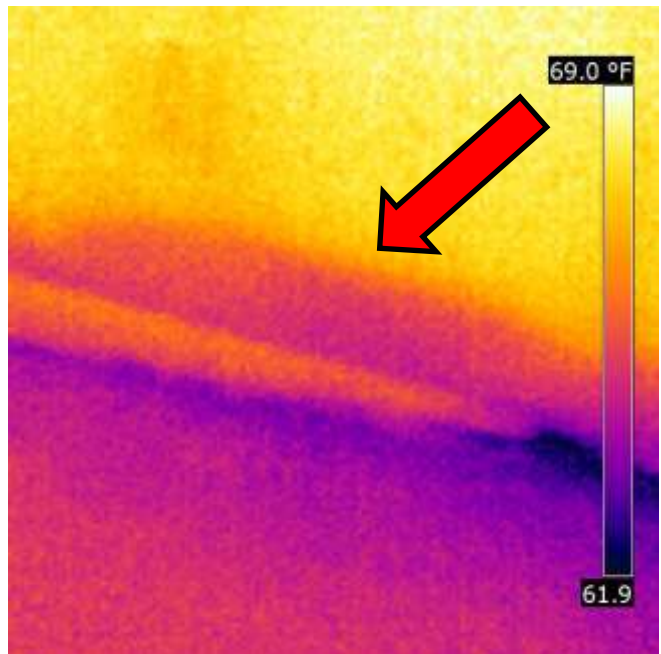
Moisture at wall adjacent to Family room
