(425) 652-6515  
Kevin@Hergert.com  
Wa. Home Inspector 619  
WSDA Inspector 79988  
WSDA Control # 1196AQ-023

Property Description: (2) story single family home  
Property age/ size: 5,620 s.f., built 1990 per listing  
Occupancy Status: Occupied

Inspection Date: 08/26/2011  
Inspection Time: 9:00 A.M. – 1:30 P.M.  
Weather Conditions: Clear, 75 deg F +-

Hergert Inspection LLC

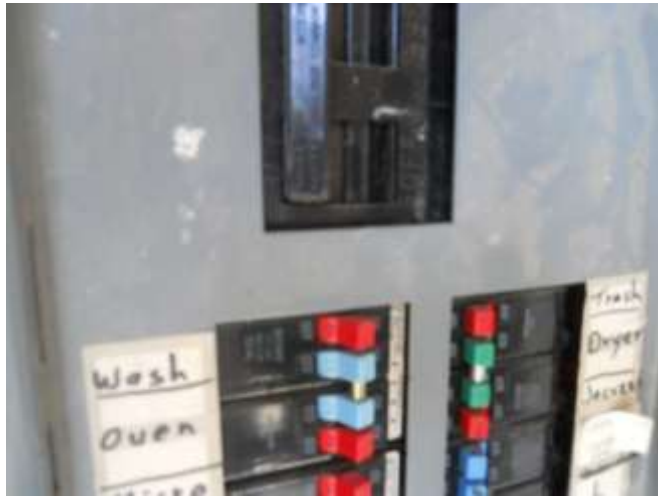
Service panel cover does not fit properly on panel

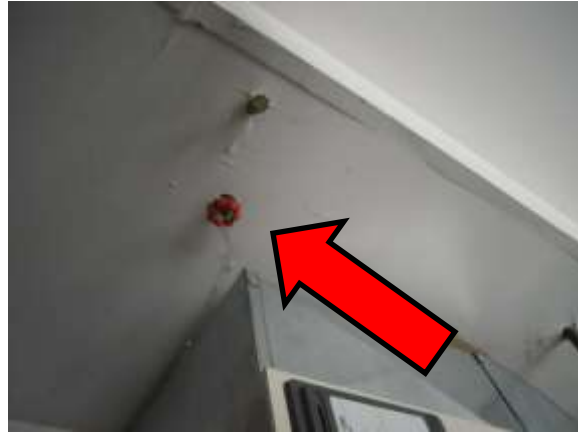
Valve at garage ceiling

- Question to Seller: What is the purpose of the red valve in the ceiling near the garage furnace

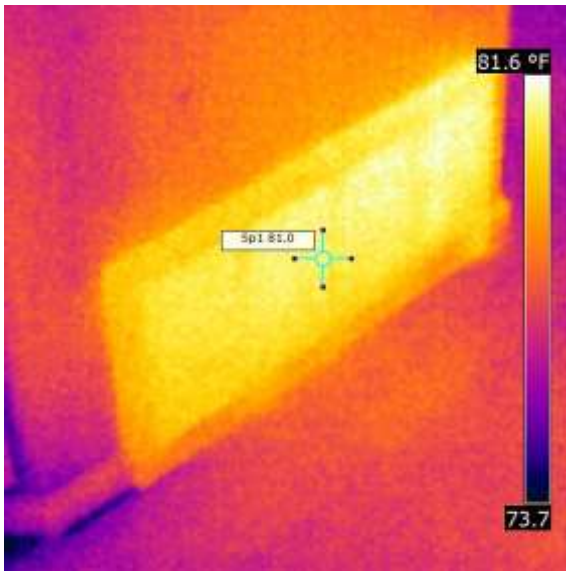
Garage Furnace: Rating: 40-70 deg F  
Heat Gain: 35 deg F  
- *Heat gain is lower than specified. See comment regarding servicing*  
Attic Furnace: Rating 15-45 deg F  
Heat Gain: 24 deg F

Garage Furnace  
Temperature measured at return air

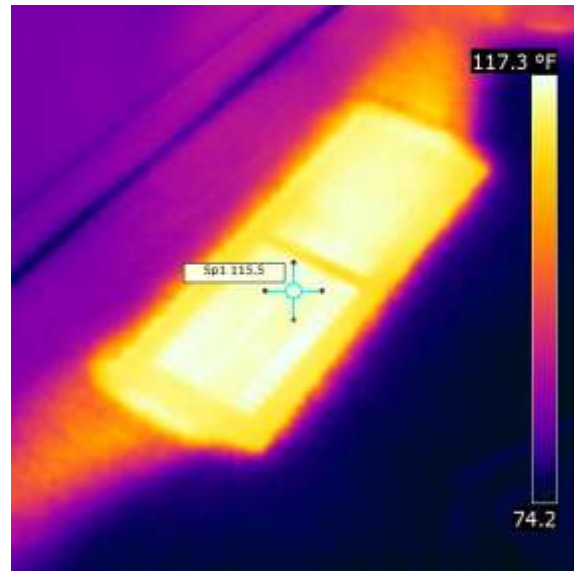
Garage Furnace  
Temperature measured at heat register

Est. Useful Life new: 25 years  
Est. age of furnace: - Unable to determine age of garage furnace. Likely installed 2001 per serial number  
- Attic furnace age is 22 years  
- Both furnaces were last serviced on 10/25/10. Recommend service of furnace every (2) years. Both furnaces are overdue for servicing

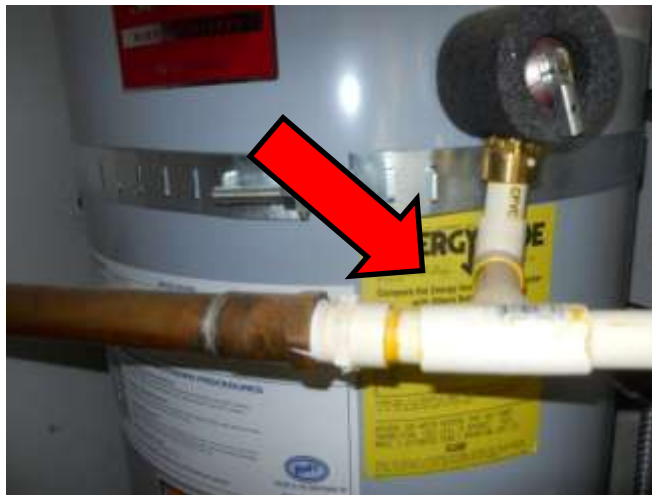
TMP drain lines are tied together

TMP valve: As per required  
- Separate TMP line should be installed for each tank  
Earthquake Straps: Installed  
Expansion Tank: No  
Flame Rollout: No visible evidence

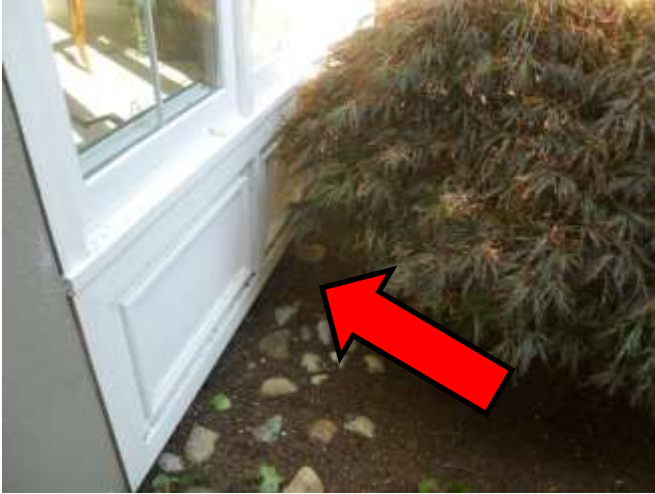
Grade at structure: Adequate grade away  
Earth to wood contact: - *Earth to wood contact in several areas (WDO Conducive condition)*  
Vegetation contact: - *Vegetation in contact with house at several locations (WDO conducive condition)*  
Roof drain discharge: Underground discharge

Earth to wood contact (typical)

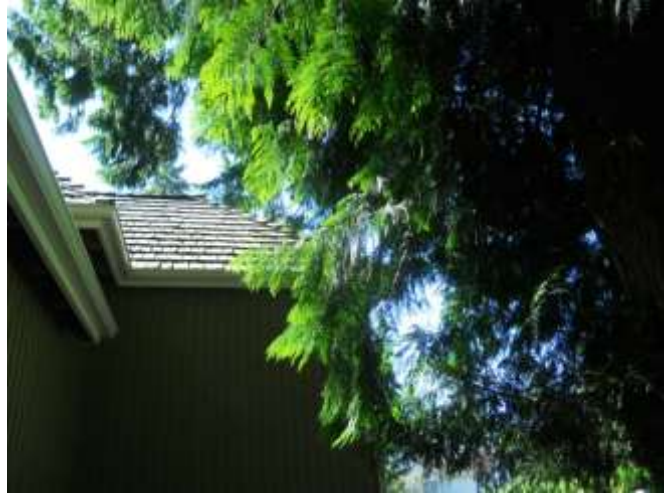
Vegetation in contact with house (typical)

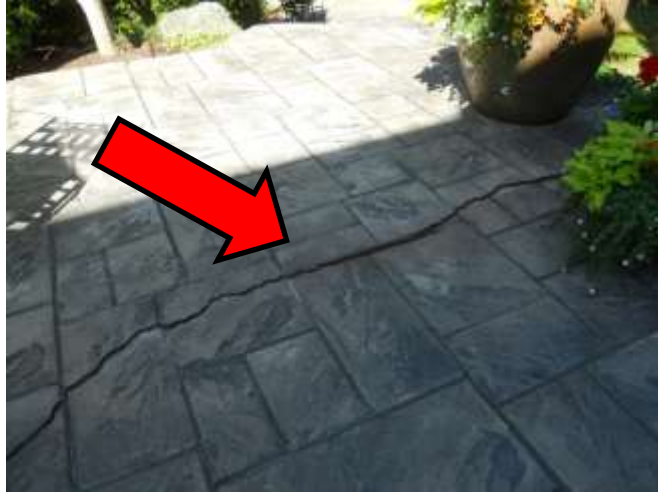
Type: Concrete  
Condition: - *Settlement at rear patio. Minor trip hazard. This hazard may be corrected by slab-jacking. The crack would still be visible*  
Trip Hazard: None  
Barricades: As required

Crack with vertical displacement  
at stamped concrete patio

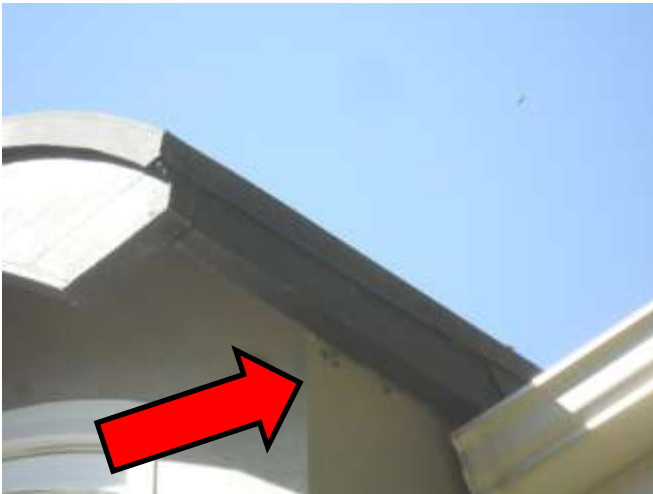
Condition: Satisfactory except as noted above  
Window/Door Flashing: Satisfactory  
Caulking: Satisfactory  
- *Active bee infestation at eave above Living room*

Active bee infestation

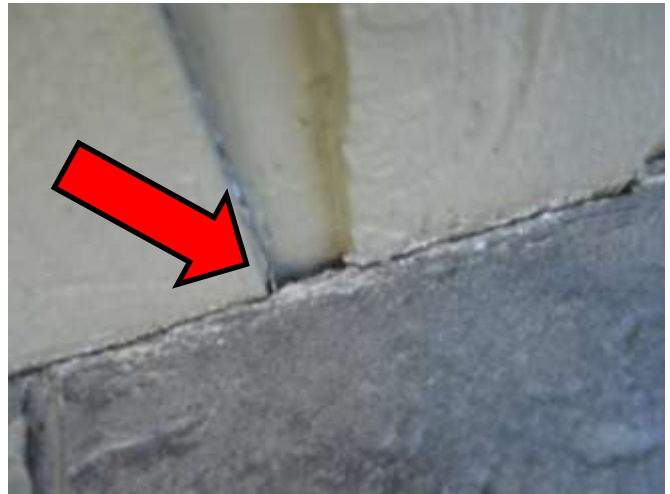
Type: Wood, masonry veneer, and Eifs type stucco  
- ***Eifs type stucco (Exterior Insulation Finishing System) is a known defect and may result in interior wood rot of the wall. Recommend further evaluation by an Eifs inspector. Inspection will likely require removal of drywall in certain areas***  
- *Gaps at siding should be filled to prevent trapped moisture. See crawlspace section*

Gaps at siding can lead to trapped moisture

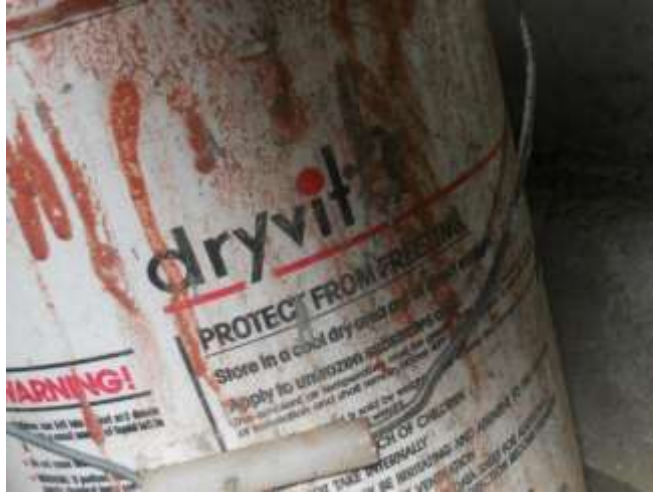
Empty bucket of “dryvit” in crawlspace

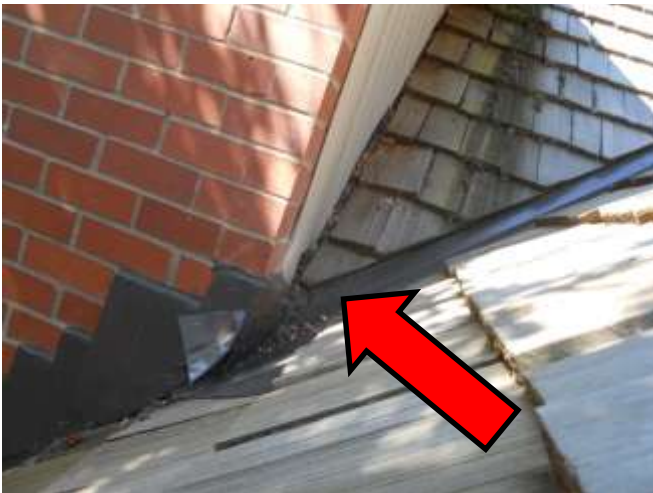
Valley at left side of entryway must be kept clear of debris

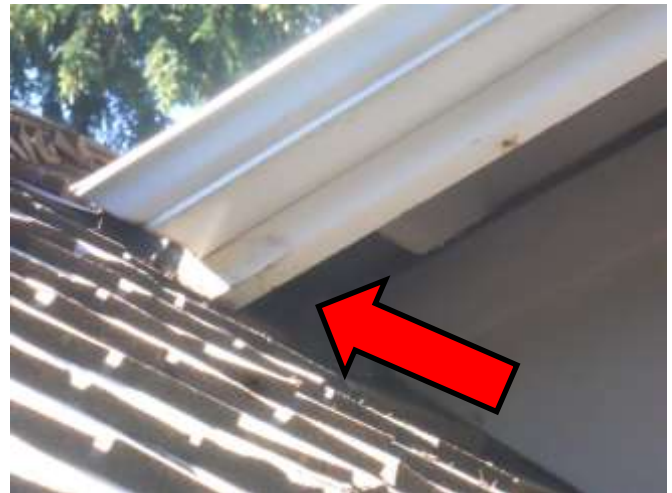
Blocking may be missing at game room (leads to bird nesting)

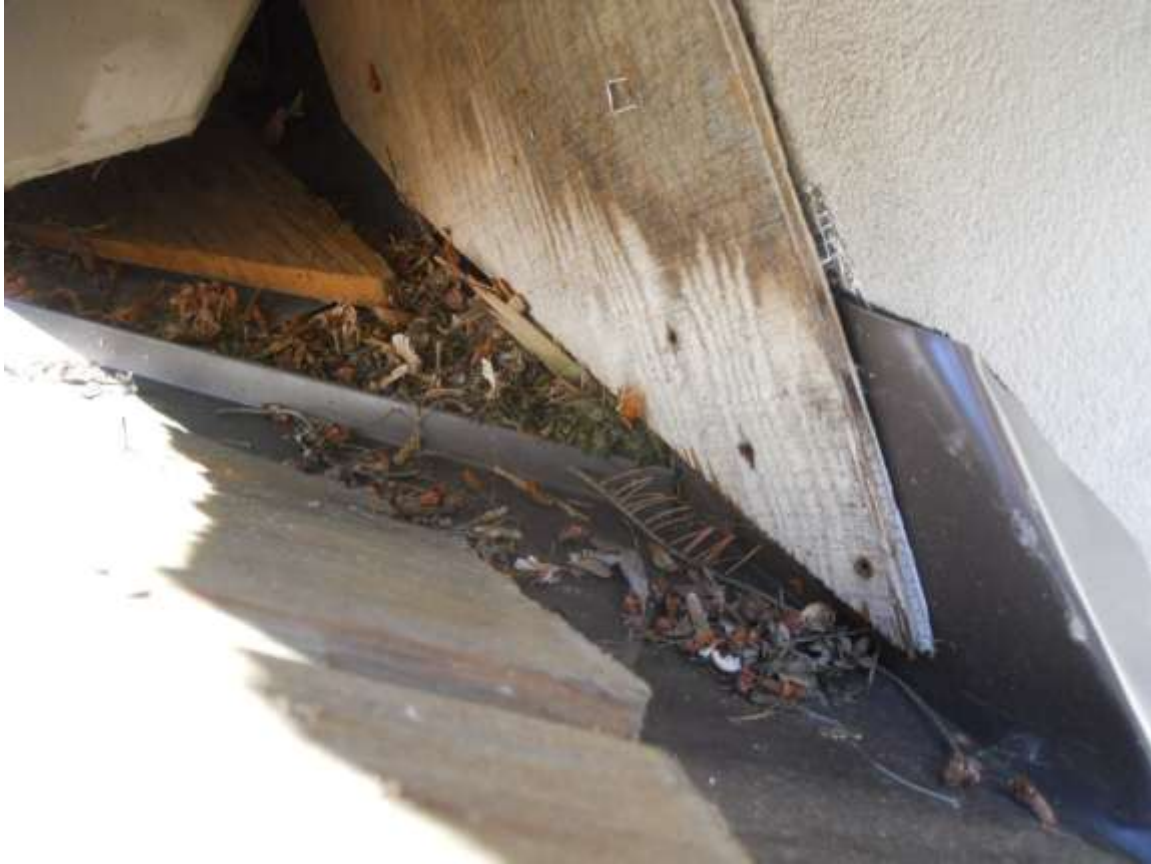
Estimated Pitch: 12:12 +-  
Material: Cedar Shake  
Layers: 1+  
How Inspected: From eave at (3) locations and from street and rear yard  
Condition: Satisfactory  
Ventilation: Eave and ridge vent  
Plumbing Vents: Satisfactory  
Flues: Satisfactory  
Flashing: - Recommend further evaluation of flashing detail at left side of Living room.  
Flashing does not appear to be completed in a workmanlike manner. Fascia should be cut to prevent damming of debris in valley. Evidence of prior leakage at this area in the Living room

Flashing detail at valley adjacent to Living Room

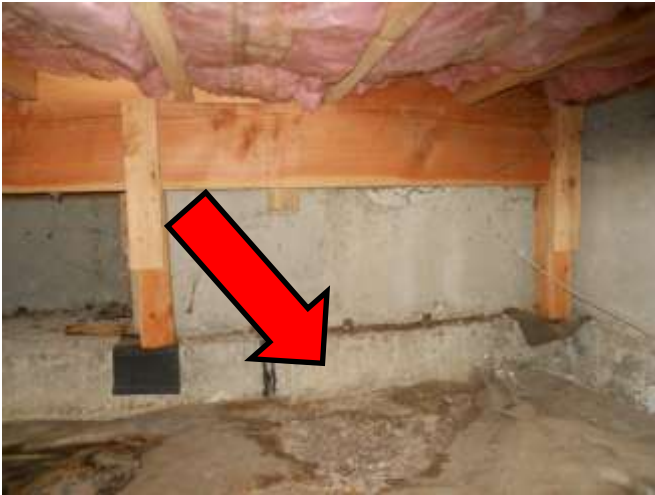
Ventilation: Appears adequate  
Vapor Barrier: As required  
Moisture Intrusion: - Evidence of moisture (and standing water) below Living room. This is at the same area as where moisture stains are visible at the ceiling above. Recommend identify source of moisture (could be from wall or a improperly directed irrigation head outside)  
Sump Pump: None visible

Puddle below Living Room

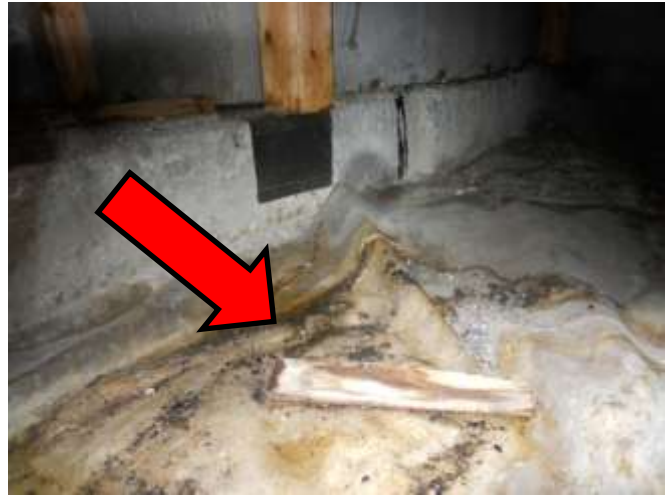
Moisture stains on vapor barrier

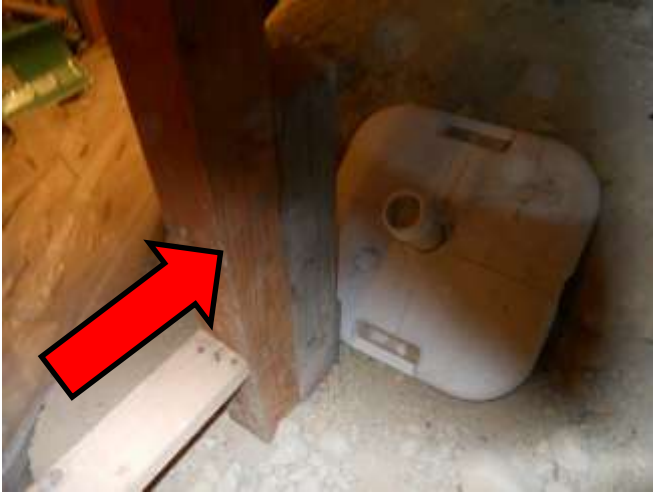
Foundation: No visible defects  
Mudsill: No visible defects  
Joists: No visible defects; limited visibility  
Post-Beams: Satisfactory  
*- A post near the crawl access appears to have been replaced. Some posts are not secured to footing below*  
Structural Movement: No visible evidence

It appears a new post was installed

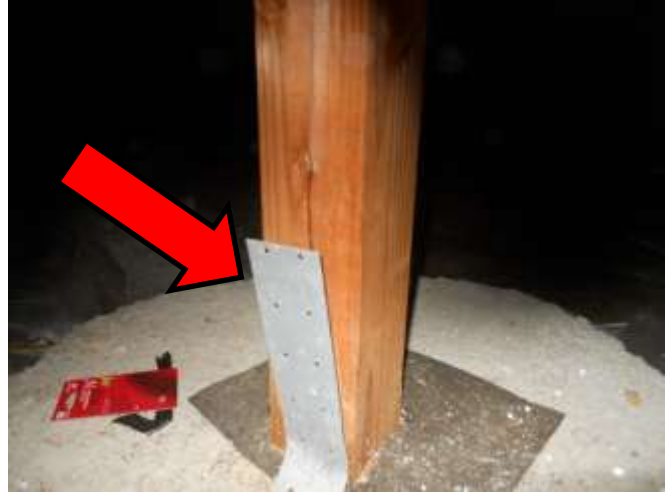
Post strap not secured

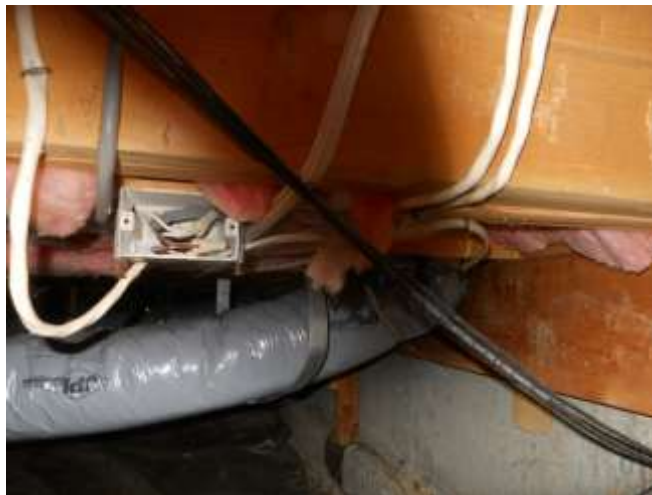
Outlets: None visible  
Wiring/ junction boxes: No visible defects  
- Several junction boxes do not have cover plates installed

Junction boxes should have cover-plates

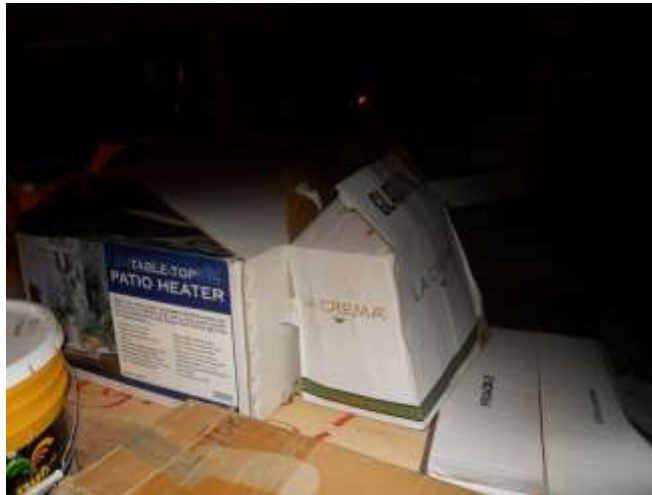
Wood and cardboard should not be stored in crawlspace

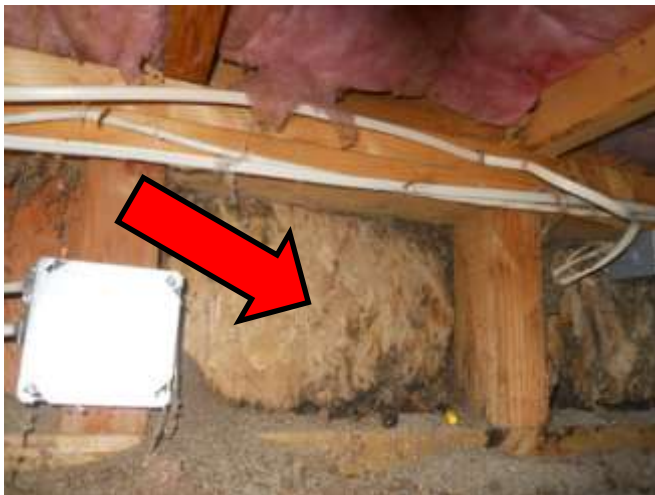
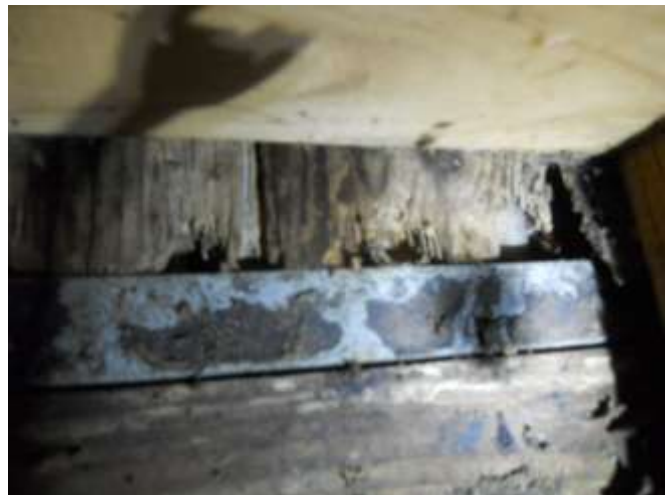
Conducive Material: - *Wood and cardboard should not be installed in crawlspace*  
Visible Evidence: - *Evidence of wood rot and potential moisture ant damage near rear patio door area. Likely cause is moisture entering this area from vertical groves in siding*

Wood rot near patio door

Wood rot near patio door  
Visible boards are siding

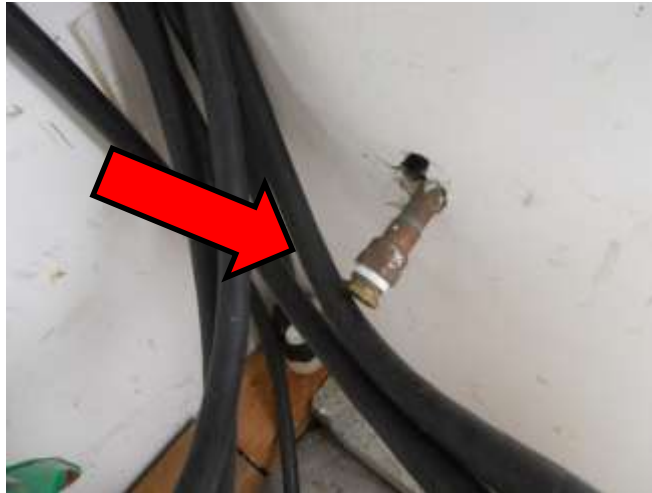
Visibility: Space is occupied  
Structural Movement: No visible evidence  
Moisture Infiltration: No visible evidence  
Walls: Satisfactory  
Ceiling: Satisfactory  
Slab: Satisfactory  
- Question to Seller: what is the capped pipe neat the electrical service panel area ?

Pipe is capped near electrical panel area

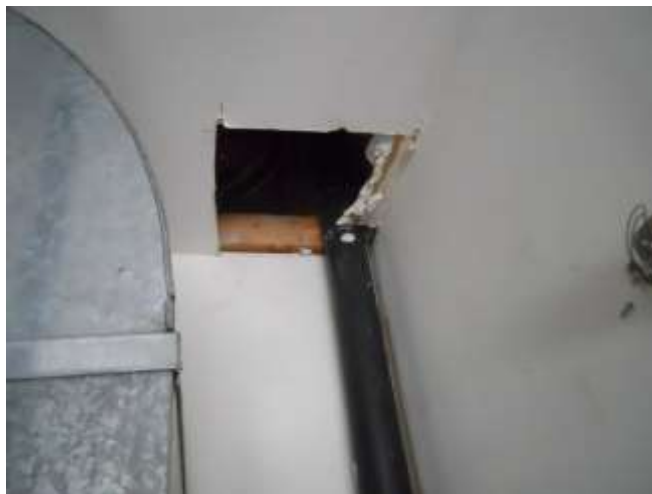
Fire separation: - Hole in garage ceiling is a breach in the 1 hour fire separation between house and garage. Question to Seller: Why was this hole cut in the garage ceiling ?  
Ignition point > above FF: In compliance

Hole cut in garage ceiling

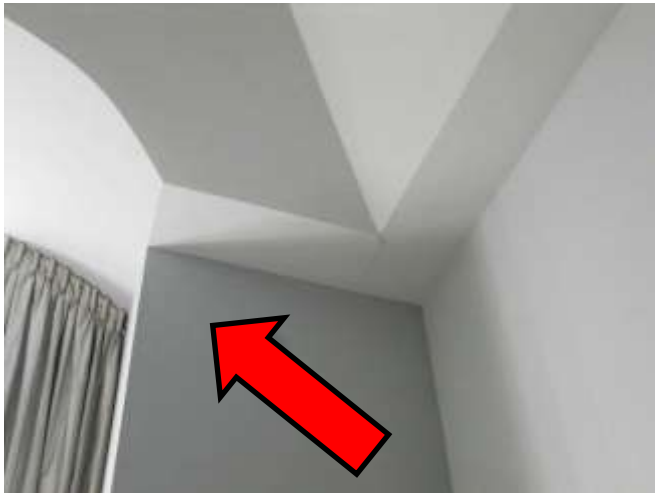
Visibility: Rooms are occupied  
Structural Movement: No visible evidence  
Moisture Infiltration: - *Evidence of moisture intrusion at Living room. See Building exterior and crawlspace sections*  
Walls: Satisfactory  
Ceiling: Satisfactory  
Flooring: Satisfactory

Moisture stains on wall

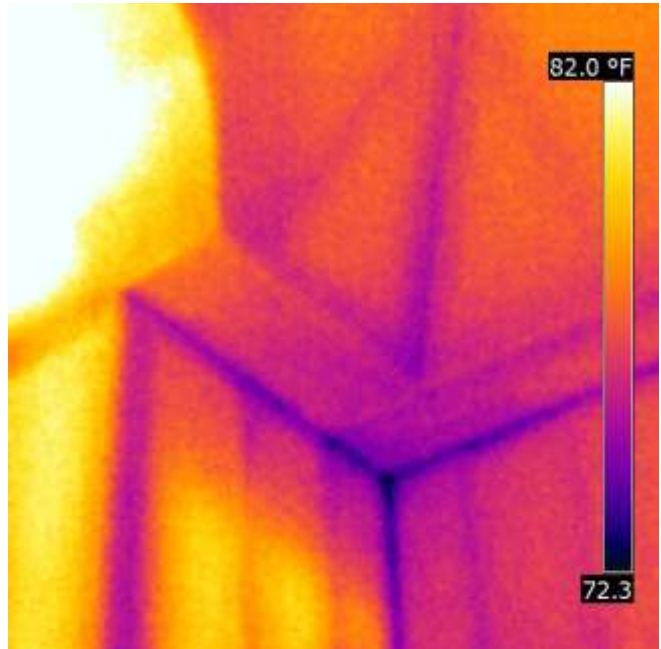
Infrared image does not indicate current moisture intrusion

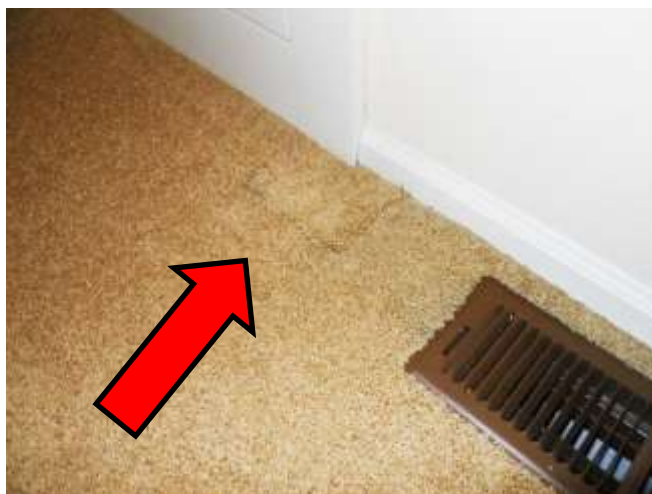
Visibility: Rooms are vacant  
Structural Movement: No visible evidence  
Moisture Infiltration: No visible evidence  
Walls: Satisfactory  
Ceiling: Satisfactory  
Flooring: Satisfactory  
*- Cut in carpeting near electronics. Carpet is not secured*

Cut in carpeting

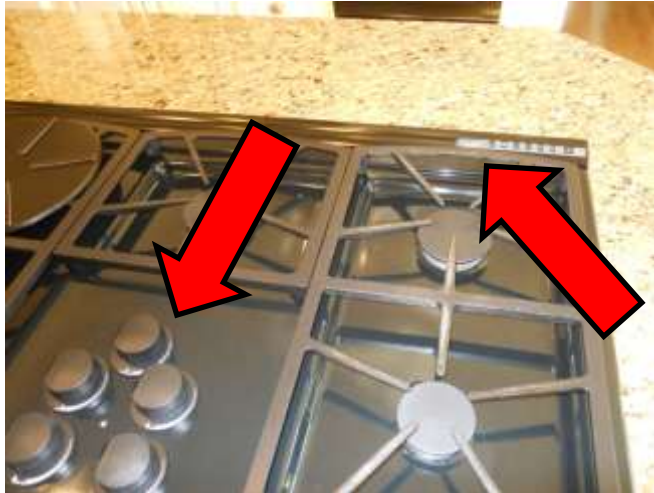
Dishwasher: Tested full cycle  
Dishwasher air gap: Visible  
Oven: Tested  
Cooktop: Tested  
*- Burner position setting indicator loose for upper mid burner*  
Microwave: Not tested  
Ventilation: Tested  
*- Control pad has melted due to excess heat; still operative*  
Refrigerator: Tested

Ventilation control pad is melted  
Loose burner control indicator

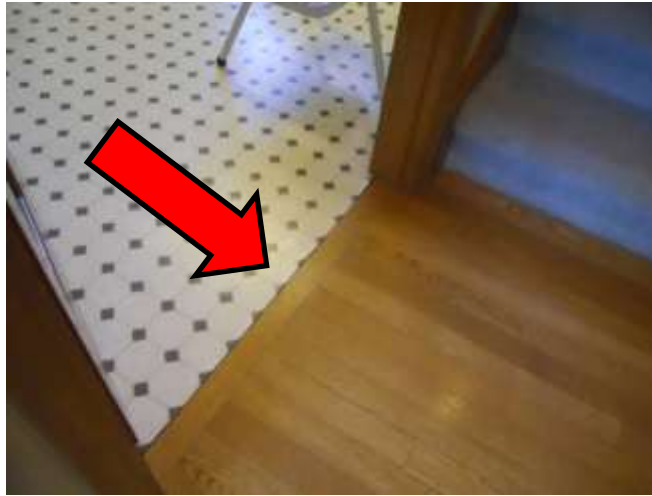
Visibility: Room is occupied  
Structural Movement: No visible evidence  
Moisture Infiltration: No visible evidence  
Walls: Satisfactory  
Ceiling: Satisfactory  
Flooring: Satisfactory  
- *Minor loose edge at vinyl floor to hardwood*  
Cabinets: Satisfactory  
Countertops: Satisfactory

Loose vinyl flooring

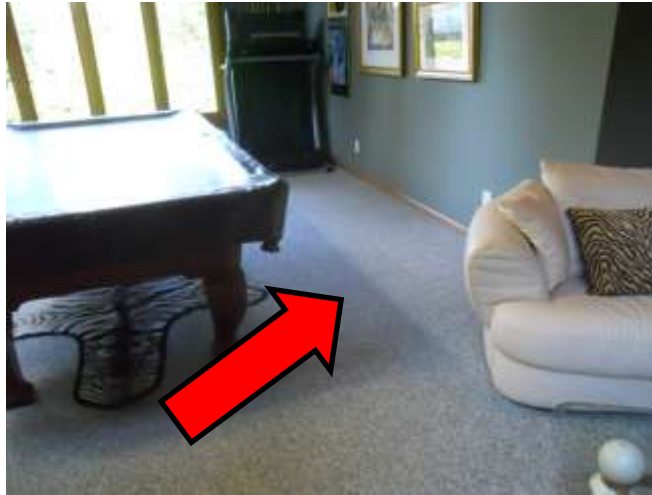
Visibility: Room is occupied  
Structural Movement: - *Minor roll in floor. Appears related to original construction*  
Moisture Infiltration: No visible evidence  
Walls: Satisfactory  
Ceiling: Satisfactory  
Flooring: Satisfactory

Depression at floor

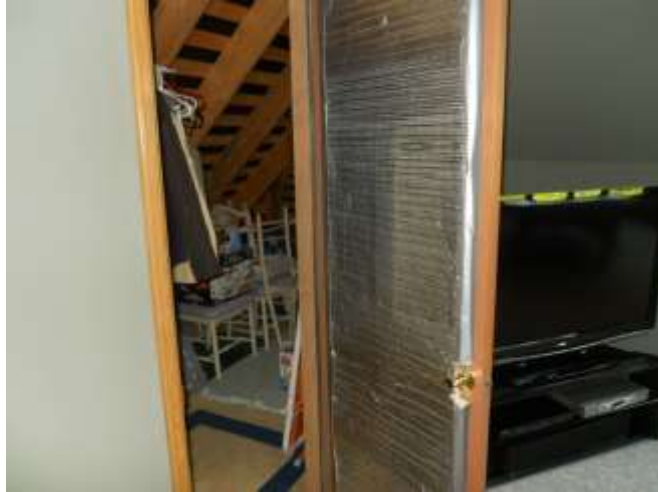
Closet door is not weather rated

Operation/latching: Tested  
Door condition: Satisfactory  
- *Recommend install proper insulation or exterior grade door at attic access closet*  
Millwork condition: Satisfactory

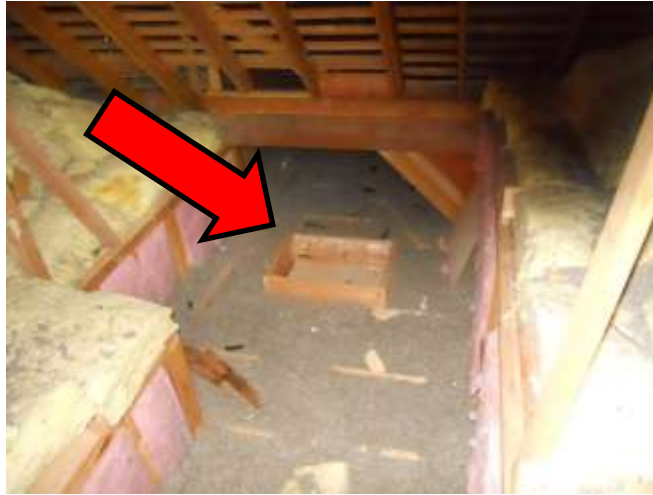
Lower attic access at Master Bedroom is not insulated

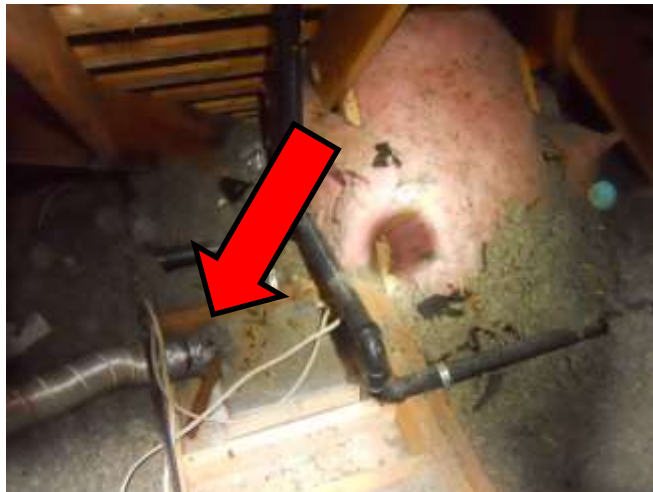
Roof Ventilation: Appears adequate  
Moisture Intrusion: No visible evidence  
Bath/Kitchen fans : - Bathroom fan vent connection is loose above main bedroom suite. Evidence of excess moisture (mold like substance on rafter) at this area

Air is blowing into attic from main bedroom suite fan

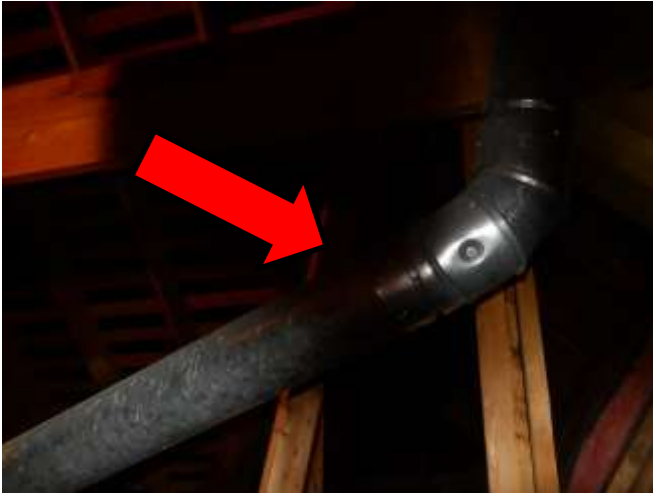
Gas Flues: - Attic furnace flue is not properly supported

Un-supported furnace flue

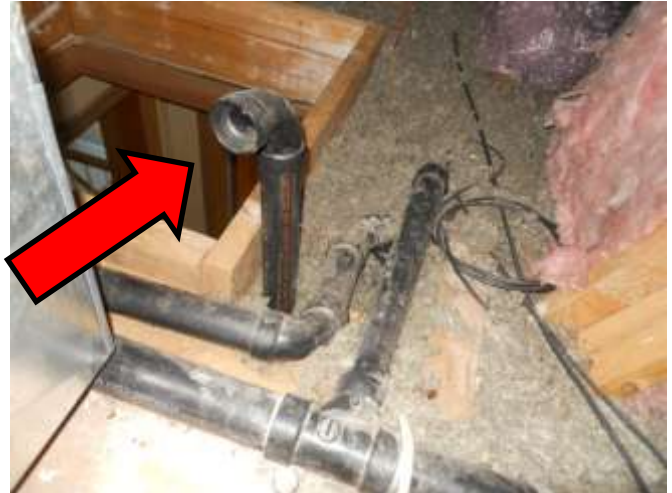
Plumbing Stacks: All vented to exterior  
- The open end plumbing stack (located near the attic furnace) should be sealed as sewer gas may escape since there would be no water in the P trap. Question to Seller: Why is this vent extension open ? Was it related to the apparent abandoned air conditioning system ?

Open plumbing vent stack
