(425) 652-6515  
Kevin@Hergert.com  
Wa. Home Inspector 619  
WSDA Inspector 79988  
WSDA Control # 1336AQ-015

Property Description: Split level house  
Property age/ size: Built 1979, 1,790 s.f. per listing  
Occupancy Status: Occupied

Inspection Date: 12/13/2011  
Inspection Time: 9:00 A.M. – 11:00 A.M. +-  
Weather Conditions: Clear, 35 deg F +-

Hergert Inspection LLC

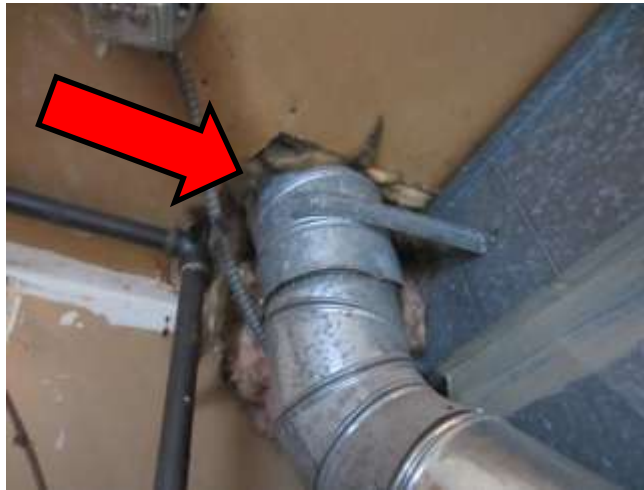
Flue Secure: Inspected  
Flue clearances: - Insulation and drywall should not be in contact with the furnace flue. Gaps at the flue should be sealed with metal or other non-combustible material

Furnace flue in contact with insulation and drywall

- Insulation and drywall should not be in contact with the furnace flue. Gaps at the flue should be sealed with metal or other non-combustible material

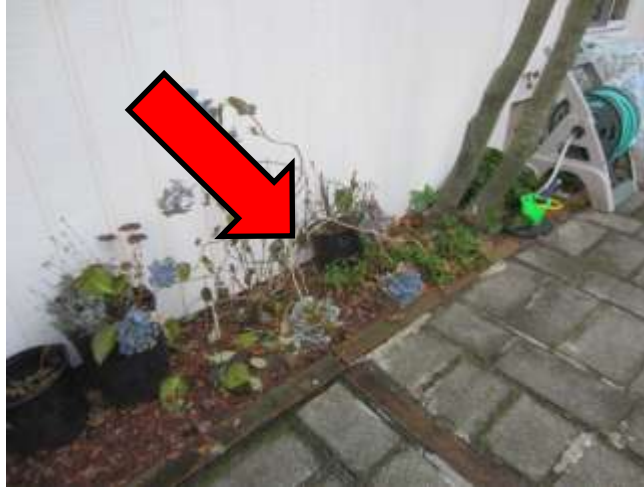
Grade at structure: Adequate grade away  
Earth to wood contact: - Structure in contact with ground (WDO conducive condition). Recommend 4-6” separation between ground and structure  
Vegetation contact: Negligible  
Roof drain discharge: Underground discharge

Siding in contact with the ground

- Structure in contact with ground (WDO conducive condition). Recommend 4-6” separation between ground and structure

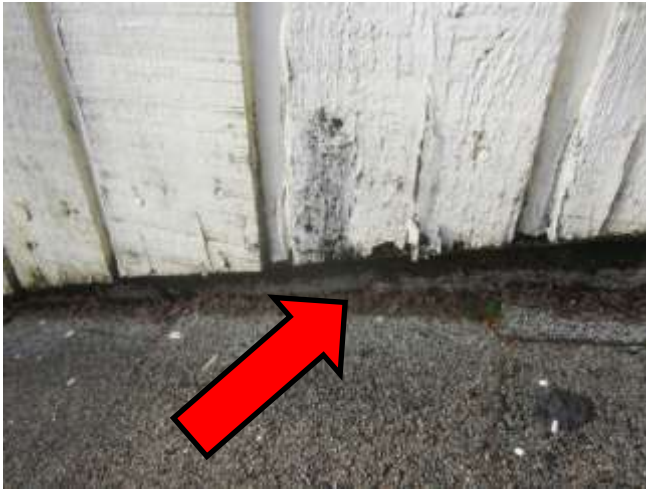
Type: Cedar  
Condition: Satisfactory  
- Minor wood rot at the lower edges of the siding at the chimney and at the top sides of the fascia boards (tails)  
Window/Door Flashing: Satisfactory  
Caulking: Satisfactory

Minor wood rot at chimney siding

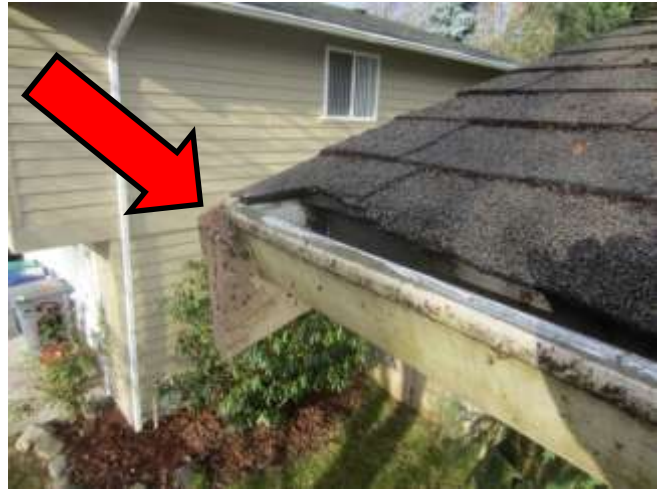
Minor wood rot at fascia boards (tails)

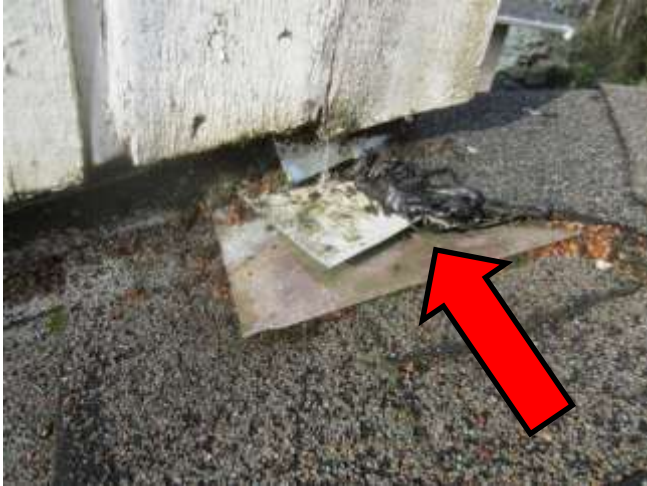
Tar has been spread at the upper corner of the chimney

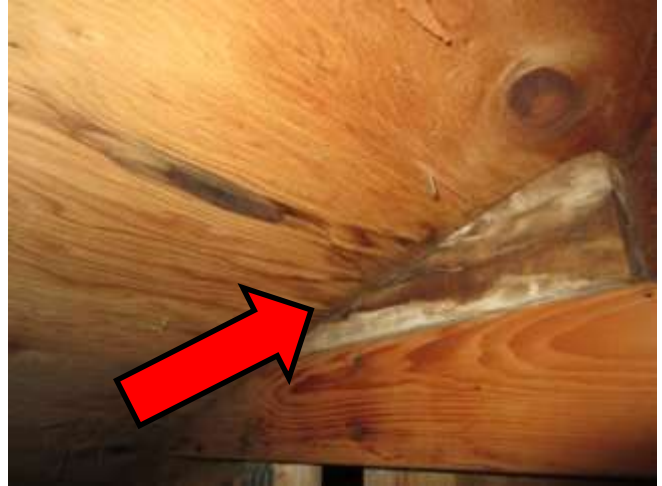
Area below image to left

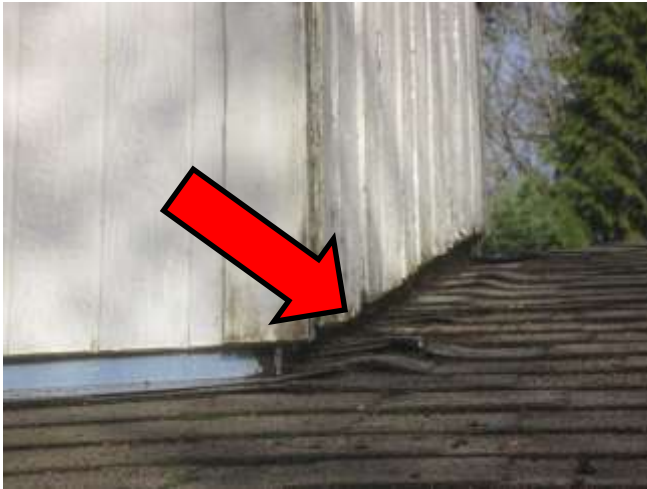
Flashing does not lay flat of roof

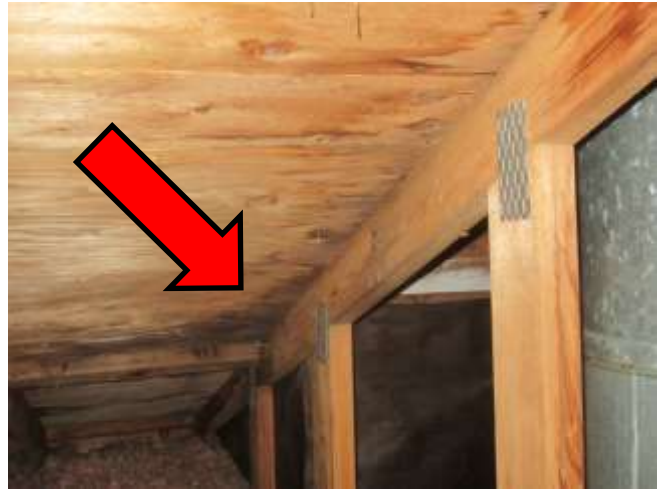
Area below image to left  
(arrow points to moisture stains)

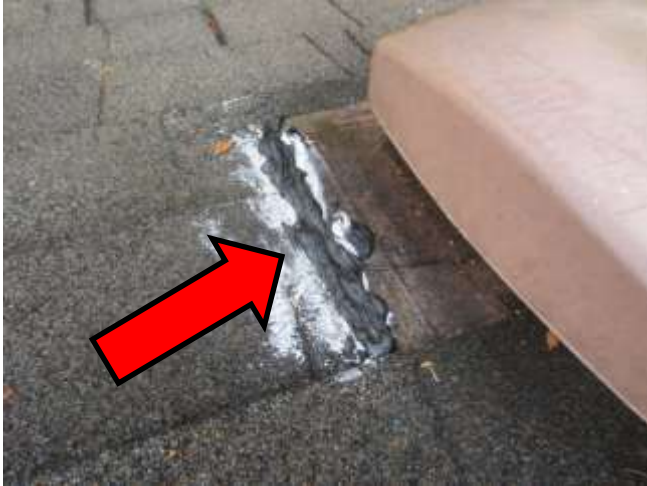
Tar repair at Hat vent

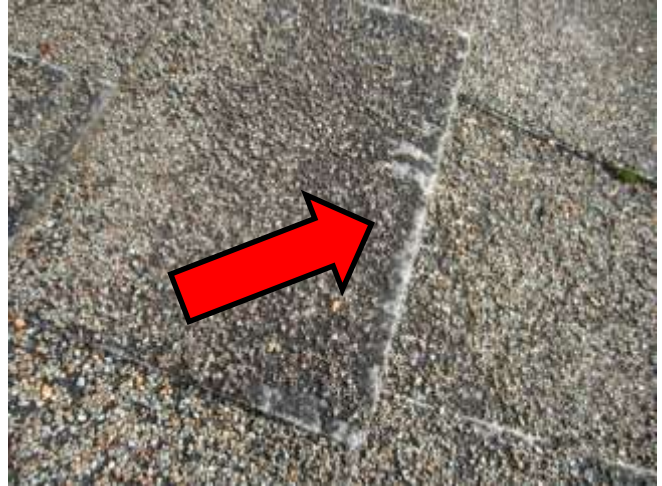
Estimated Pitch: 4:12  
Material: Composition  
Layers: 1+  
How Inspected: Traversed the roof  
Condition: ***- Roofing material is nearing the end of its useful life. Most shingles have lost a significant amount of the coating granules. Some shingles are exposed to the fibers***  
Ventilation: Eave and roof vent  
Plumbing Vents: Satisfactory  
Flues: Satisfactory  
Flashing: ***- Evidence of leakage at the roof to wall area of the chimney. Attempts have been made to repair this leakage with tar. The flashing adjacent to the chimney does not lay flat to the roof surface. Evidence of repairs at several roof "hat" vents***

Fibers visible at shingle (typical)

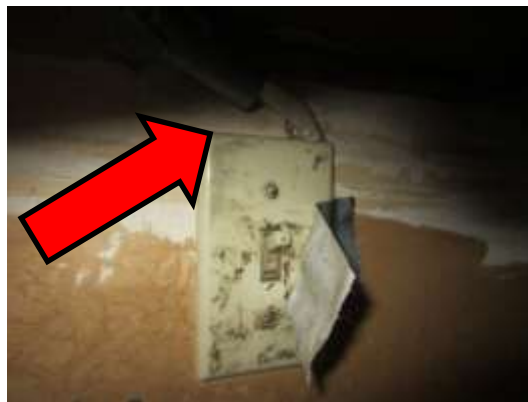
Switches/Lights: Tested  
Outlets: All visible tested  
- GFCI protected outlet (controls all bathrooms) is not properly wired. The GFCI protects the bathrooms but does not protect this outlet (line-load reversed)  
- Improper "extension cord and handyman type" wiring throughout the garage.  
Recommend repairs by a licensed electrician

Surface wires in the garage

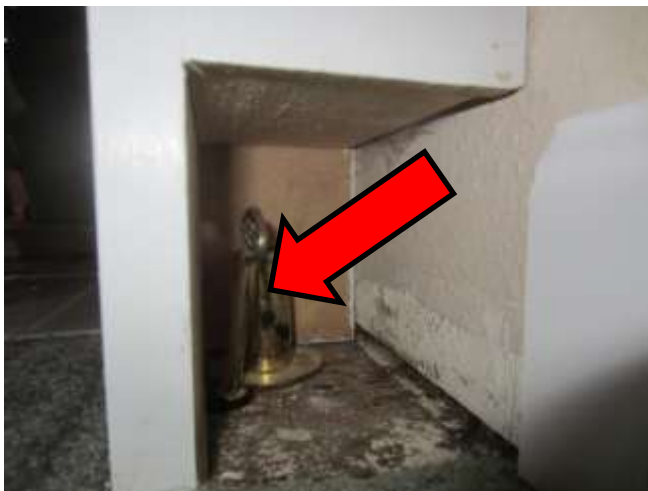
Type: - Wood burning with gas log lighter  
- Gas valve key operation is restricted by the adjacent millwork. The log lighter arm is substantially deteriorated (should not be used)  
Tested: Damper tested

Unable to quickly rotate gas valve key

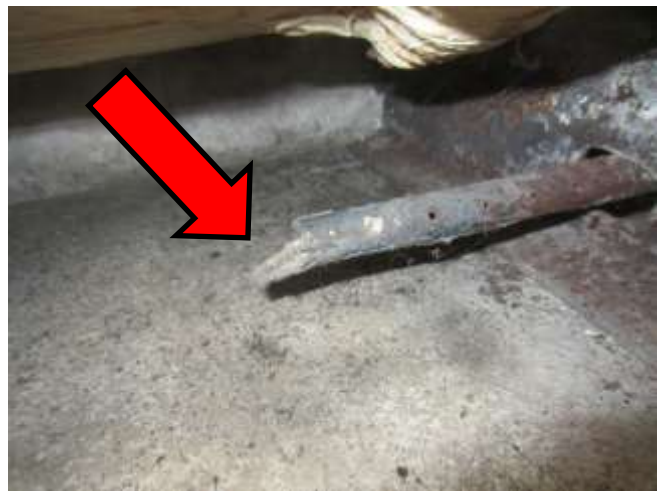
End of log lighter is gone (rusted)

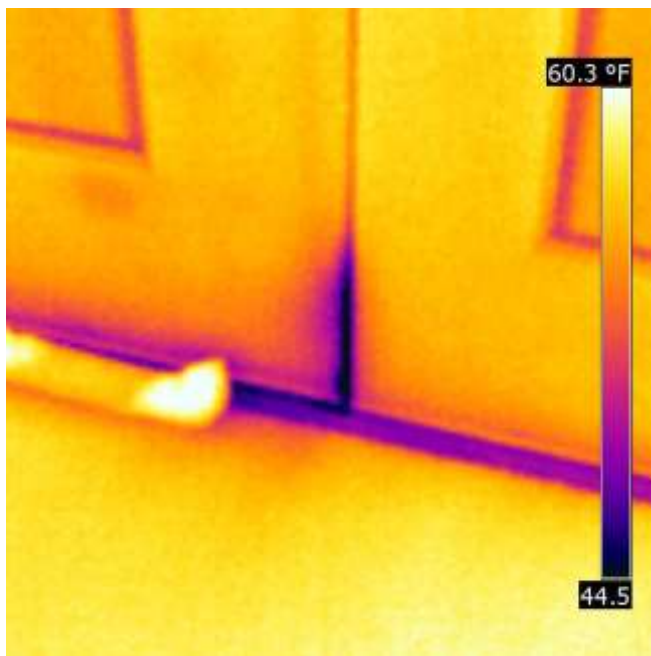
Air leakage at front doors

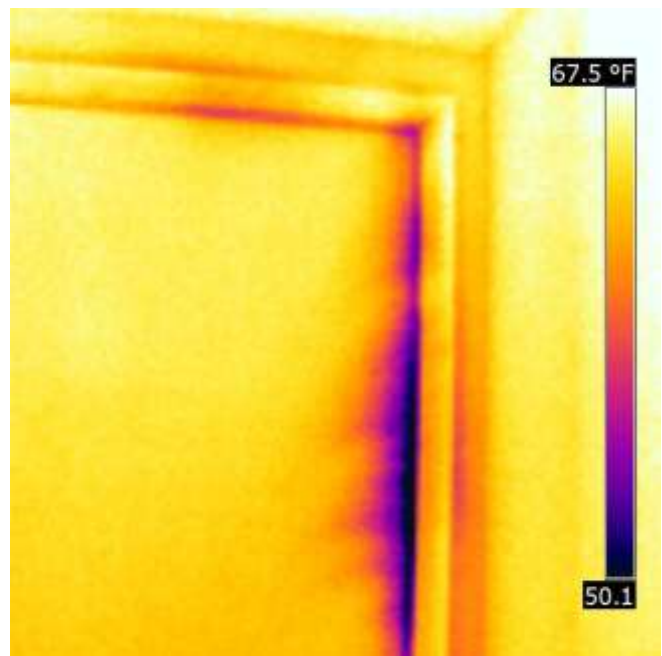
Air leakage at house-garage door

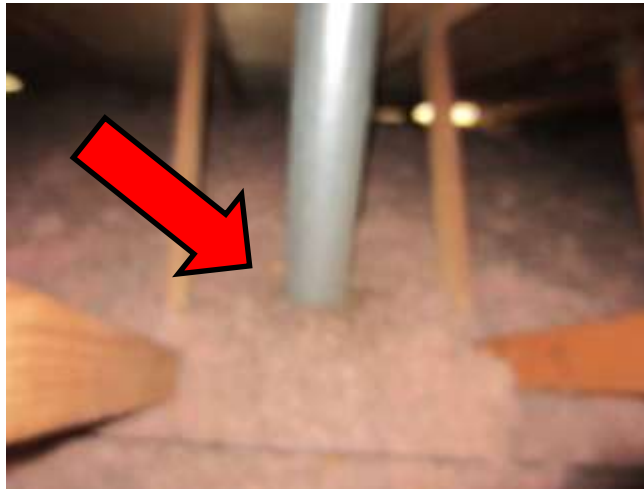
Insulation should not be in contact with the flue

Plumbing Stacks: All vented to exterior  
Gas Flues: No visible defects  
- Insulation baffle should be installed around the furnace flue
