Property Description: (2) story single family home with daylight basement
Property age/ size: Built 1976, 3,060 s.f. per listing
Occupancy Status: Vacant

Inspection Date: 12/26/2011
Inspection Time: 9:00 A.M. – 12:00 P.M.
Weather Conditions: Overcast, 50 deg F +-

Hergert Inspection LLC

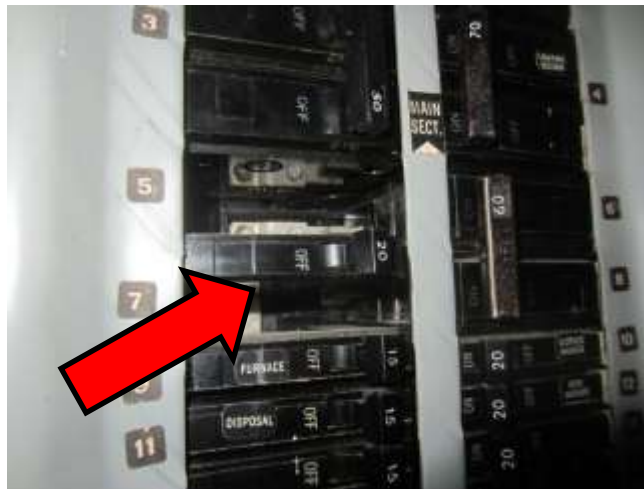
- Knock-out covers missing at electrical panel cover
- Main domestic water service of house should not be located above or adjacent to the electrical panel

Missing knockout covers

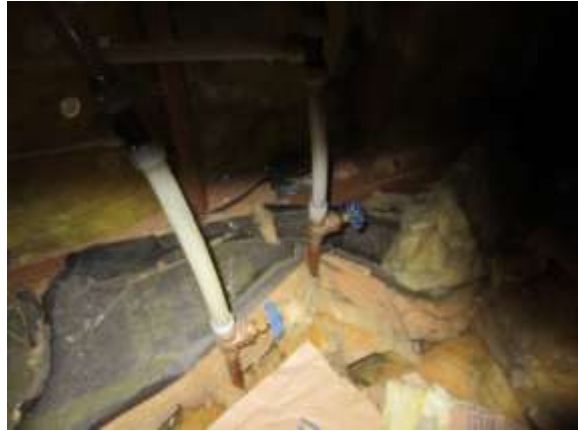
Plastic domestic water pipes

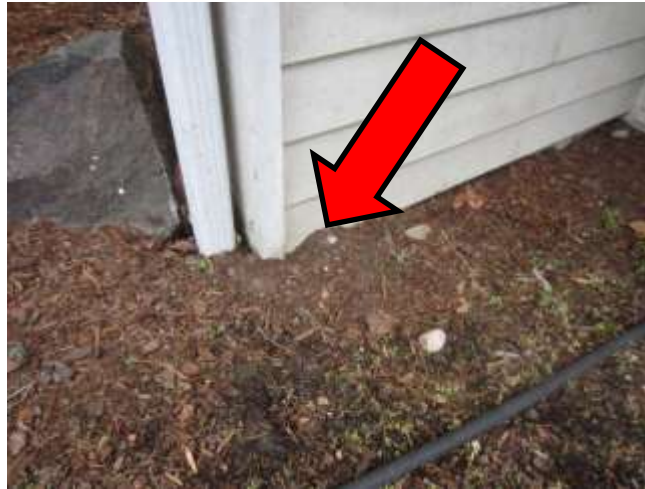
- Structure in contact with ground (WDO conducive condition). Recommend 4-6” separation between ground and structure

Earth to wood contact (typical)

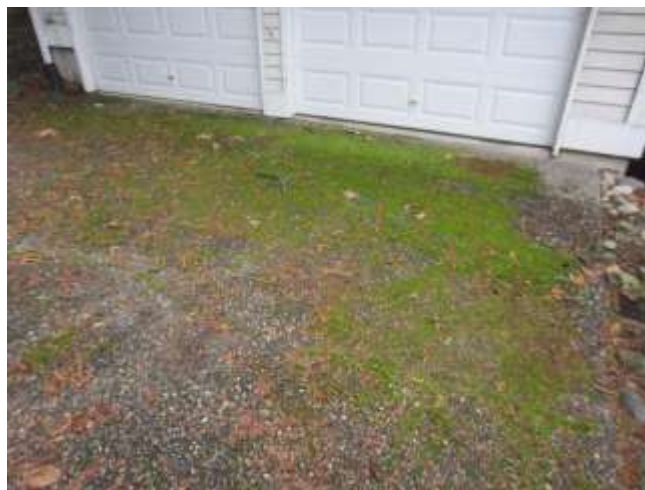
Slip hazard at driveway due to moss build up

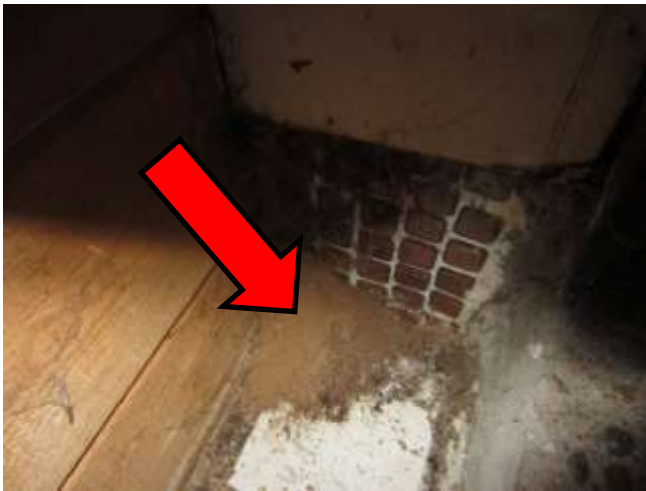
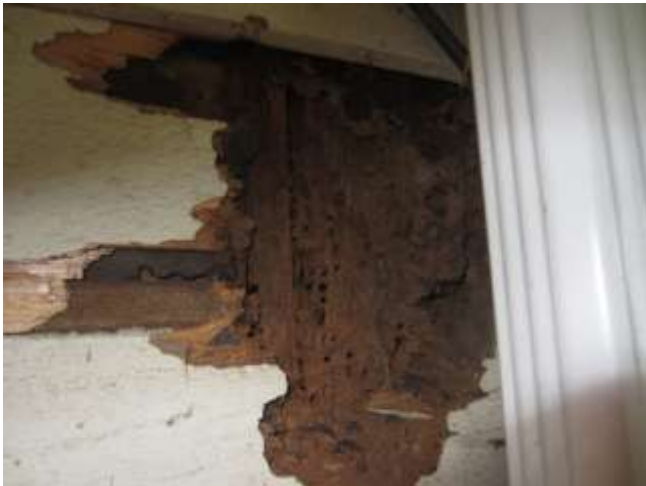
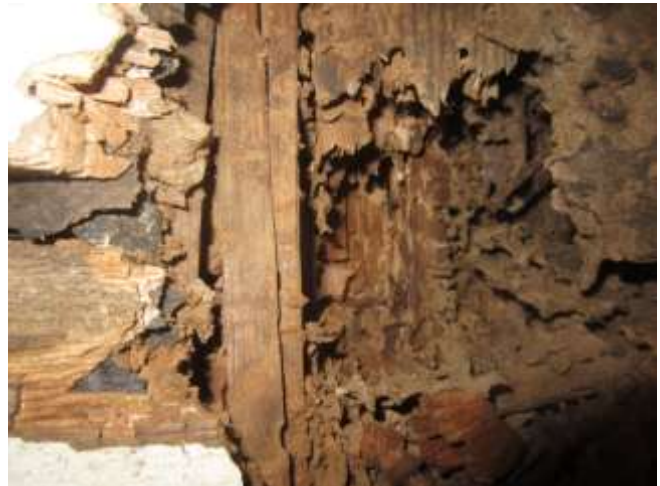
- Wood rot and moisture ant damage at the S.E. corner of the basement. This damage may extend further to the adjacent areas. Invasive testing is needed to confirm the extent of the damage. No active moisture ant activity detected
- Flashing not installed at top of foundation wall be chimney. Minor detection of wood rot at this area
- Several metal tiles are bent (crushed). Recommend replacement of these tiles or sealing of the raised edges to prevent moisture intrusion. Condition of the cedar shakes below not visible
- Gas piping should be painted with rust proof paint and not lying on the ground
- Gas outlet for deck BBQ should be sealed/capped while not in use

Moisture ant damage

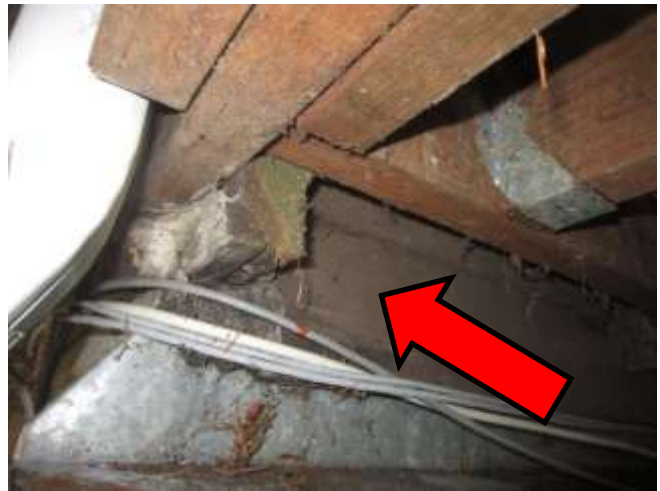
Area above moisture ant damage

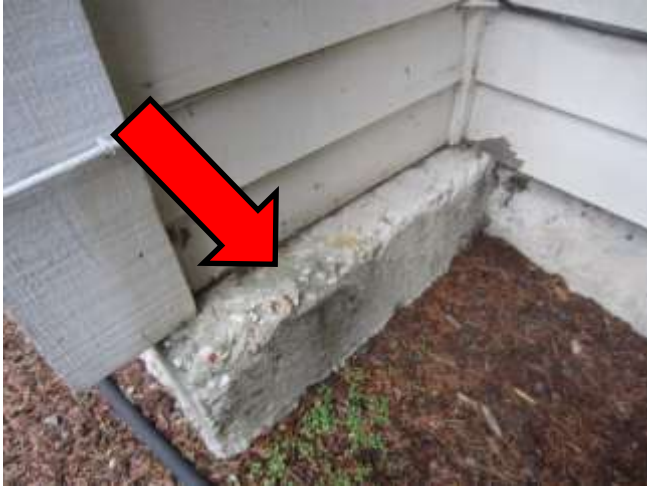
Flashing missing at concrete foundation

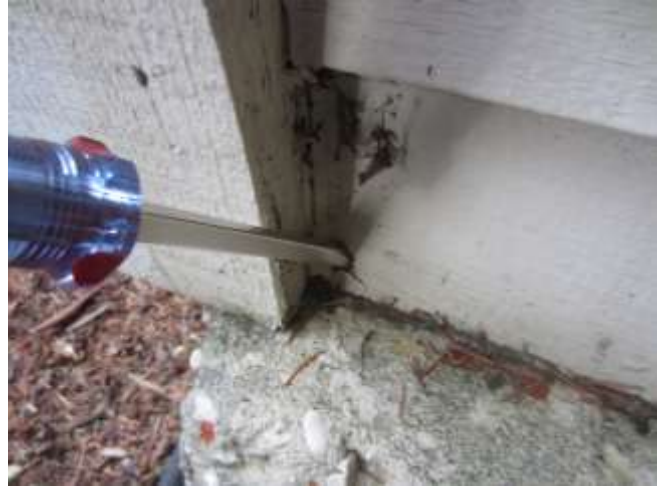
Wood rot (see image to left)

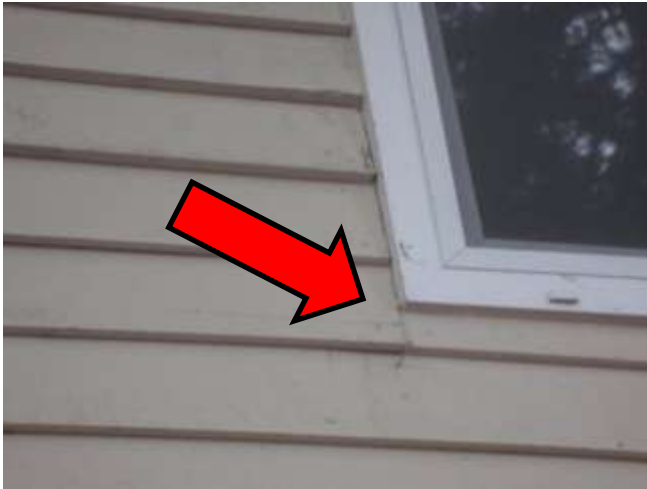
Caulking not complete at Master Bathroom

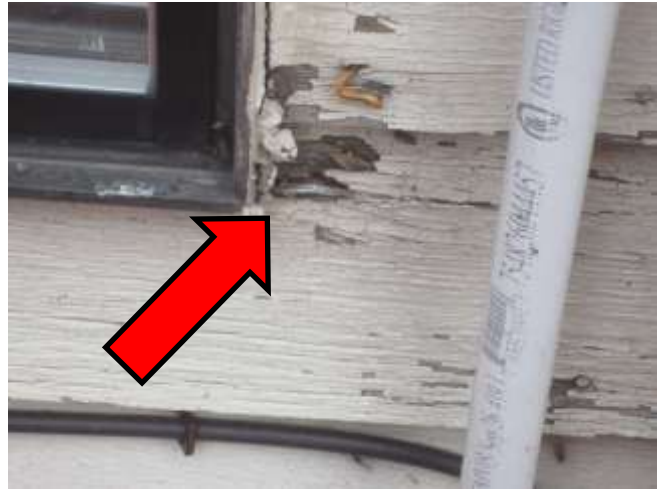
Moisture damage at Siding

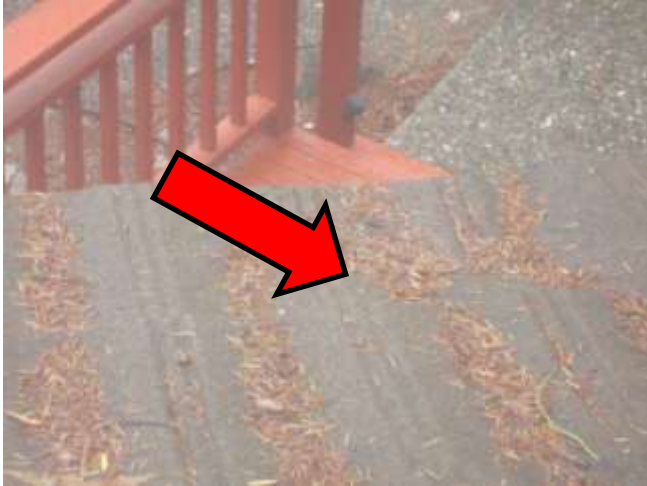
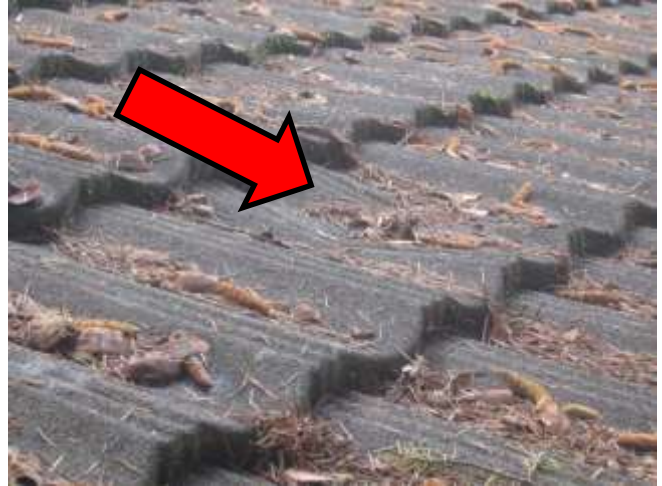
Crushed roofing

Crushed roofing (typical)

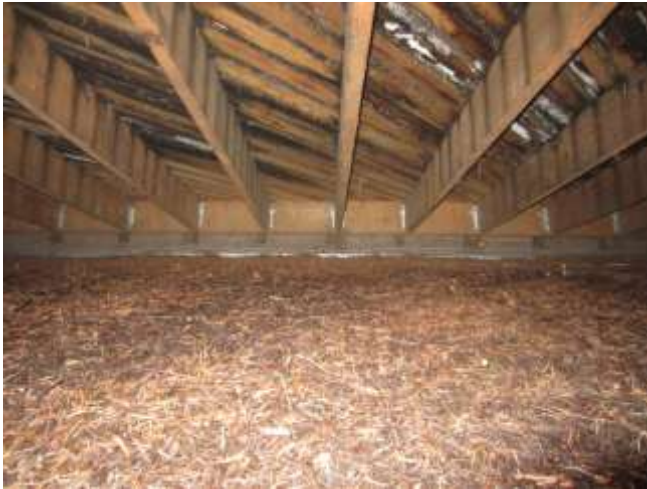
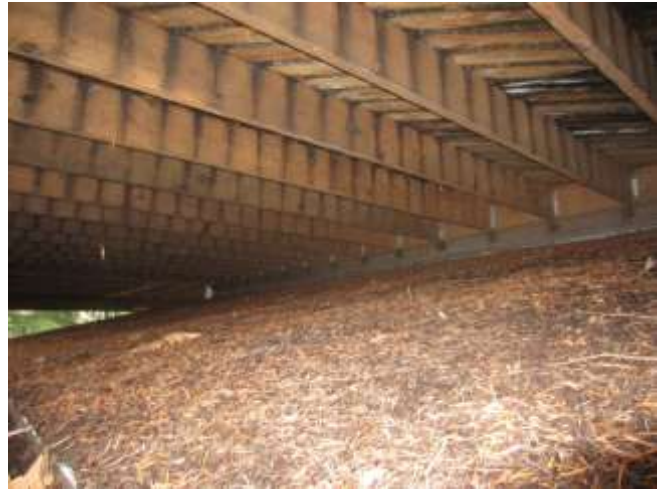
Debris on hot tub area extension roof

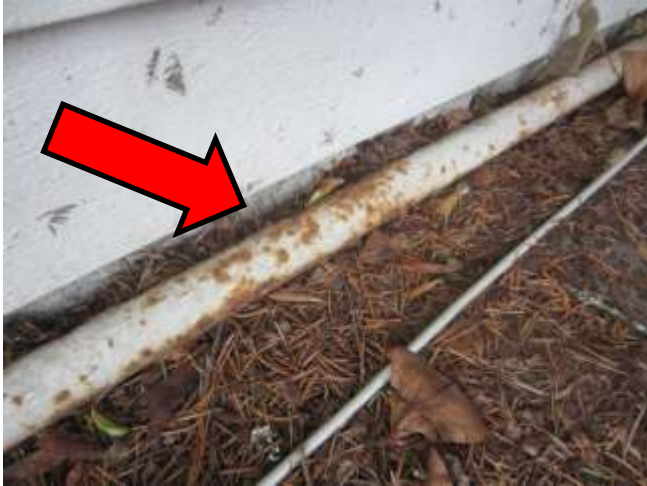
Gas pipe lying on the ground

Hose Bibs: - *Domestic water not active, not tested*
Gas Piping: Inspected
- Gas piping should be painted with rust proof paint and not lying on the ground
- Gas outlet for deck BBQ should be sealed/capped while not in use

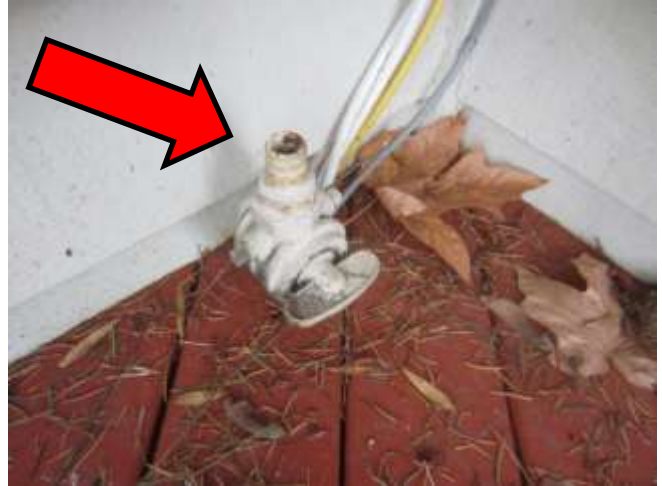
Open gas valve at deck

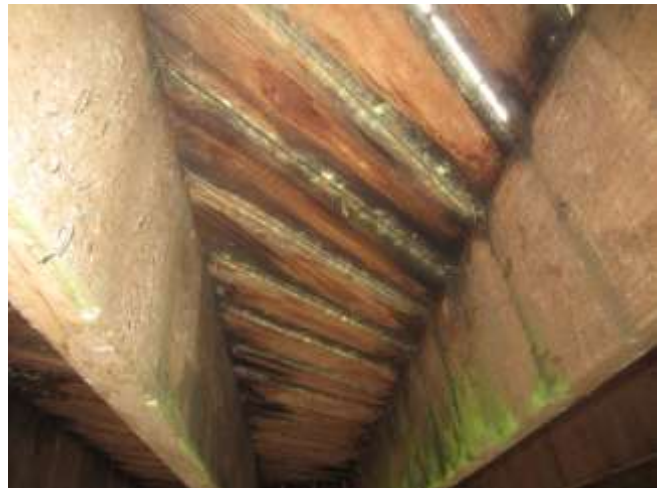
Minor wood rot at decking (typical)

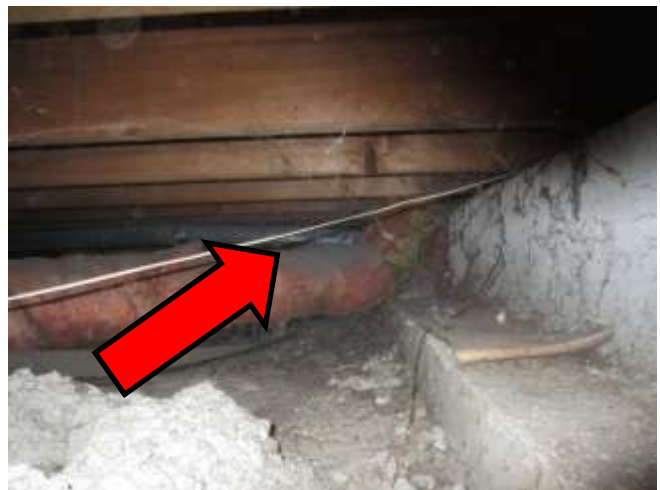
- Evidence of dryer vent gaps (lint in crawlspace)

Lint at crawlspace

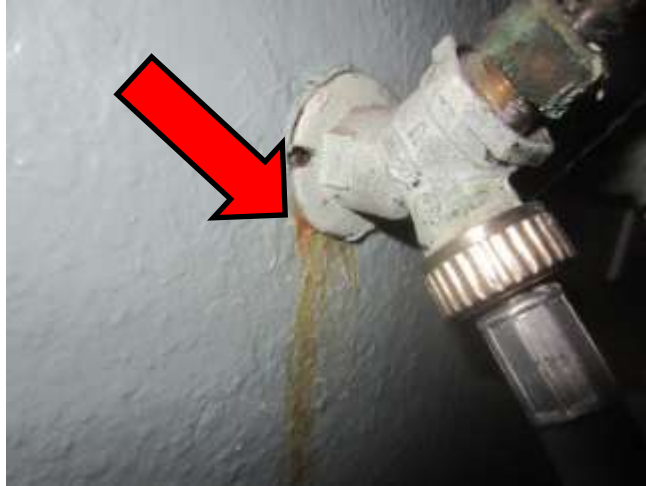
Evidence of moisture leak from washer supply line

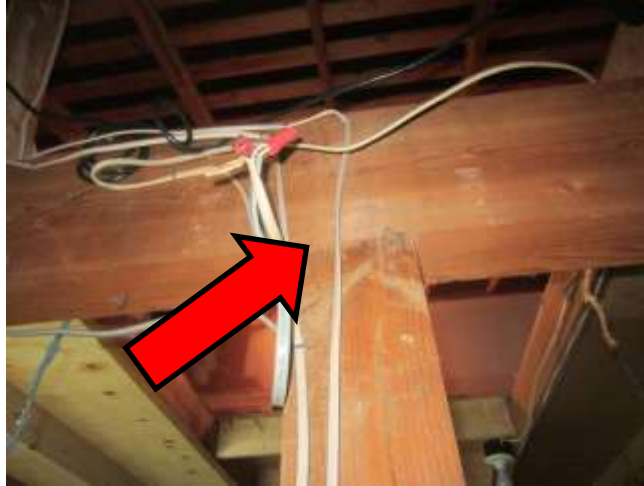
Recommend additional post to beam connection

- Recommend additional metal T strap at post to beam connection
- Electrical wire splices should be made within closed junction boxes

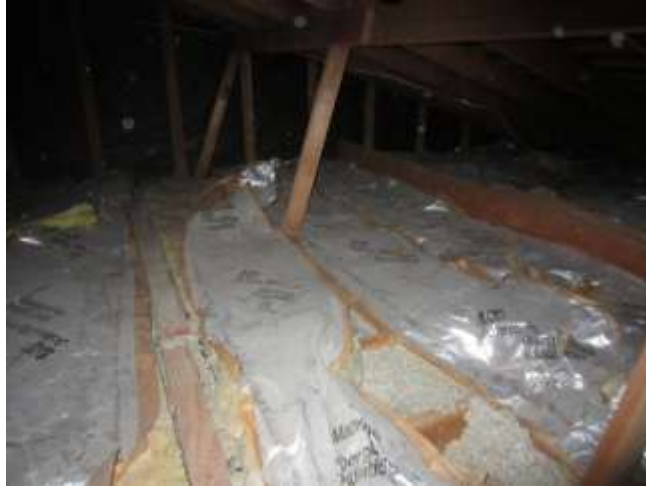
Type: Blown in
Condition: - Faced (vapor barrier) insulation should not be installed above blown in insulation

Vapor barrier on cold side of insulation
above blown in insulation.
This configuration can lead to condensation

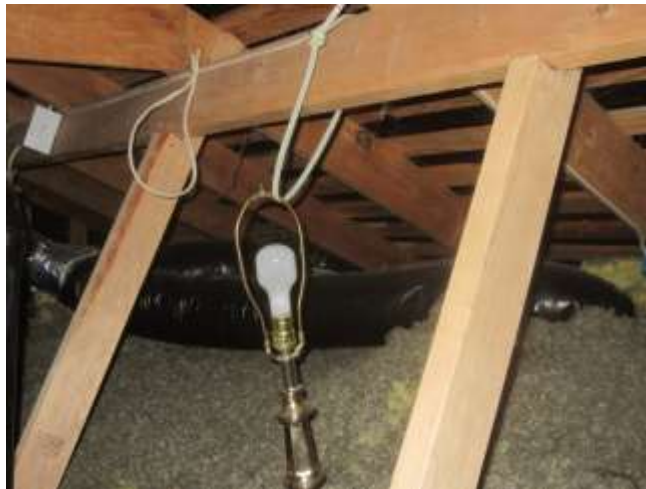
Improper attic light
