Property Description: (2) Story home with basement  
Occupancy Status: Partially occupied

Inspection Date: 07/27/2011  
Inspection Time: 10:00 A.M. – 1:00 P.M.  
Weather Conditions: Scattered clouds, 60 deg F +-

Hergert Inspection LLC

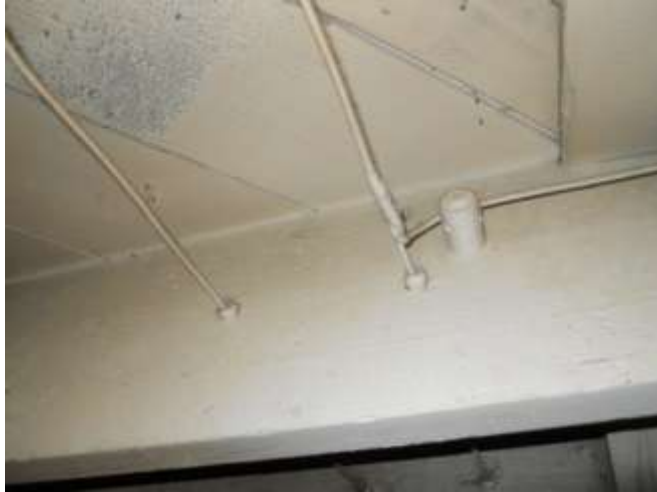
*- Branch wiring for home consists of knob and tube wiring and what appears to be aluminum wiring. Electrical outlets throughout house are not grounded and are inadequate in quantity for modern electrical needs. Service panel is likely not adequately sized to upgrade service throughout house. Recommend full updating (replacement) of electrical system*

Knob and tube wiring in basement

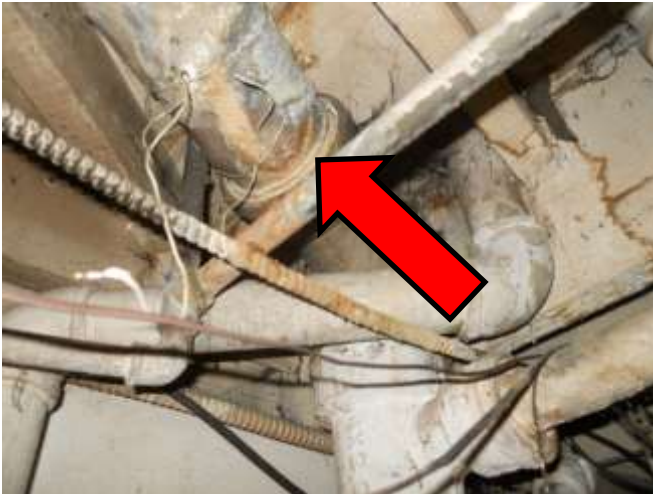
- Discharge: Public sewer  
*- Recommend side sewer scope due to age of property*
- House Piping: Cast iron  
Pipe Condition: *- Deterioration visible at waste lines. Recommend replacement of the lines visible in the basement*

Cracked waste line

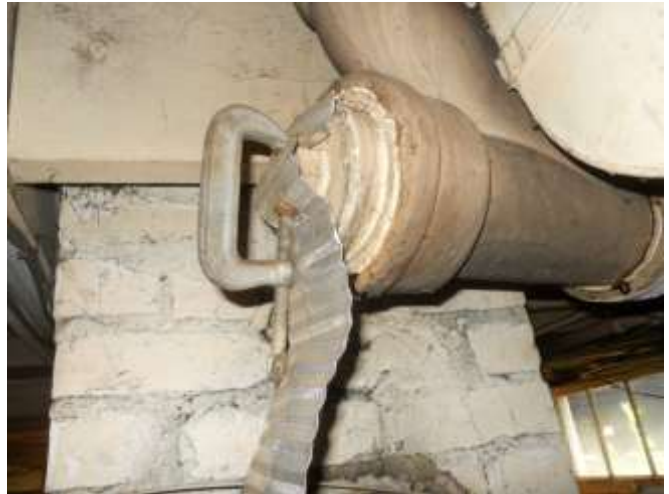
C clamp on waste line

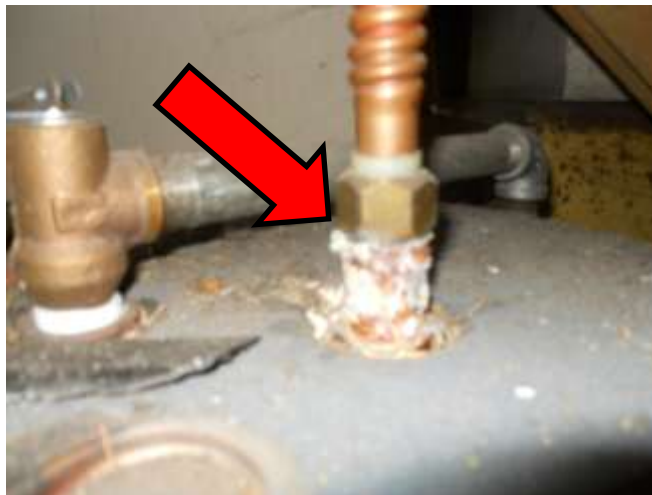
- Water heater is substantially beyond its anticipated useful life expectancy. Galvanic corrosion at water connection

Corrosion at water connection

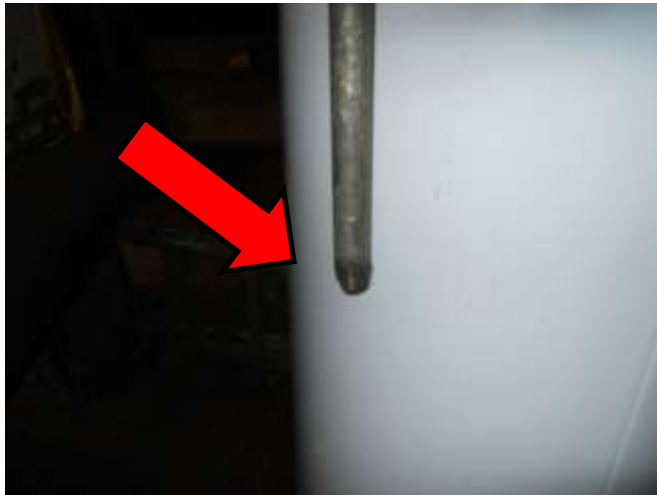
TMP valve: - TMP relief line should extend to within 6" of ground and not have a threaded end  
Earthquake Straps: - Earthquake restraints not installed

TMP line should not be threaded at end

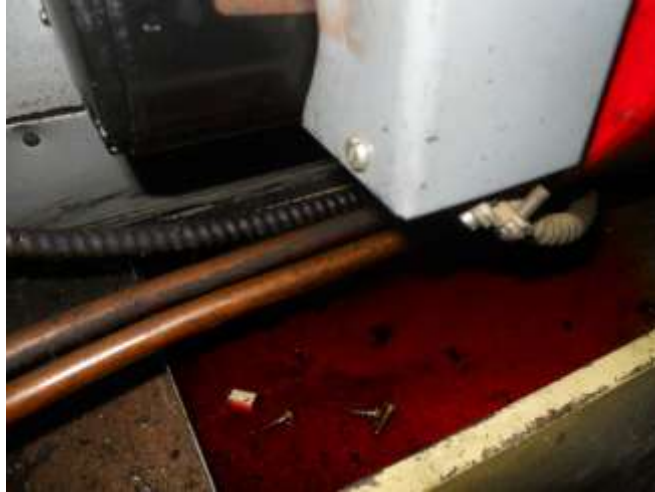
Est. Useful Life new: 25 years  
Est. age of furnace: - Presumed to be original equipment 80 years +-  
*- Furnace is far beyond its anticipated useful life expectancy. Furnace is also obsolete due to lack of efficiency. Leaks visible at oil lines. Furnace cycles on and off. Recommend replacement of furnace (preferably with a high efficiency natural gas furnace if gas is available)*

Oil leak at furnace

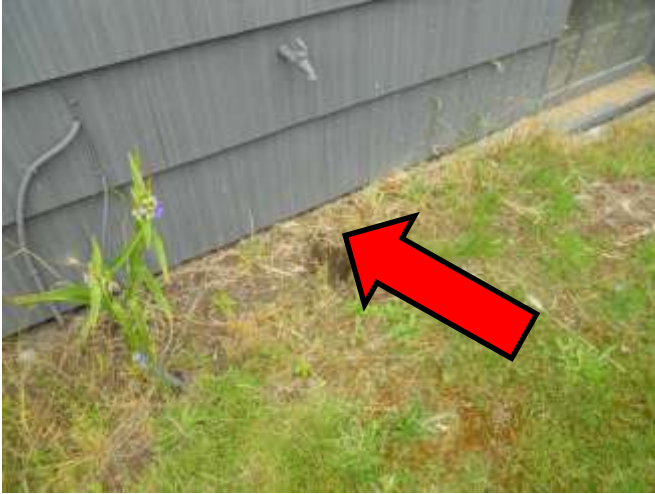
Grade at structure: Adequate grade away  
Earth to wood contact: - Exterior grade should be 4-6" below siding. WDO conducive condition  
Vegetation contact: Negligible  
Roof drain discharge: Underground discharge

Exterior grade is in contact with siding

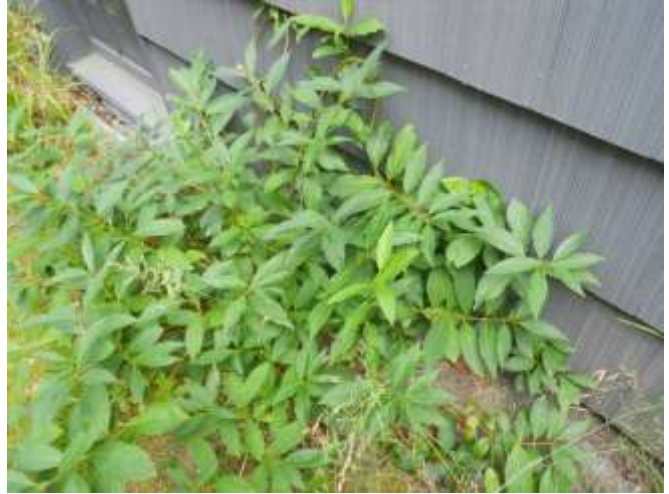
Vegetation in contact with siding

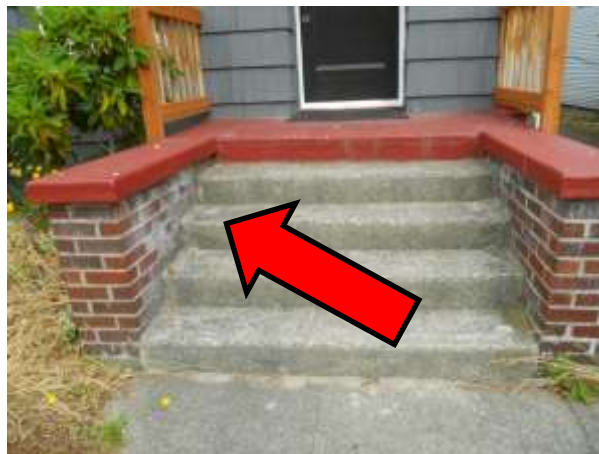
Type: Concrete  
Condition: Satisfactory  
Trip Hazard: None  
Handrails: - Graspable handrail missing at front entry  
Barricades: As required

Graspable handrail not installed

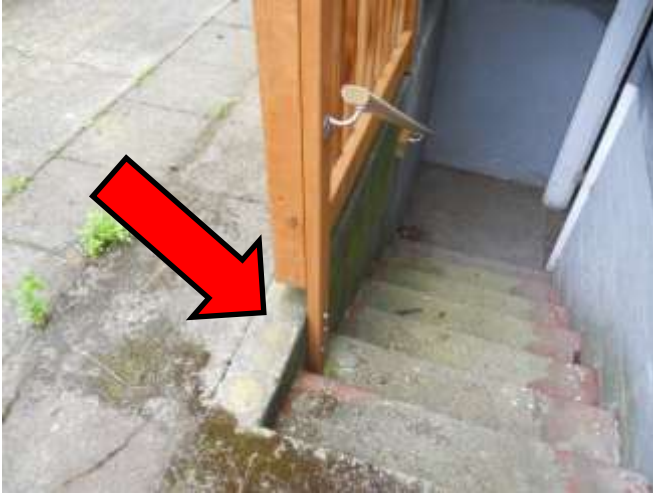
- Type: Concrete
- Condition: Satisfactory
- Trip Hazard: - Inconsistent stair riser height at side entry (trip hazard)
- Handrails: - Graspable handrail and barricade should extend to top of stairwell at side entry
- Barricades: - See comment above

Barricade and handrail should extend to top

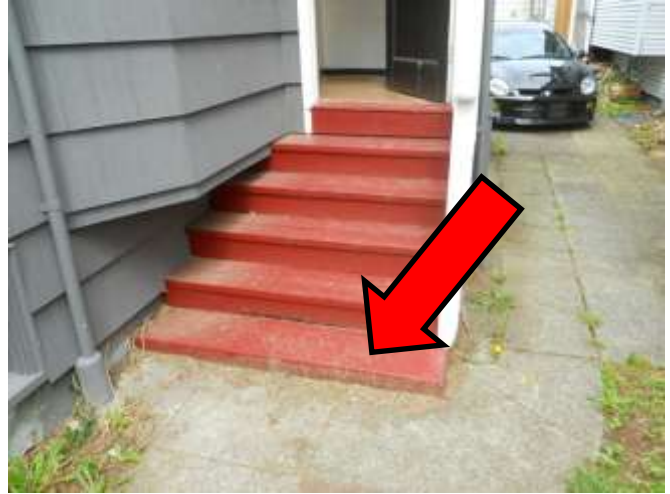
Trip hazard at stairs

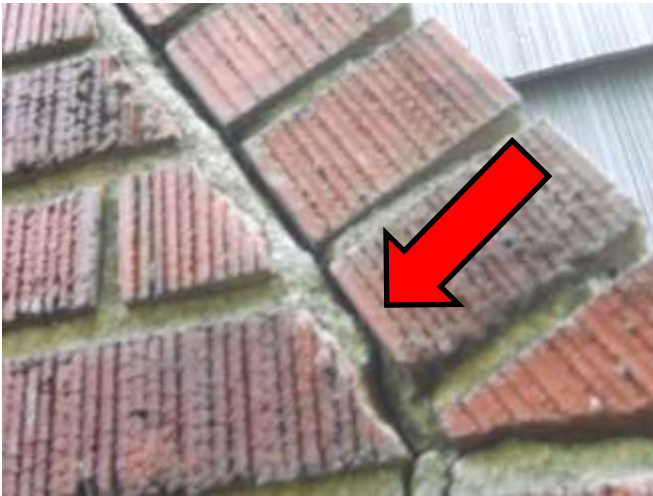
*- Substantial deterioration of mortar at chimney. Recommend repair as needed*

Mortar deterioration at chimney

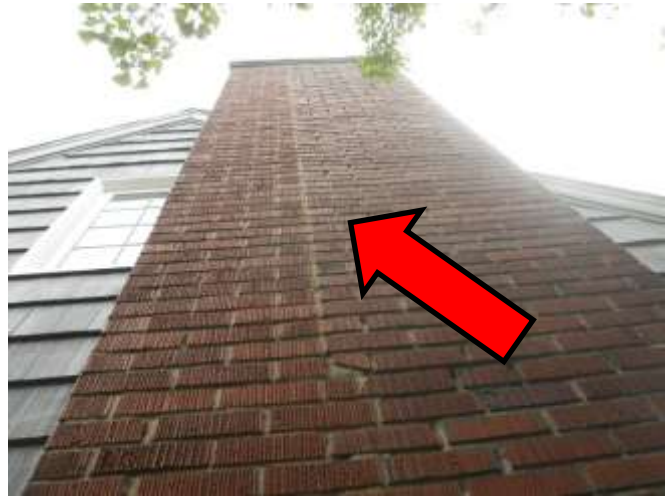
Fireplace appears to have been modified since original construction

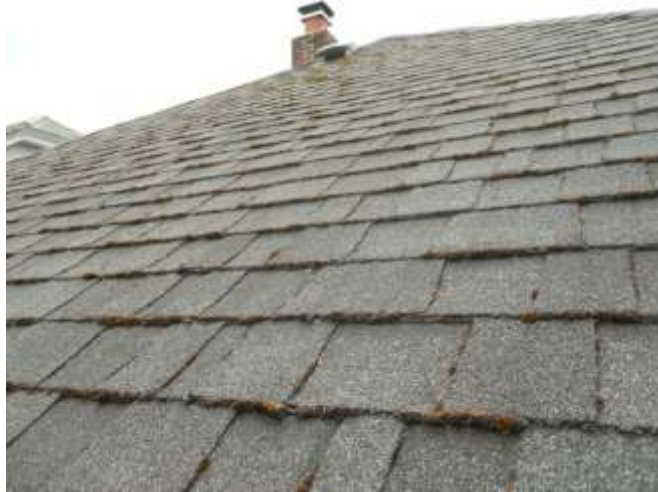
Estimated Pitch: 9:12 and 12:12  
Material: Composition  
Layers: 1+  
How Inspected: From eave at (2) locations and from street and rear yard  
Condition: Satisfactory  
- Recommend clean moss build-up from roof (do not pressure wash)  
Ventilation: - Roof ventilation not identified for upper roof. Recommend install "hat vents" to provide ventilation  
Plumbing Vents: Satisfactory  
Flues: Satisfactory  
Flashing: Satisfactory

Moss buildup at roof (typical)

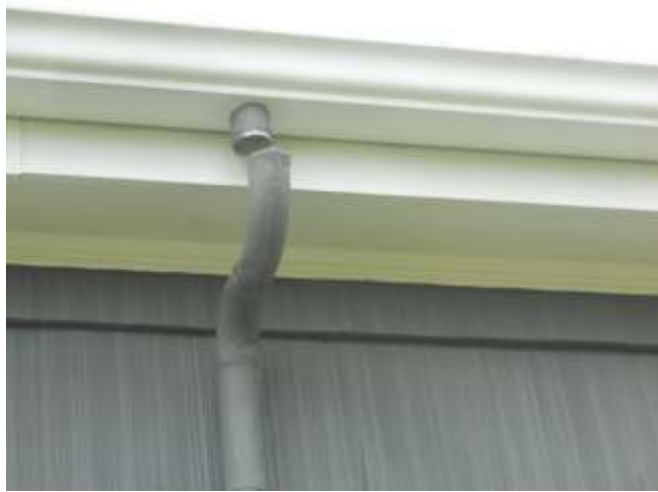
Type: Continuous metal and wood  
Condition: - Downspout not connected at rear of home

Downspout not connected

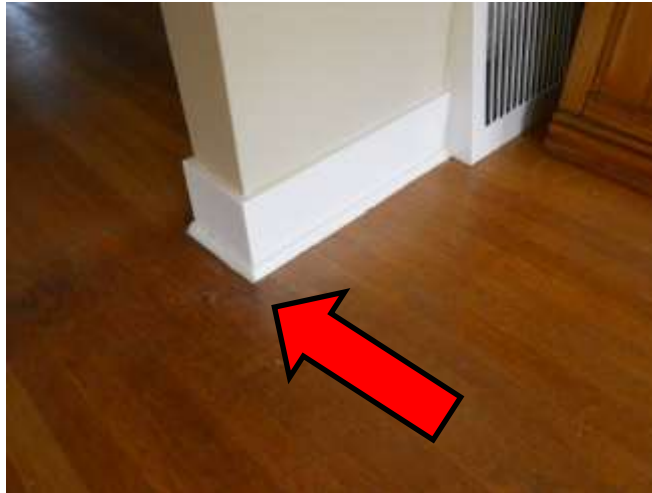
- Visibility: Rooms are primarily vacant  
Structural Movement: - *Structural sag at Living room – Dining Room. See Basement section*  
Moisture Infiltration: - *Evidence of prior roof leak in Dining room*  
Walls: Satisfactory  
Ceiling: Satisfactory  
Flooring: Satisfactory

Structural sag at Living room

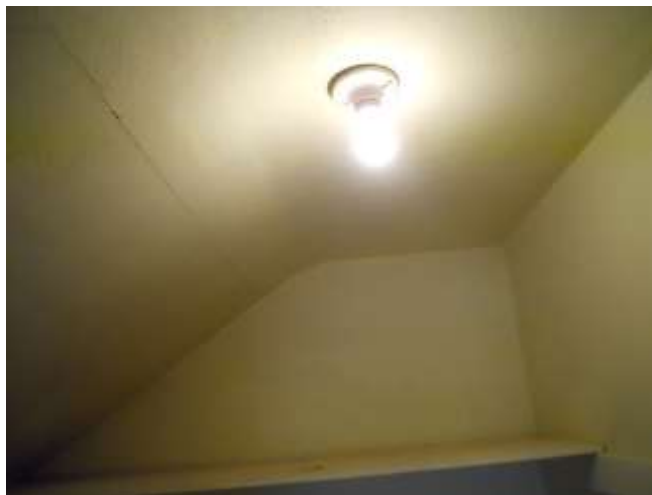
- Switches/Lights: All visible tested  
- *Exposed light bulb fixtures in closets are a fire hazard*  
Outlets: - *Outlets are not grounded and system obsolete. See Electrical section*  
Smoke Detector: - *Smoke detectors should be installed at each floor and in each bedroom*

Fire hazard at exposed bulb light fixtures

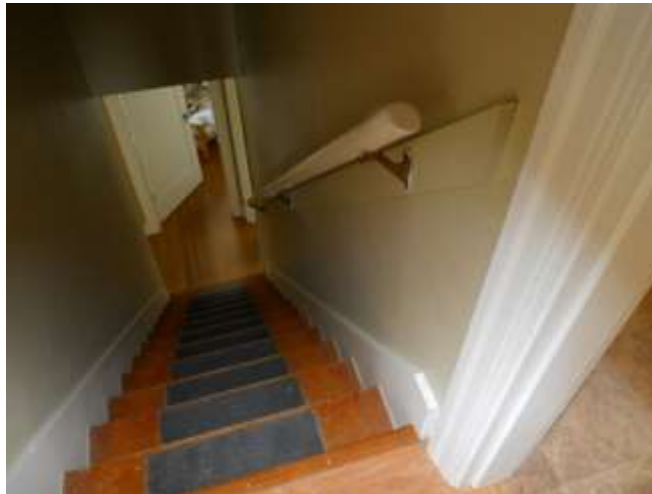
Operation/latching: Tested  
Door condition: Satisfactory  
Millwork condition: Satisfactory  
***- Graspable handrail should return to wall and extend to base of stairwell (upgraded to current code) due to stairwell height, tread rise/run, and materials***

Steep stairwell with wood treads

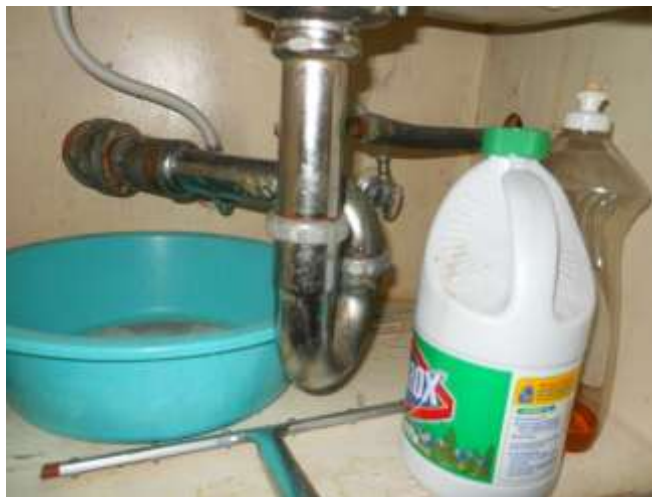
Dishwasher: *- Dishwasher is not connected*  
Range: *- Not tested*  
Ventilation: Tested  
Refrigerator: n/a

Dishwasher not connected

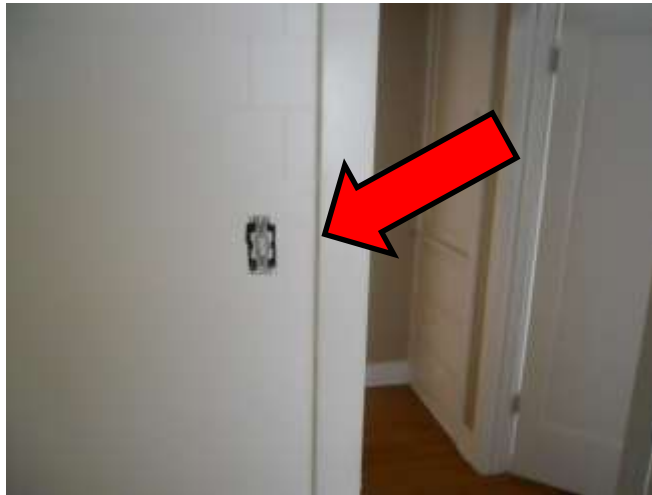
Switches/Lights: All visible tested  
*- Light switch to floor 1 is inside shower area. Relocate switch*  
Outlets: *- See Electrical section*

Light switch in shower area

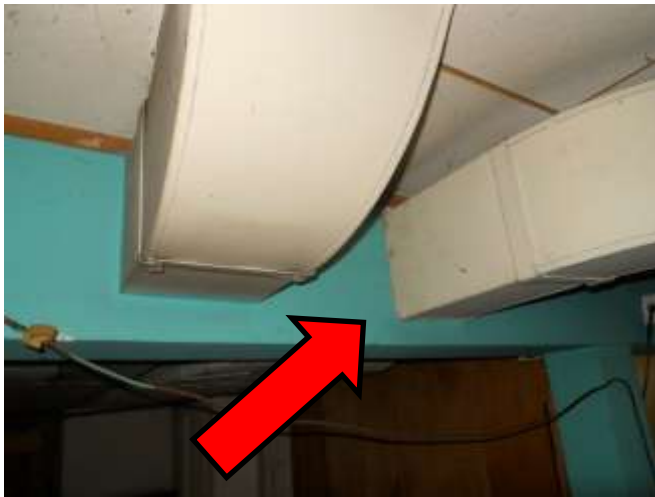
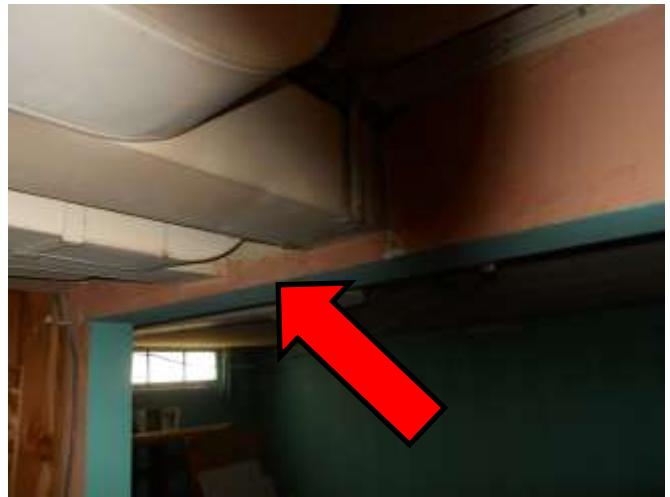
Structural Movement: - Primary floor beam beneath Living room and Dining room has been over-notched. Less than 2" of wood remains at the base of the beam. Recommend supports at cut area

Beam has been over notched  
Floor is sagging above

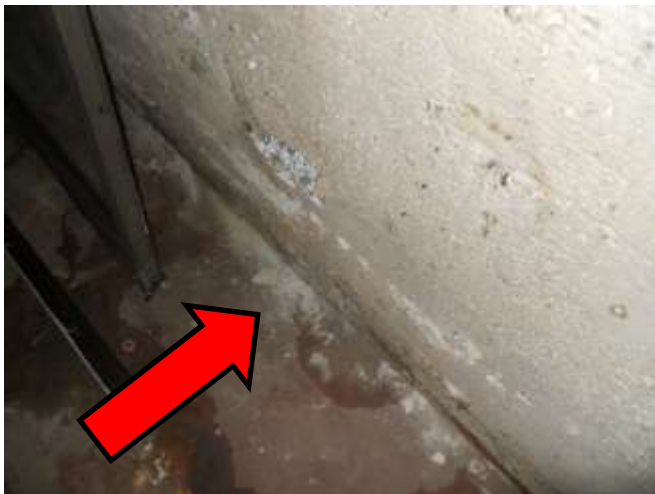
Moisture Infiltration: - Evidence of moisture intrusion at side door. Recommend cut in floor drain and connect to plumbing waste system  
- Evidence of moisture intrusion at N.W. foundation wall. Recommend continue to monitor during periods of heavy rainfall

Evidenec of moisture intrusion at N.W. wall

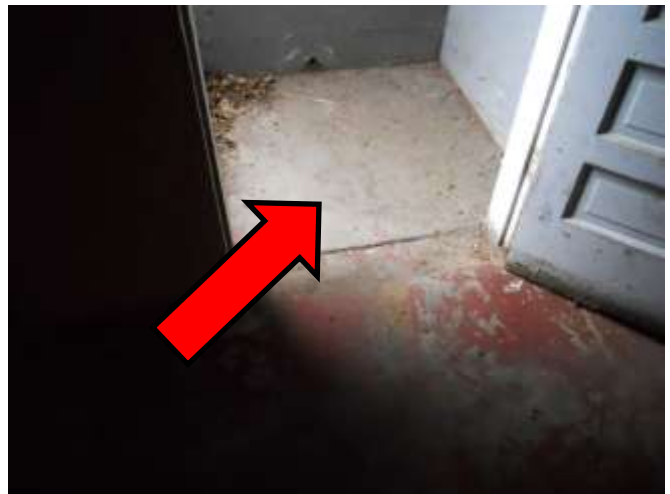
Floor drain missing from side stairwell

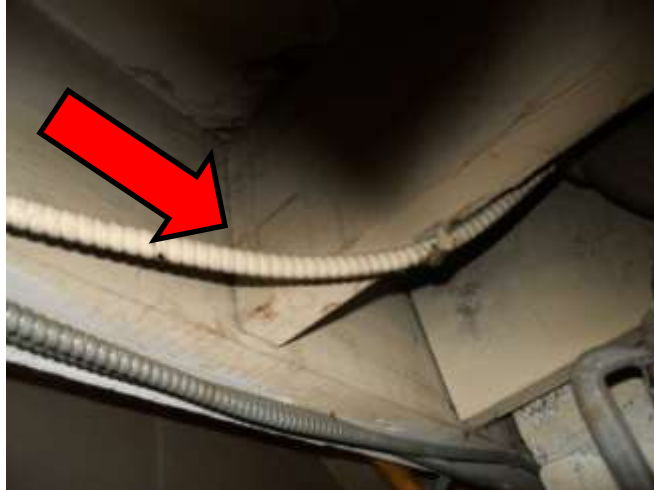
- Joist hangers should be installed at perpendicular junctions of floor 1 joists

Joist hangers should be installed

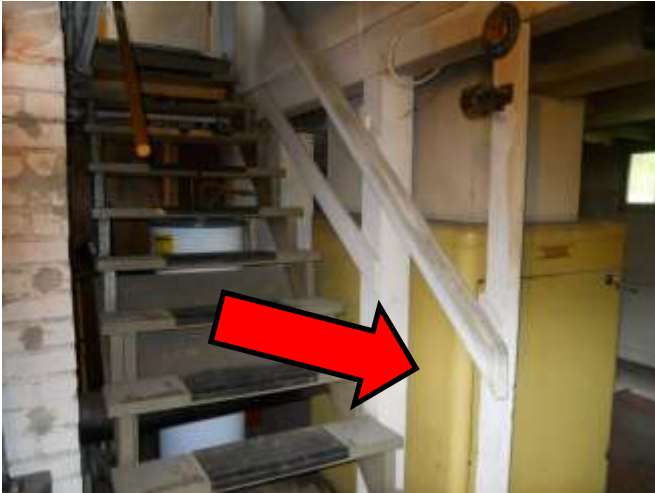
Stairs: - Recommend install graspable rails and barricades per current code (both sides and between open areas of stair treads (4" sphere maximum to pass thru gaps))

Barricade safety hazard

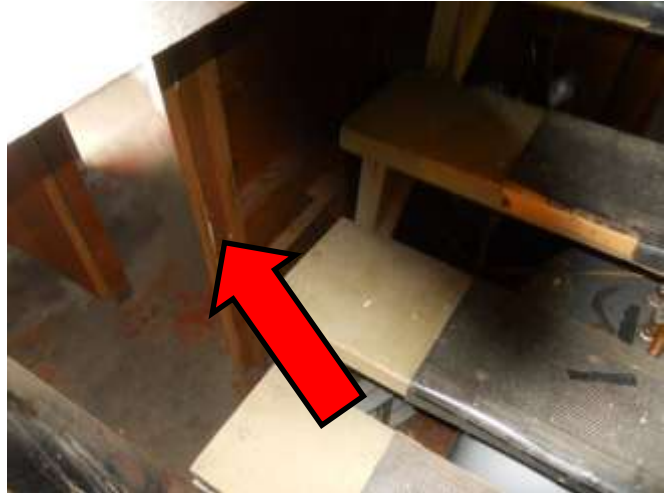
Barricade missing entirely

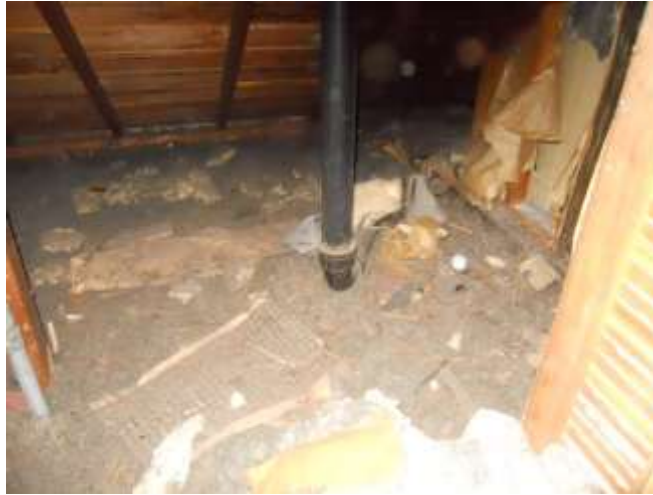
Debris should be cleaned from attic area

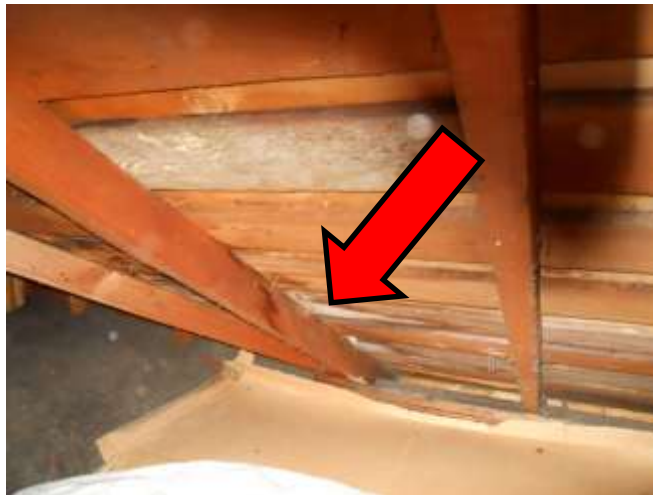
Roof Ventilation: Appears adequate at visible areas  
Moisture Intrusion: - Moisture intrusion at Dining room below. Recommend continue to monitor this area during periods of heavy rainfall

Area of possible moisture intrusion
