Property Description: (1) story single family home with basement  
Property age/ size: 1,680 s.f., built 1929 per listing  
Occupancy Status: Vacant

Inspection Date: 07/30/2011  
Inspection Time: 9:45 A.M. – 12:15 P.M.  
Weather Conditions: Clear, 65 deg F +-

Hergert Inspection LLC

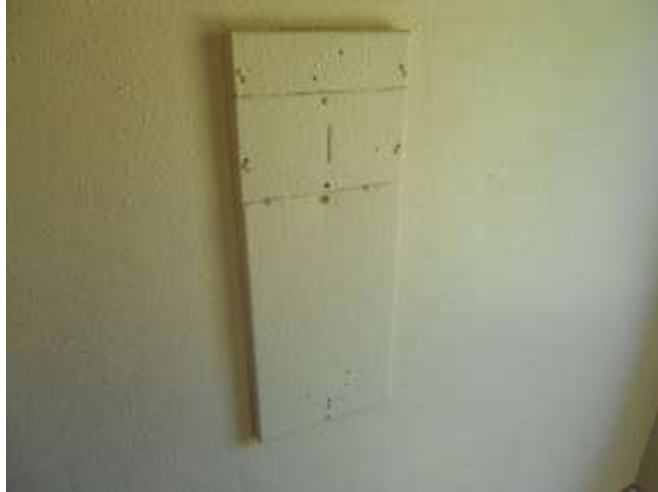
*- Panel at floor 1 hallway was likely the original electrical panel for the house. Electrical wires are typically spliced at this location. Unable to open this cover as it is painted shut*

Assumed original electrical panel at floor 1 hallway

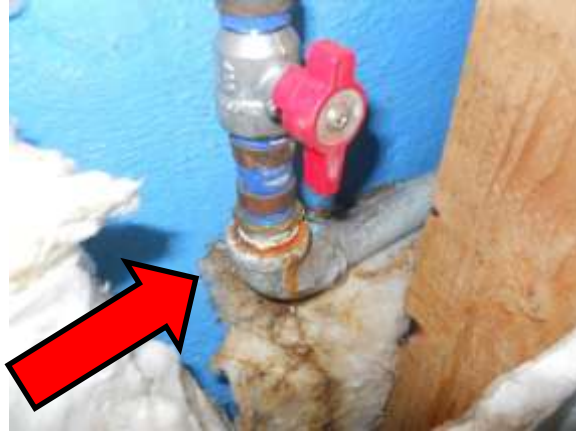
- Minor leak and corrosion at domestic water supply pipe in basement bedroom
- Galvanized pipes rust from the inside out. There is evidence of this condition as the functional flow of the water is reduced when multiple plumbing fixtures are operated simultaneously

Leak at domestic Water Shut off

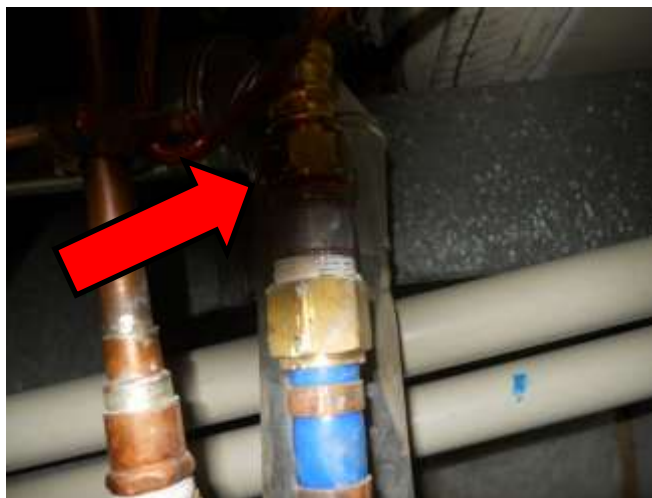
Corrosion at water pipe connection

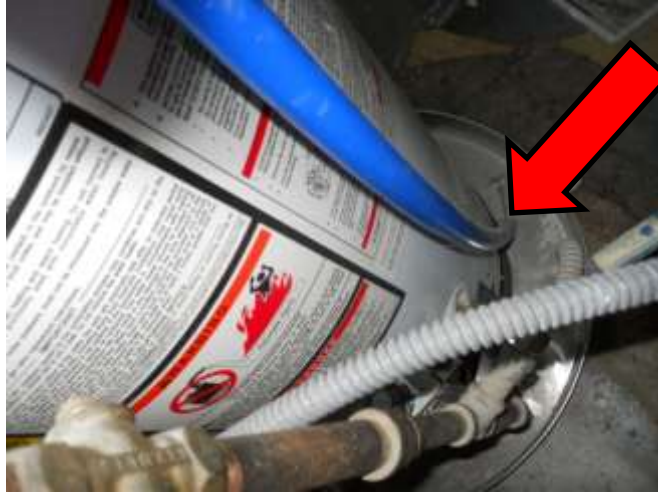
TMP valve: - TMP drain line end is wedged into drip pan. End of pipe should not be blocked  
Earthquake Straps: - Earthquake restraints are not installed  
Flame Rollout: No visible evidence

TMP drain line should not be blocked

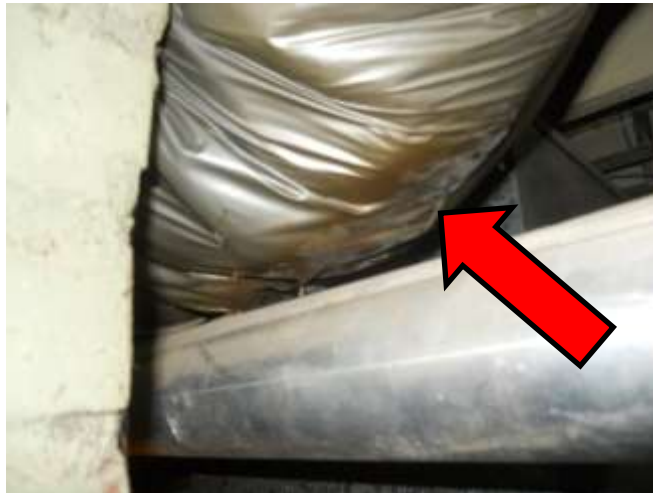
Secure: Inspected  
Clearances: - Remove insulation at heat duct adjacent to water heater flue  
Draft Hood: Inspected

Insulation cover of heat duct is melting

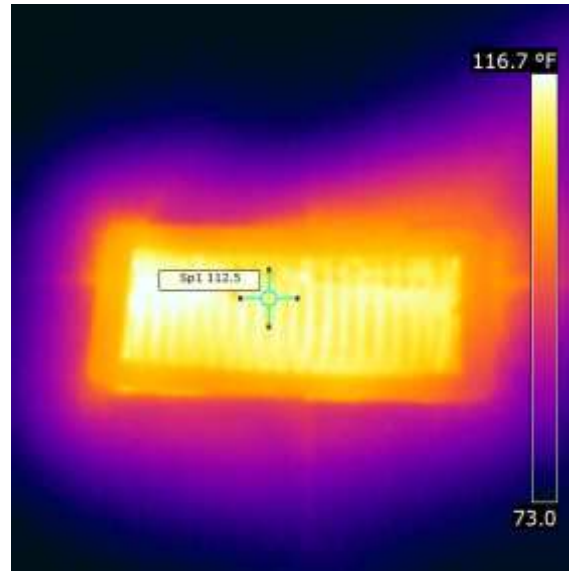
Rating: 30-60 deg F  
@ return air: - Not located. Assumed 70 deg F  
@ nearest register: 117 deg F  
Heat Gain: 47 deg F. Heat gain is within specifications of furnace

Temperature measured at heat register

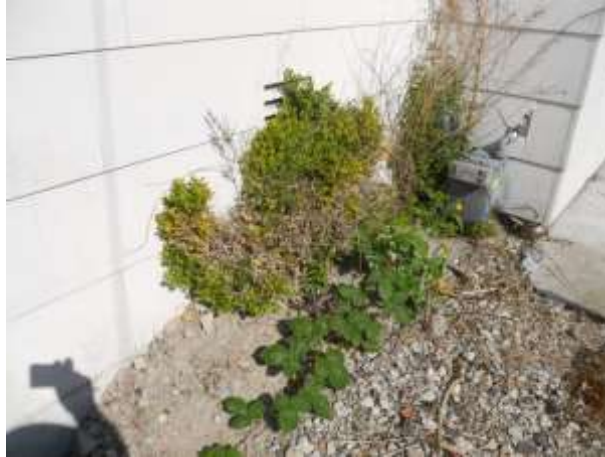
Minor area of vegetation in contact with house

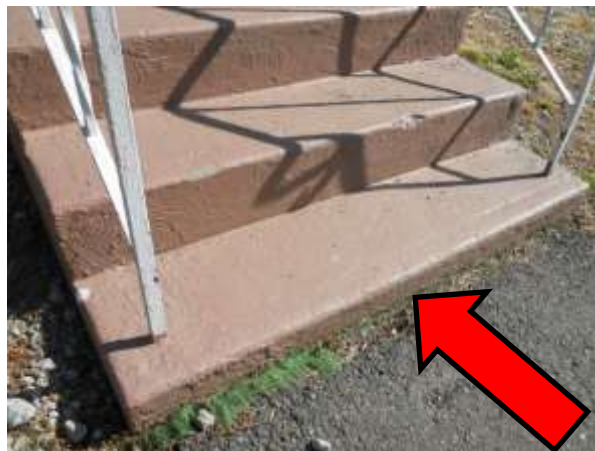
Type: Concrete  
Condition: Satisfactory  
Trip Hazard: *- Step from driveway is not the same height as the other stairs. Minor trip hazard. There is no minor fix for this condition*  
Handrails: As required  
Barricades: As required

First step height is not consistent with other steps

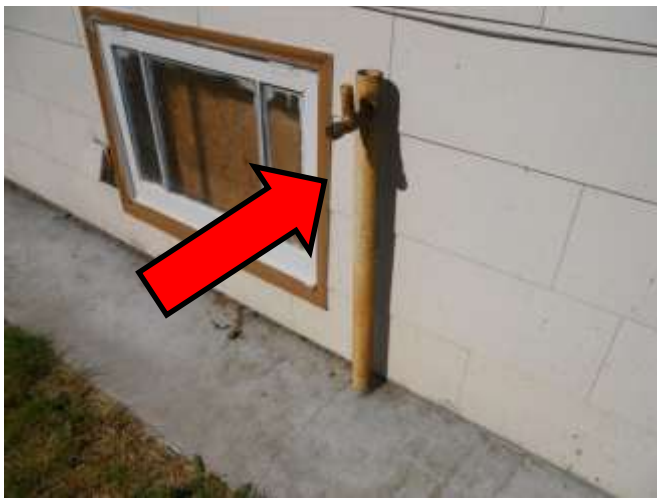
Evidence of abandoned oil tank

Overhead Power Lines: Yes  
Retaining Walls: None that affect structure  
Underground Oil Tank: - Evidence of prior oil tank. Recommend investigate if tank was properly removed or decommissioned  
Irrigation System: None visible  
Other: - Garage and shed are in very poor condition. Interior not inspected

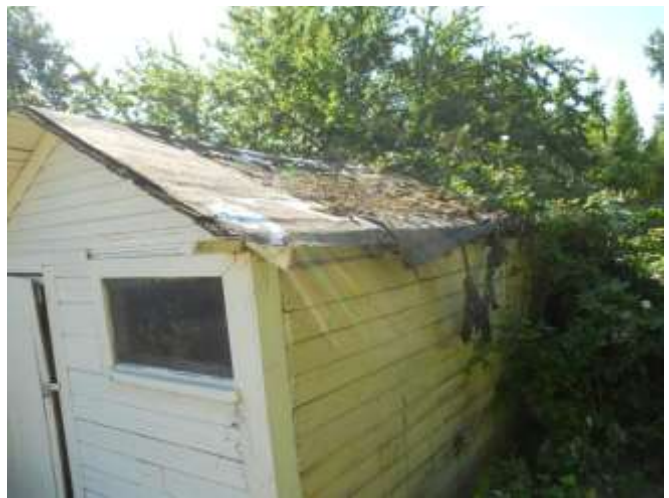
Garage and shed

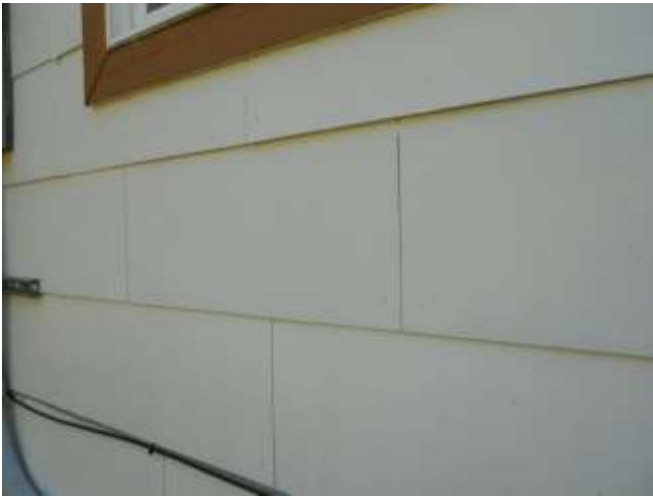
Type: - Siding likely contains asbestos. Do not disturb without proper testing. Several siding boards are damaged. Recommend seal all gaps and holes  
Condition: Satisfactory  
Window/Door Flashing: Satisfactory  
Caulking: Satisfactory

Siding appears to be asbestos type

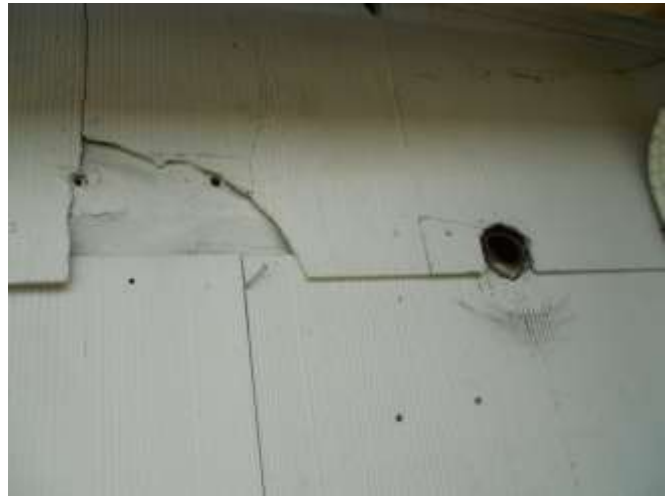
Damaged siding (typical)

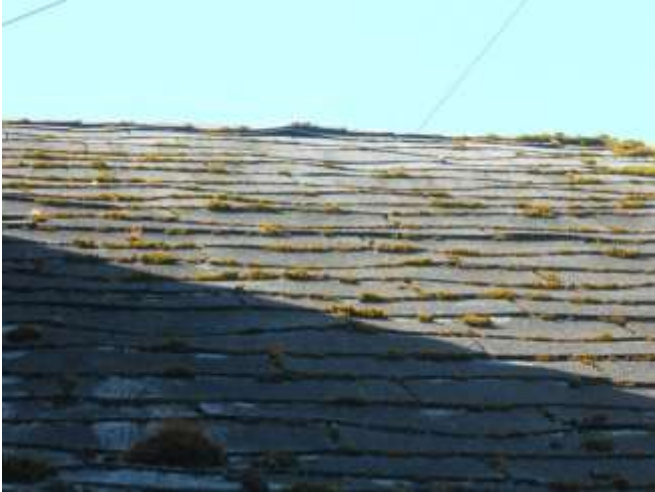
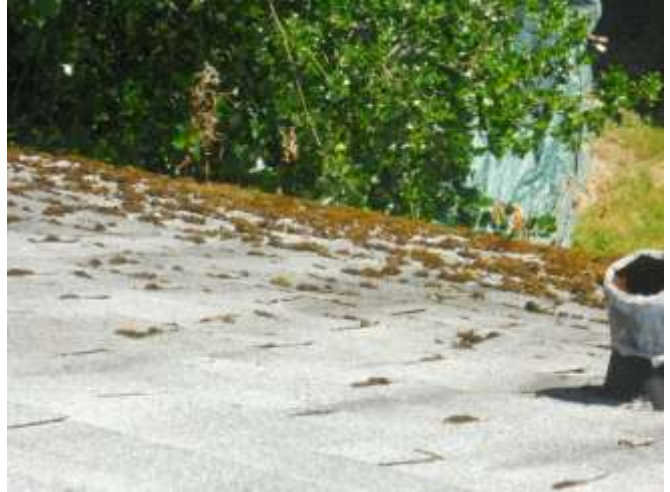
Estimated Pitch: 6:12  
Material: Composition  
Layers: 2+  
How Inspected: Traversed roof  
Condition: - Recommend clean moss and debris from roof. Uneven appearance of shingles is likely due to the cedar shakes beneath and lack of proper roof ventilation  
- When roof is replaced, remove all existing roofing, including the cedar shakes. Install proper roof to wall and kick-out flashings  
Ventilation: None  
Plumbing Vents: Satisfactory  
Flues: - Extensive deterioration of chimney mortar. Recommend metal water heater vent extend from water heater to exterior  
Flashing: - Roof to wall flashing not installed at entryway roof. Recommend install flashing. If not, caulking must be repaired and maintained to prevent roof leaks

Moss build up at roof

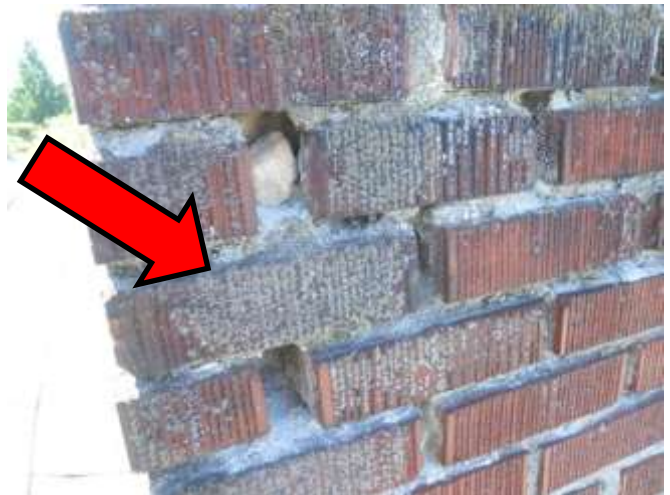
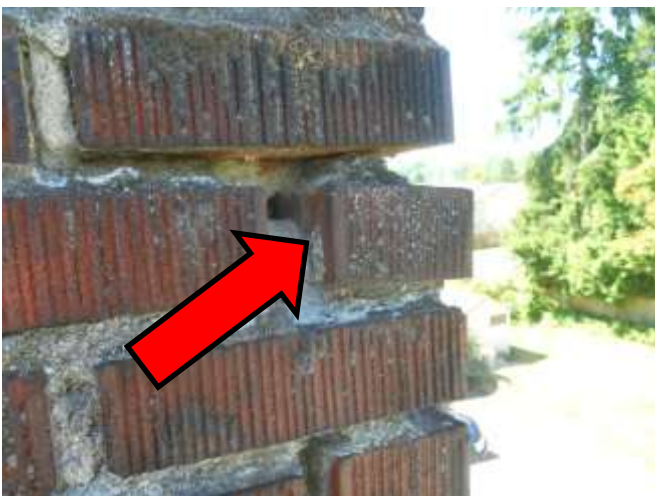
Deterioration of mortar

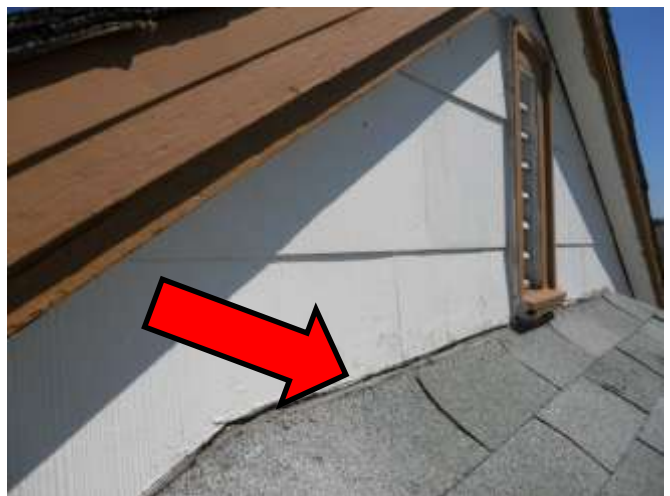
Roof to wall flashing not installed

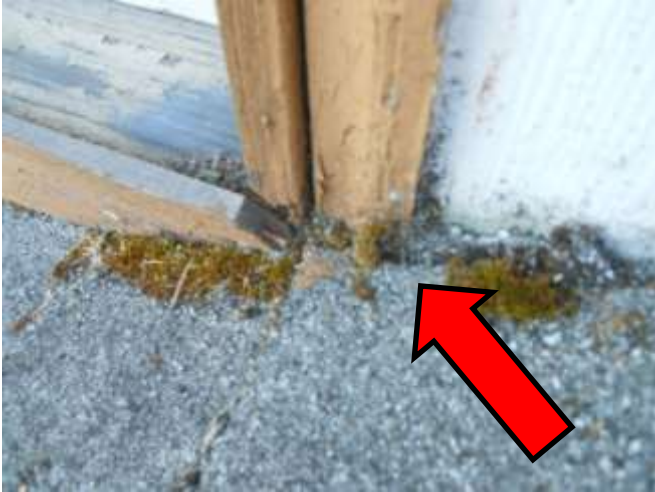
Flashing not installed at window above rear entry

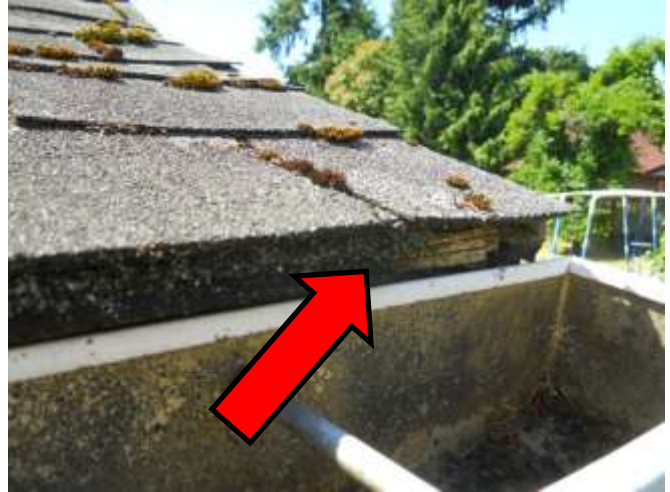
Sheathing deterioration at edged

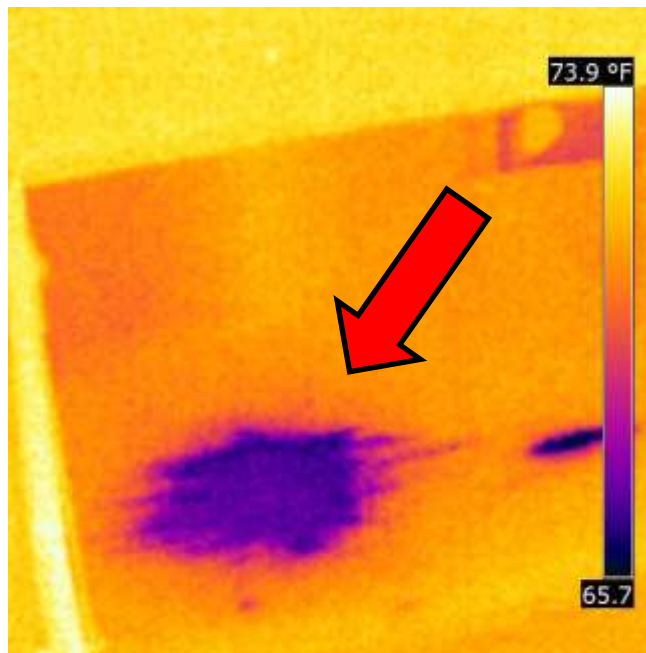
Functional flow: Appears adequate  
Hot/ Cold: Tested  
Drainage: Appears adequate  
Visible leaks: - *Leak at waste line of sink*  
Caulking: Satisfactory  
Fixtures: No visible defects

Leak at kitchen waste line

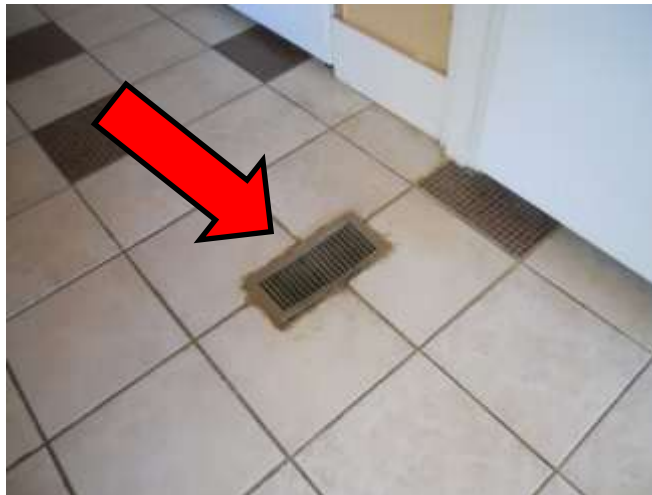
Source: Floor register  
- *Trip hazard at heat register in kitchen*

Trip hazard at heat register in middle of room

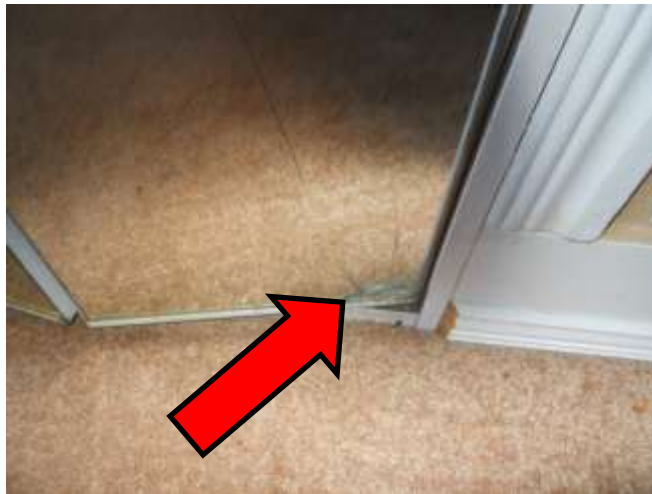
Broken bi-fold door

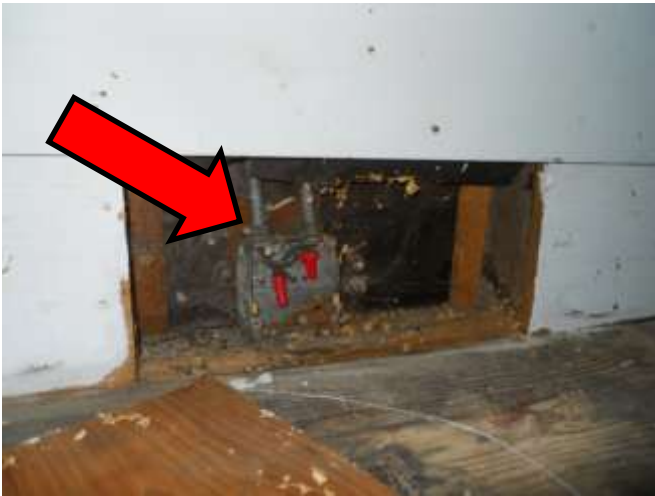
Cover plate missing at junction box

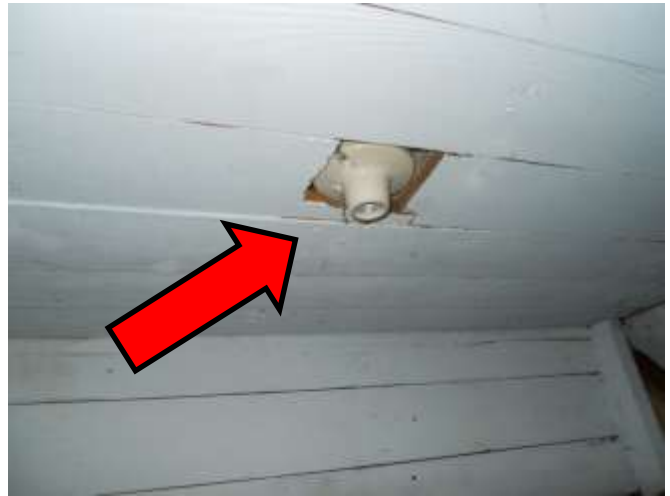
Exposed light bulb fixtures are a fire hazard  
Items could get into contact with hot light bulbs

Outlets: All visible tested  
- *Cover missing at electrical junction box in basement hallway*  
- *Exposed light fixtures in closets are a fire hazard. Replace with fixture that has cover*

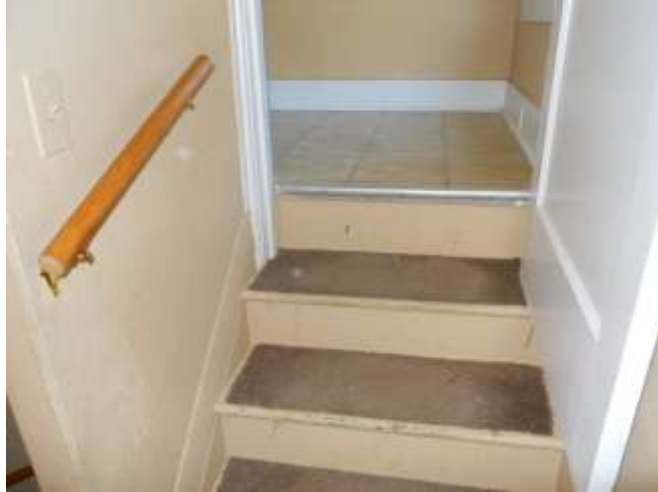
Handrails: - *Installed. Would not meet current code requirements*  
Barricades: - *Installed. Would not meet current code requirements*  
Trip Hazard: None

Staircase configuration would not meet current code requirements. Configuration does not appear to create any additional trip or fall hazard to occupants

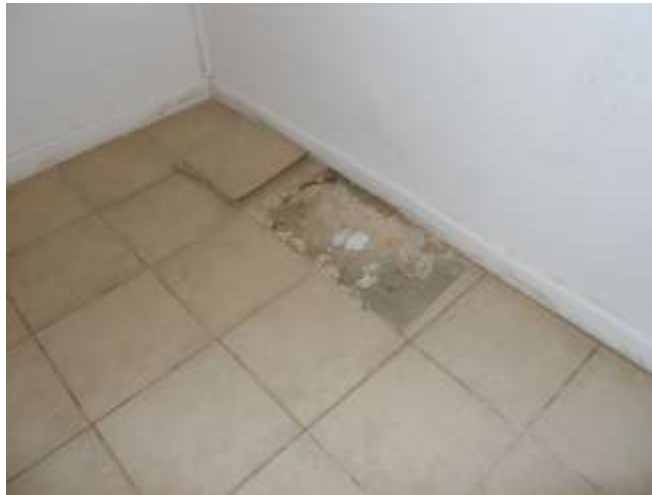
Visibility: Room is vacant  
Structural Movement: No visible evidence  
Moisture Infiltration: - *Evidence of prior moisture at West wall of mechanical room. It appears that the source of the moisture may have been a downspout which has since been extended to drain away from the house*  
Walls: Satisfactory  
Ceiling: Satisfactory  
Flooring: Satisfactory

Loose tiles at mechanical room due to moisture

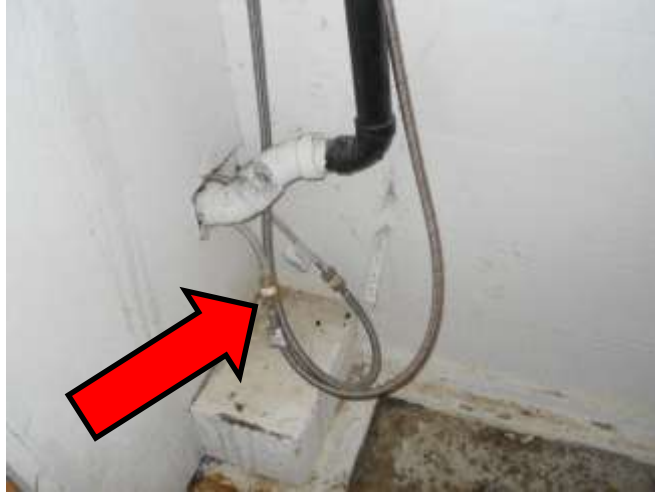
Improper extension of water supply lines to sink

- Improper extension of plumbing lines to utility sink. Recommend proper pipe extension by a licensed plumber

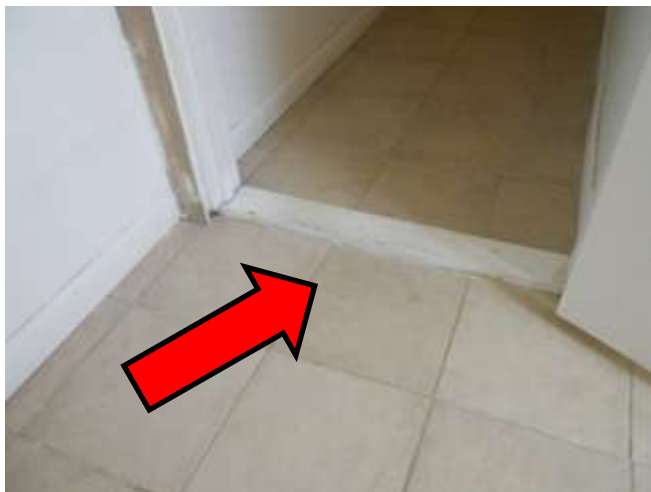
Trip hazard at entryway to room

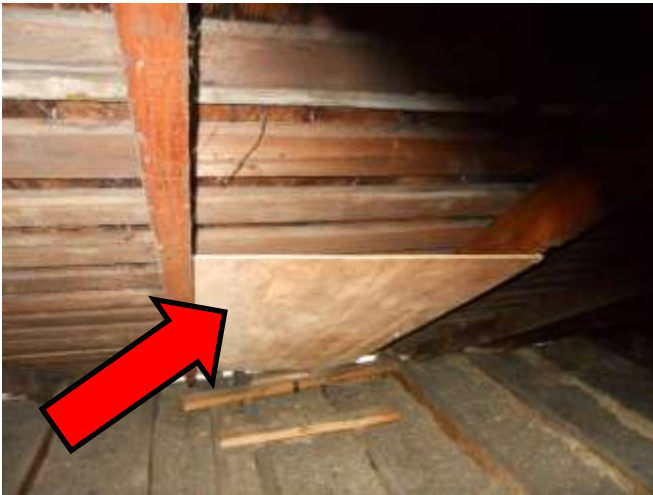
Evidence of prior leak  
Board is placed to divert rainwater

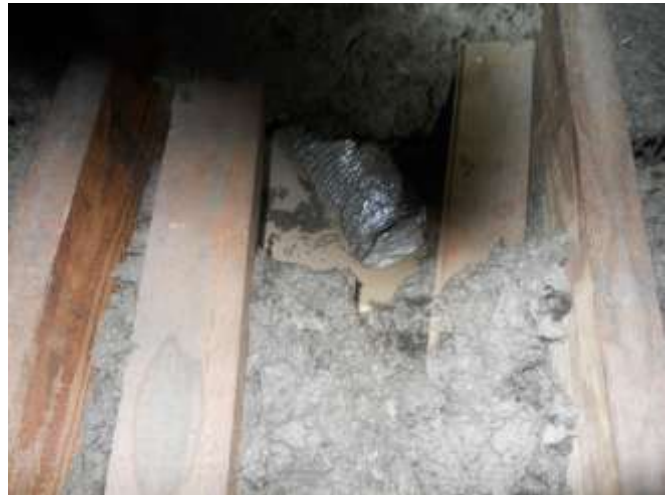
Roof Ventilation: - None  
- Recommend install roof ventilation when roof is replaced  
Moisture Intrusion: No visible evidence  
Bath/Kitchen fans : - Vent is open into the attic. Vents should extend to the exterior

Vent should be extended to the exterior

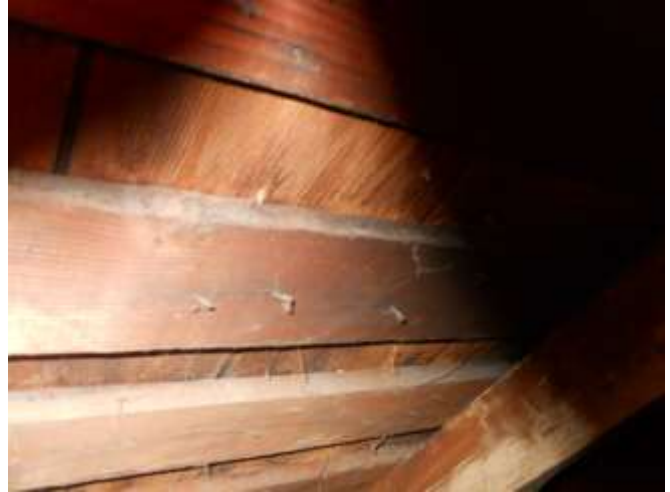
Shake roof on skip sheathing

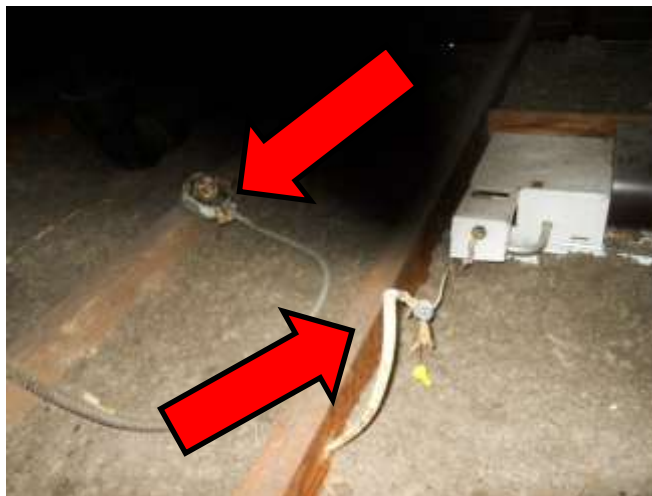
Exposed wires and junction box in attic

Outlets: None visible  
Wiring/ junction boxes: - Exposed wires and junction boxes in attic. Recommend repair by a licensed electrician
