Property Description: (1) story single family home
Property age/ size: 1,024 s.f., built 1944 per listing
Occupancy Status: Occupied

Inspection Date: 09/08/2011
Inspection Time: 11:15 A.M. – 1:45 P.M.
Weather Conditions: Clear, 70 deg F +-

Hergert Inspection LLC

Summary of Inspection

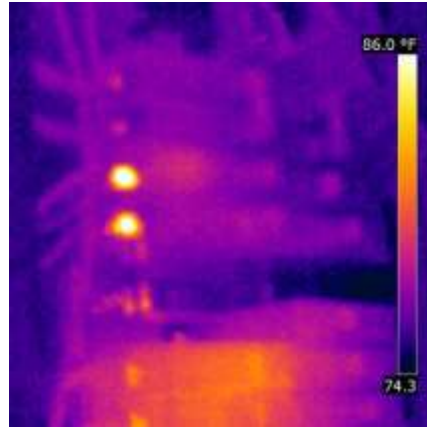
No evidence of over heating

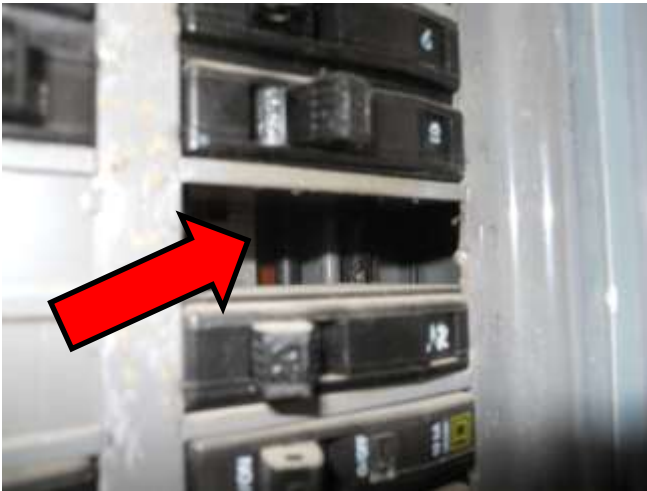
Location: Utility room
Manufacturer: Square D
Type: Split bus bar
Panel Rating: 125 AMP
Main Disconnect: n/a
Serv. wire Size/ Rating: 125 AMP
Grounding: Copper to exterior ground rod, limited visibility
Panel Clearance: 30" wide, 3' in front as required
- Abandoned breakers should be removed. Knockout missing at cover panel
- Burn mark at location of prior breaker. Recommend inspection by a licensed electrician

Knockout missing

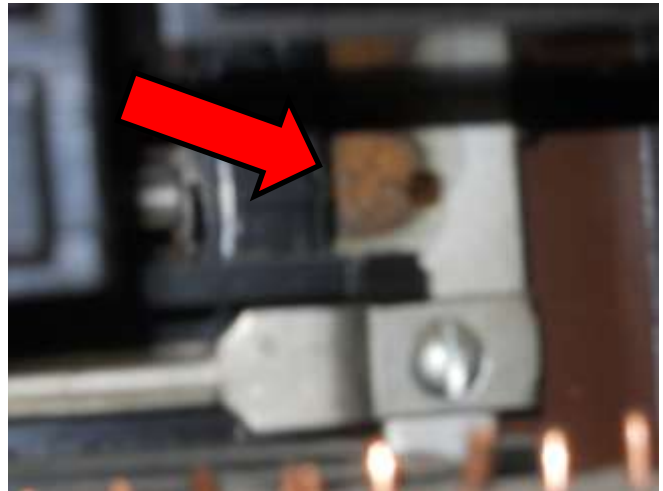
- Abandoned breakers should be removed. Knockout missing at cover panel
- Burn mark at location of prior breaker. Recommend inspection by a licensed electrician

Burn mark at bus bar

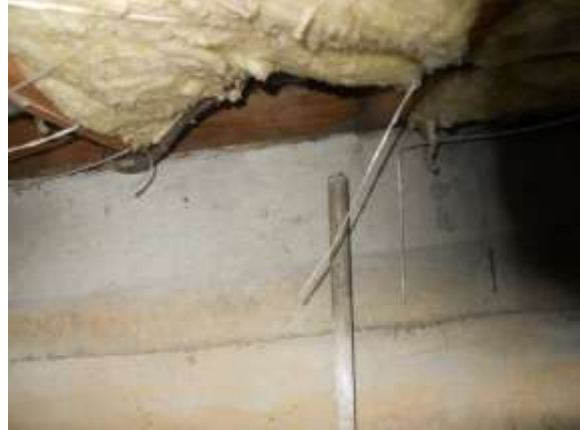
Abandoned galvanized supply line

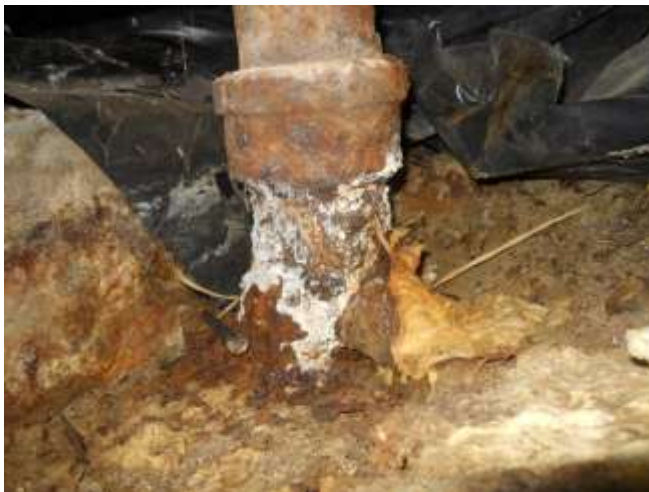
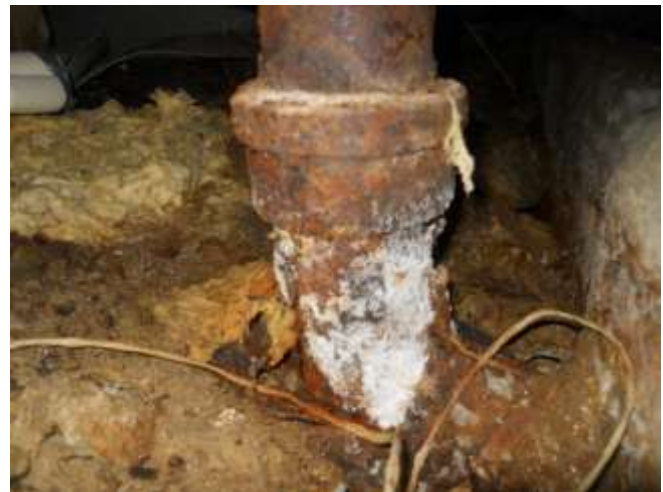
Discharge: Public sewer
House Piping: Steel and cast iron where visible
Pipe Condition: ***- Substantial corrosion and deterioration at Sanitary sewer waste line near ground. Recommend sewer scope to determine integrity of buried pipe. At a minimum, the visible deteriorated pipe should be replaced***

Deterioration of sanitary sewer pipe
View from North

Deterioration of sanitary sewer pipe
View from South

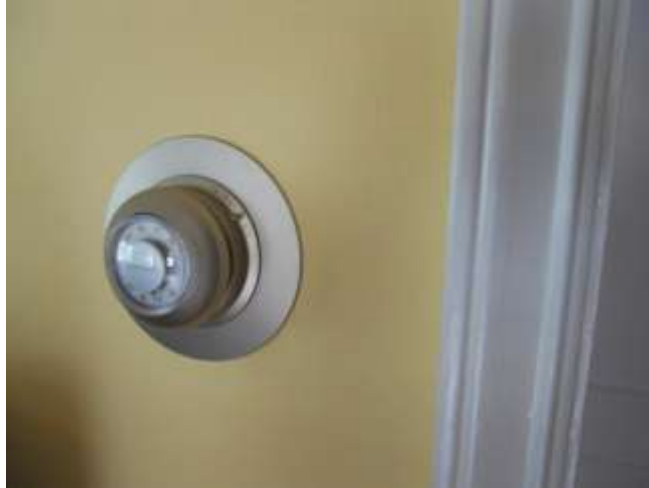
Thermostat: Living Room
- Recommend replacement of thermostat with 5 or 7 day programmable type
Disconnect: Switch on furnace
Combustion Air: Appears adequate

Outdated thermostat

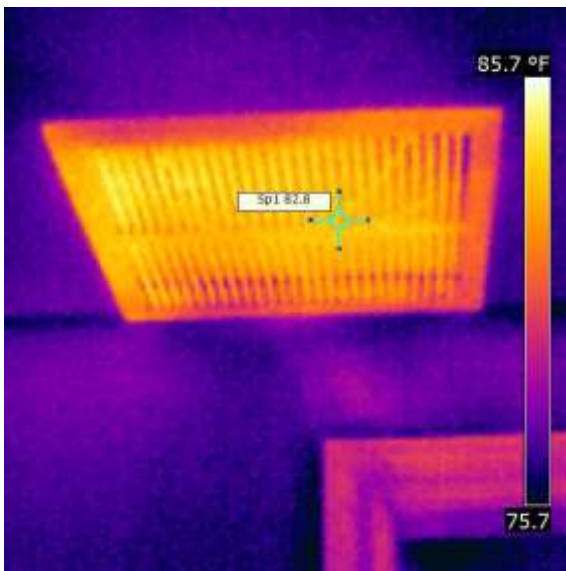
Temperature measured at return air

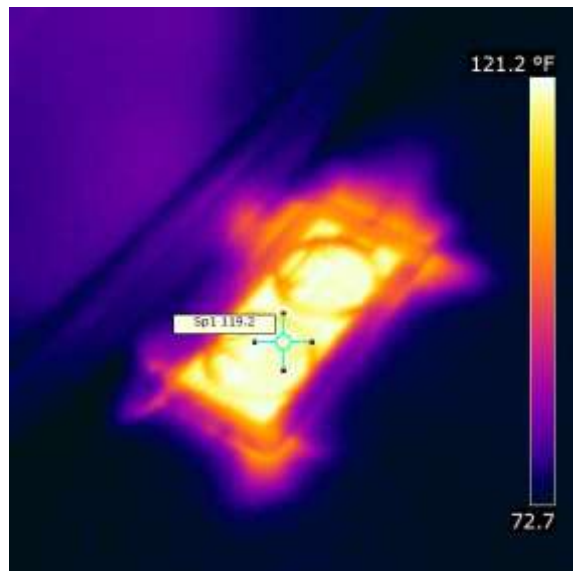
Rating: 30-60 deg F
@ return air: 86 deg F
@ nearest register: 121 deg F
Heat Gain: 35 deg F. Heat gain is within specifications of furnace

Temperature measured at heat register

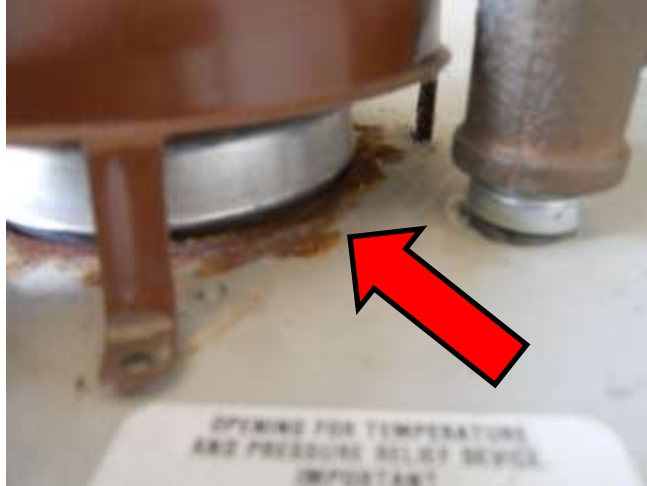
Secure: Inspected
Clearances: As required where visible
Draft Hood: - *Evidence of flue gases not properly venting to the exterior. This condition may be the result of the dryer vent exhausting to the exterior causing negative pressure in the Utility room. The flue gases would then be drawn back into the room. Recommend provide an external source of air (grate to crawlspace) to provide adequate draft of the flue gases*

Evidence of inadequate draft at the water heater flue

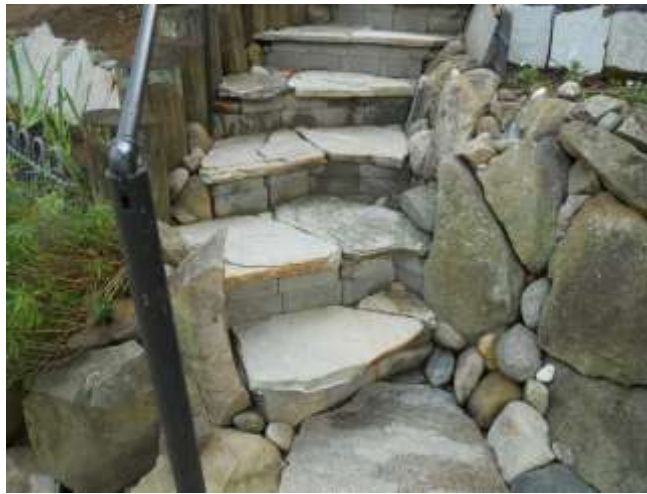
Type: Stamped concrete patio and stone stairs
Condition: Satisfactory
Trip Hazard: *- Rear stairs would not meet current building code and are a trip hazard*
Handrails: As required

Uneven stairs to rear yard

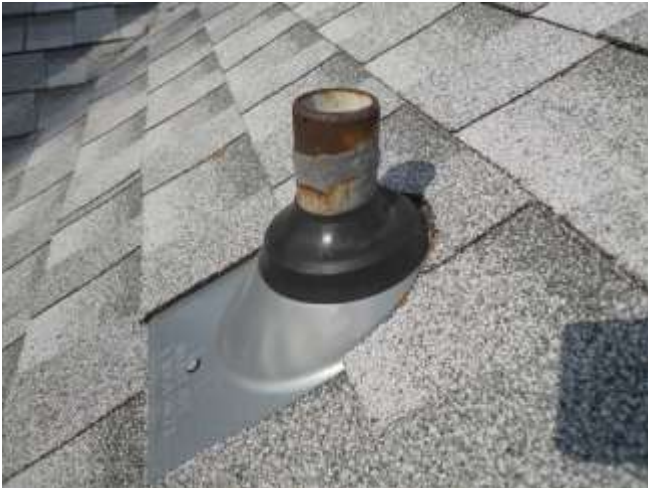
Plumbing vent stack should extend 6" + above roof

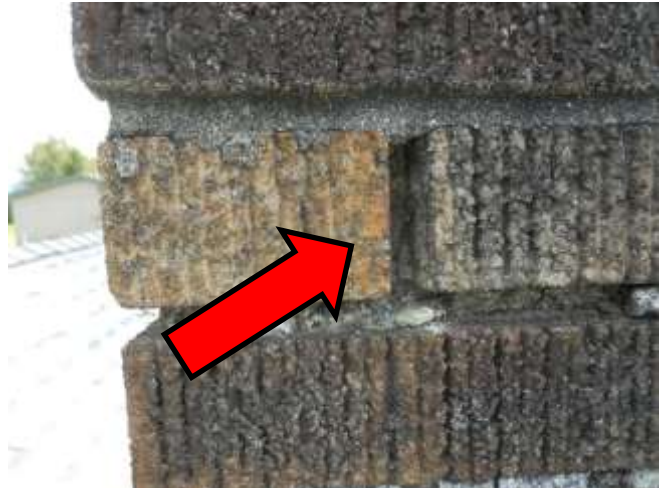
Mortar deterioration at chimney

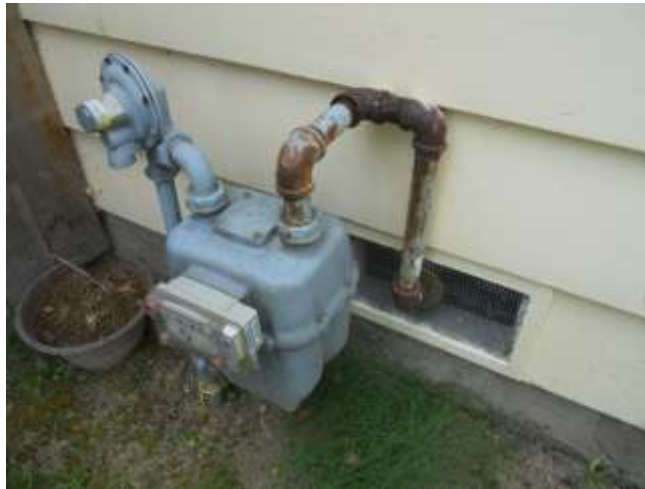
Current code would not allow a gas meter to be located within 3' of a foundation vent

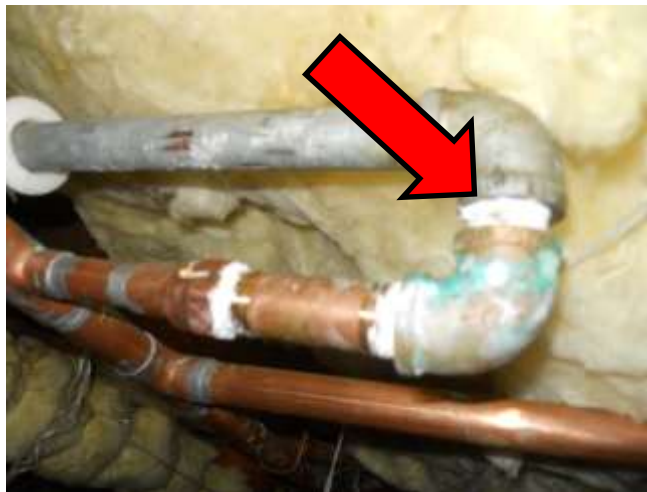
Connection of copper to galvanized pipes for rear hose bib may lead to galvanic corrosion and an eventual leak

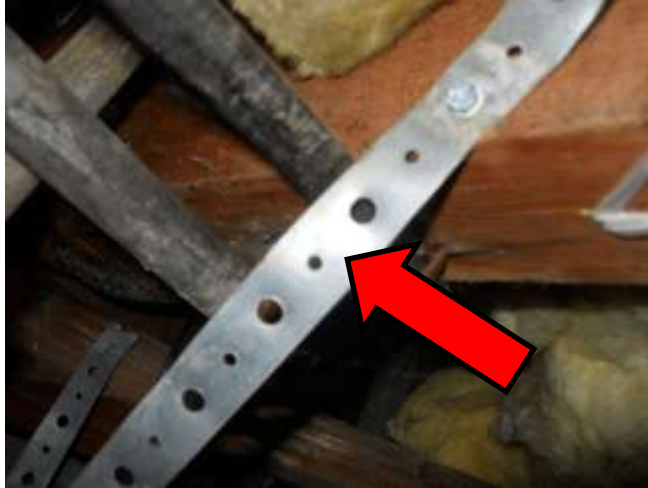
Outlets: None visible
Wiring/ junction boxes: - *Edge of metal strap is in contact with electrical wire near crawl access. This condition could result in cutting of the protective covering of the wires*

Edge of Metal strap in contact with electrical wire

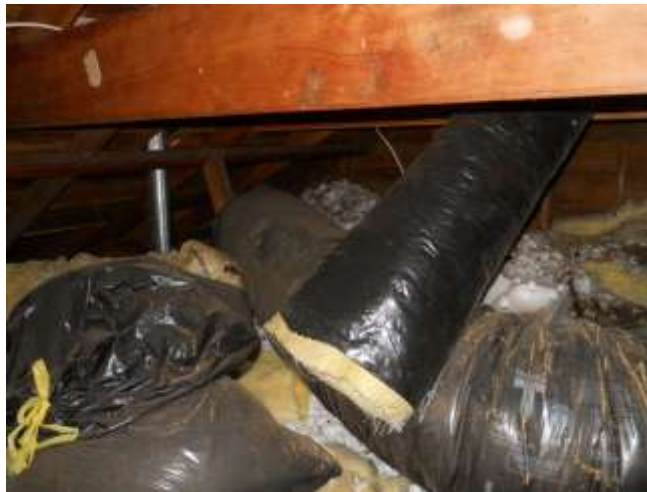
Debris in attic

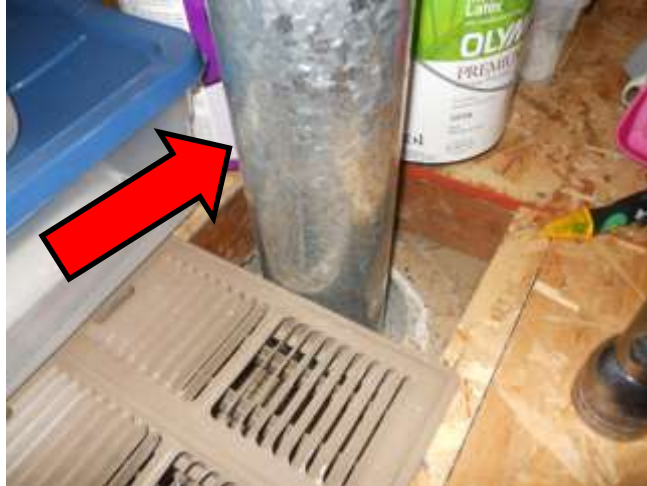
Plumbing Stacks: All vented to exterior
Gas Flues: No visible defects
- Recommend shield around flue to keep combustibles 1" + away from flue

Furnace flue should have shield to prevent combustibles from coming within 1”
