Client:
Address: Duvall, Wa

Property Description: (2) story single family home
Estimated property age: Built 1991 per listing
Occupancy Status: Vacant

Inspection Date: 11/4/2019
Inspection Time: 3:30 P.M. - 6:00 P.M. +-
Weather Conditions: Overcast, 40 deg f +-

Hergert Inspection LLC

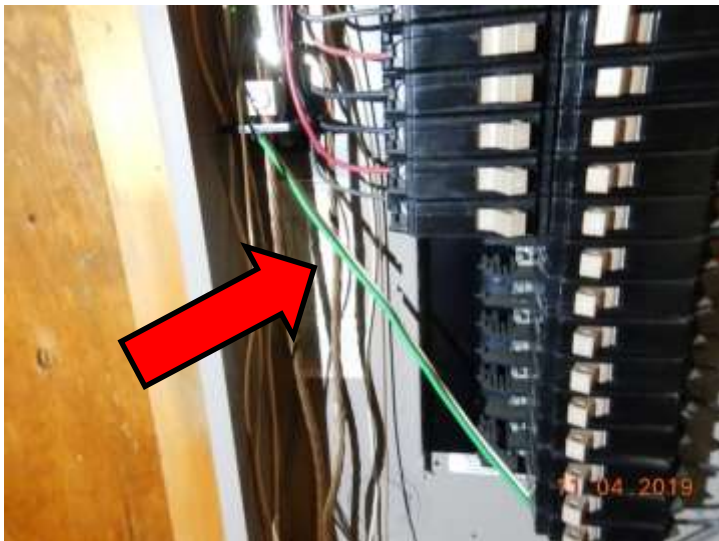
Type: Copper romex and multi-strand aluminum
Breakers: - A "homeowner" installed circuit-branch wiring has been installed. Recommend removal of this improperly installed wiring by a licensed electrician
Circuit breaker legend: Appears proper and complete. Individual circuit breakers are not tested

Homeowner installed wires under tension

- A “homeowner” installed circuit-branch wiring has been installed. Recommend removal of this improperly installed wiring by a licensed electrician

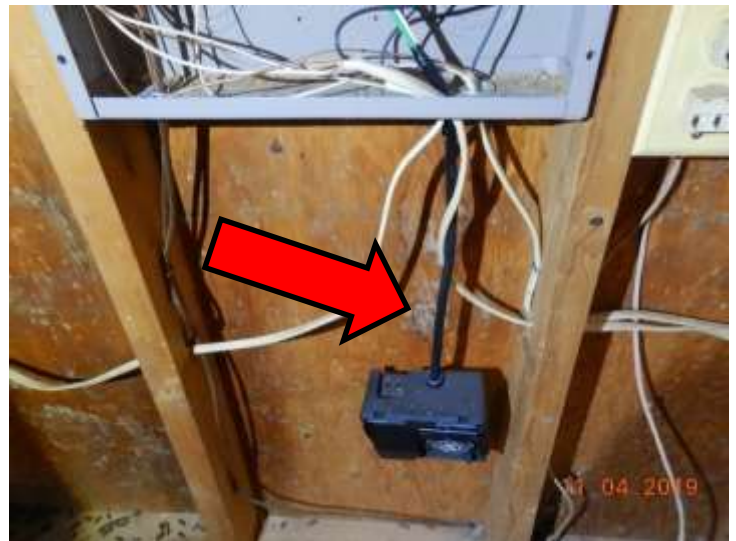
Homeowner added wiring/ outlet

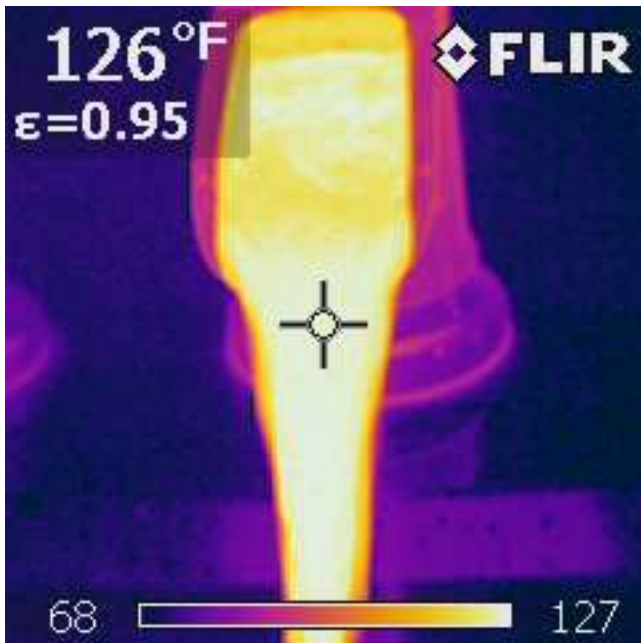
Measured temperature: - The water temperature was measured at 127 deg F; this temperature is above the recommended setting of 120 deg F. This adjustment is typically a simple adjustment to the water heater thermostat

Hot water temperature

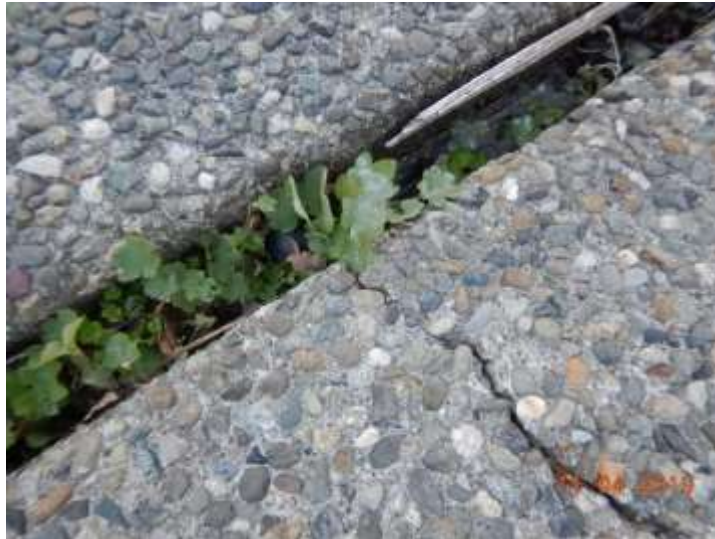
Type: Concrete
Condition: - Recommend sealing all cracks at the driveway to help reduce further deterioration from moisture intrusion and damage from the expansion of freezing moisture
Trip Hazard: - The gaps at the driveway expansion joints are a potential trip hazard

Cracks at the driveway, rotted out expansion joints

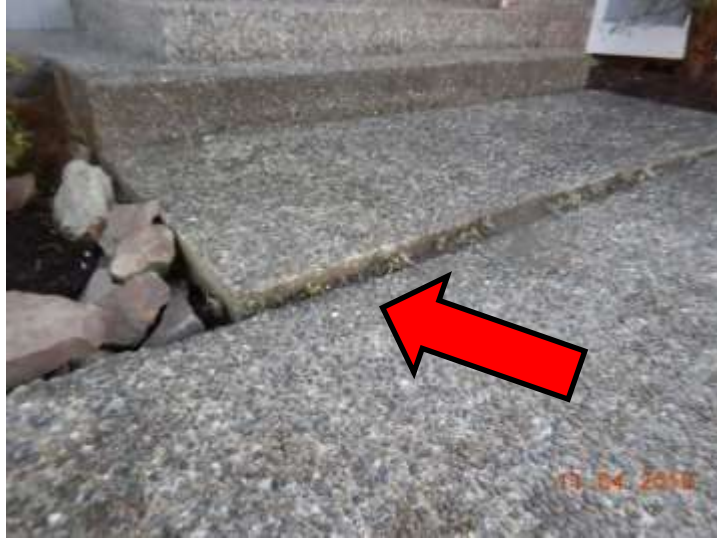
Type: Concrete
Condition: Satisfactory
Trip Hazard: - There is substantial settlement of the front walkway. A trip hazard exists due to the raised edges at the walkway
Handrails: A reasonable graspable handrail is installed
Barricades: A reasonable barricade is installed

Trip hazard at the vertical displacement

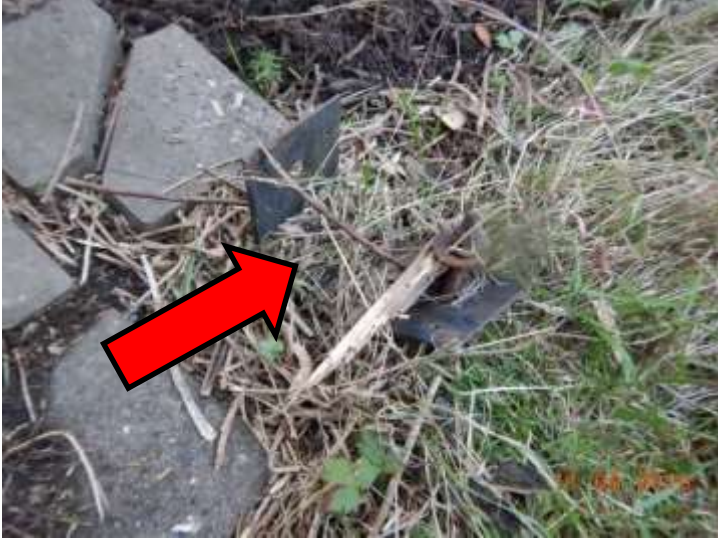
House Identification #: Visible
Overhead Power Lines: No
Retaining Walls: None that affect structure
Underground Oil Tank: No visible evidence
Other: - The metal brackets located at the ground of the side yard are a trip hazard. These brackets appear to be from removed trellises
- Seller: demonstrate that the mechanical awning at the rear deck functions as designed

Metal bracket set in the ground

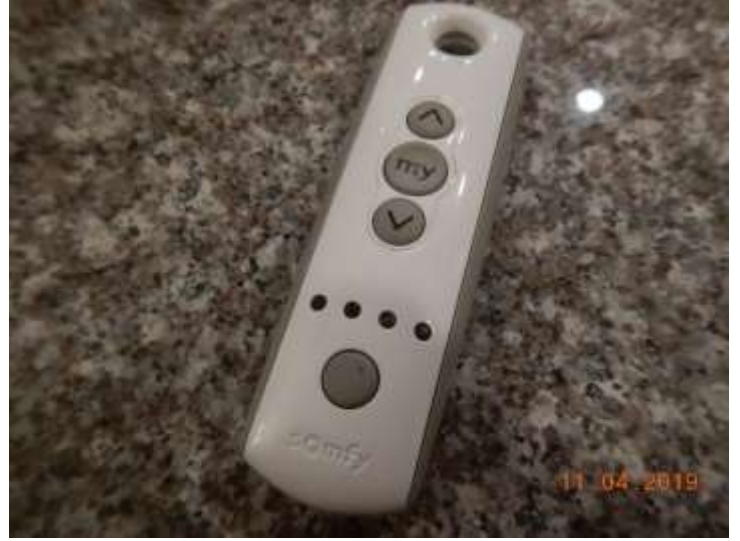
The awning did not respond to the remote control

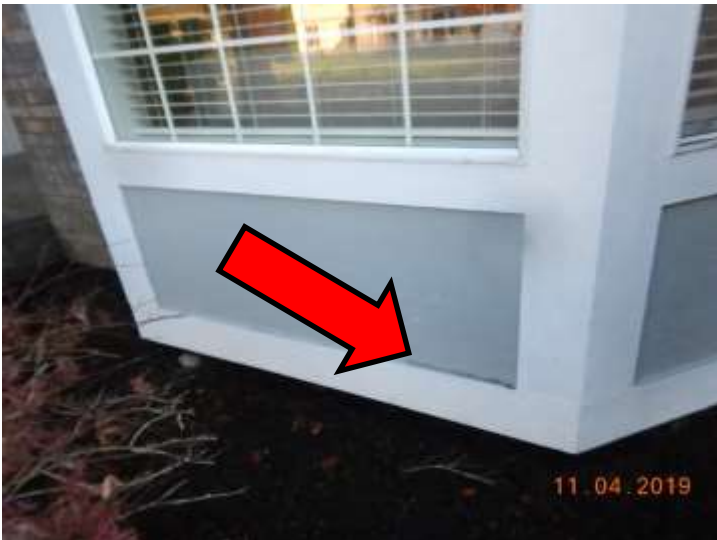
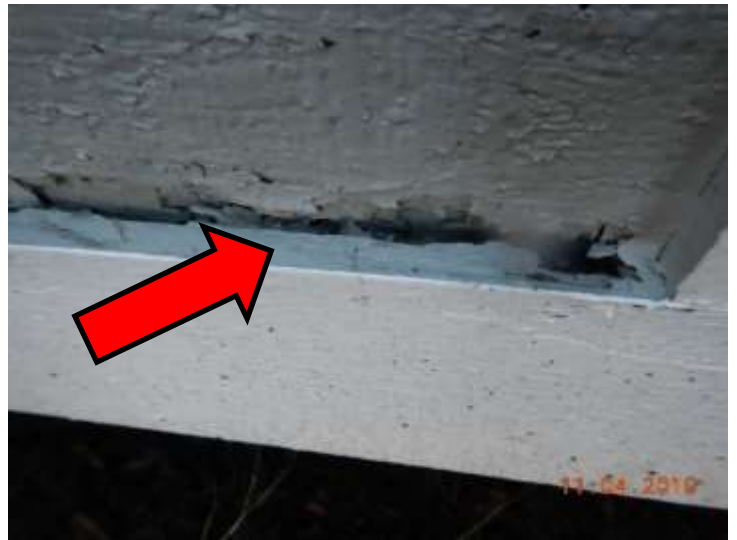
Type: Cedar
Condition: Overall satisfactory
- There is evidence of wood rot at the lower edge of the siding of the Living room bay window
Window/Door Flashing: Satisfactory
Paint and caulking: Satisfactory
Exterior vents: Satisfactory

Evidence of wood rot

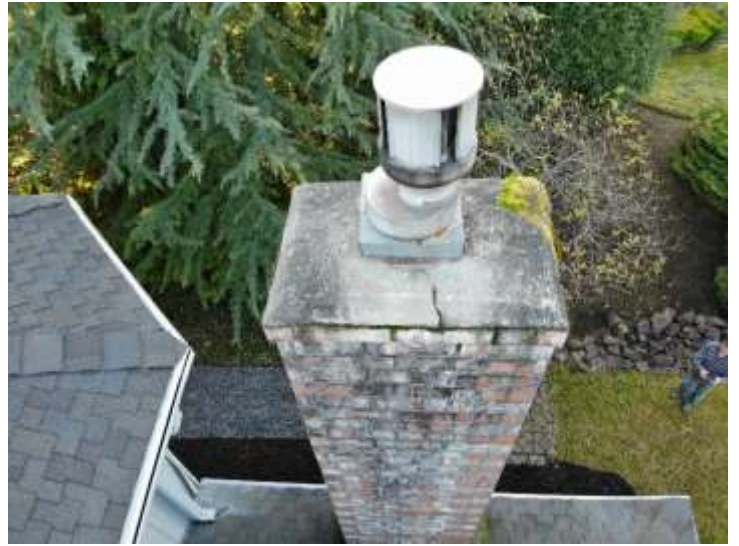
Chimney. A minor crack is visible at the cap

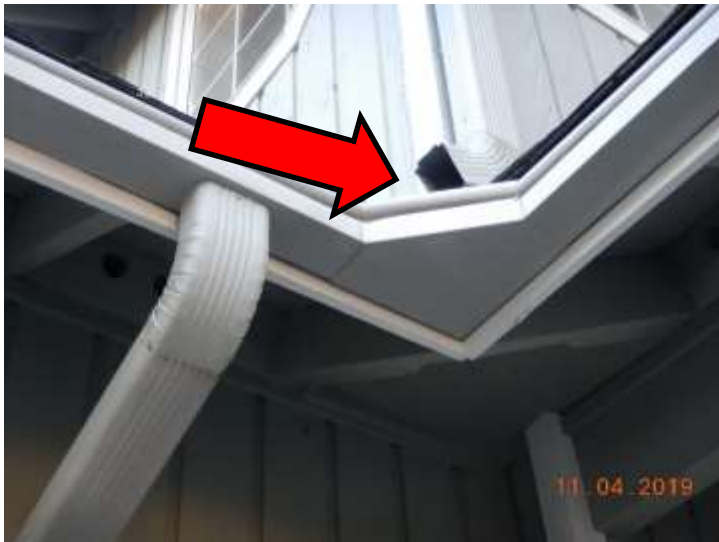
Condition: - The gutter drainage system located at the right side of the garage is not completed in a workmanlike manner. There is evidence that water will spill over the lower gutter onto the driveway and walks and the downspout extension located in front of the walkway is not properly installed to prevent leakage
- Recommend relocation of the downspouts noted above to a location that will prevent water from being discharged onto the driveway and walks. The discharge may result in the buildup of moss and/or ice

The upper downspout will overshoot the lower gutter during strong rain events

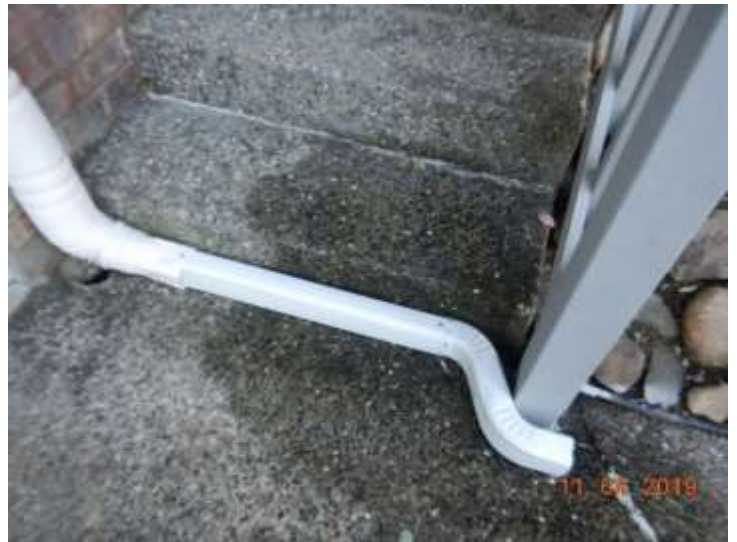
Evidence of water discharge onto the walkway and driveway

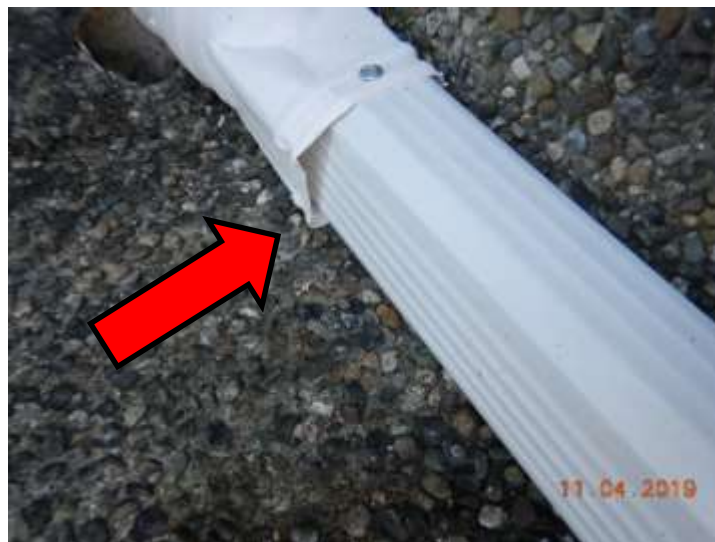
The connection of the extension is installed backwards which will allow leakage

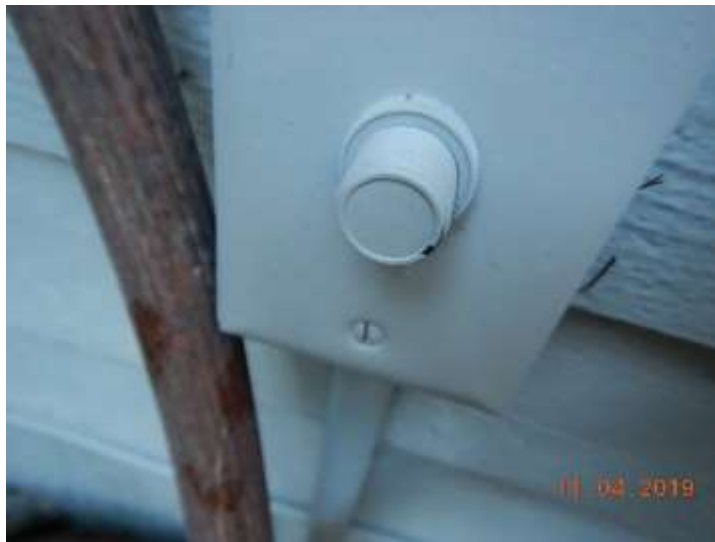
Painted photocell sensor

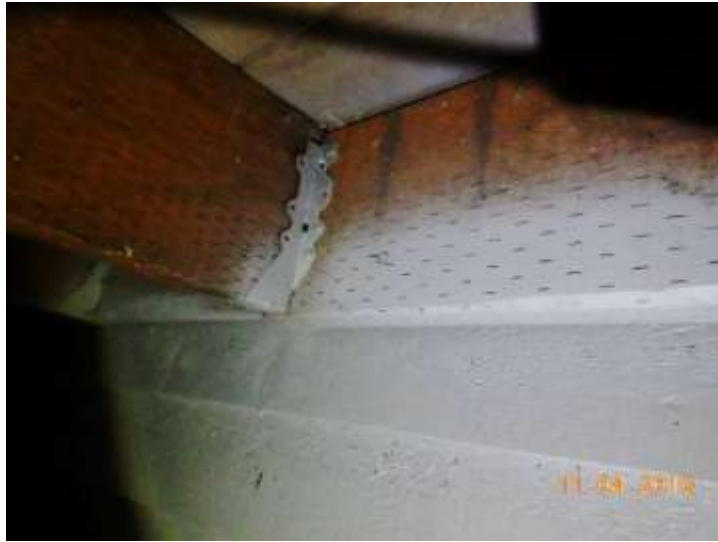
The deck is not lag bolted to the home

Connection to structure: - Recommend the installation of lag bolts to fasten the deck ledger to the home. Although likely not required at the time of construction of the home, this fastening system is a new “code” requirement to reduce the likelihood of failure of a deck structure

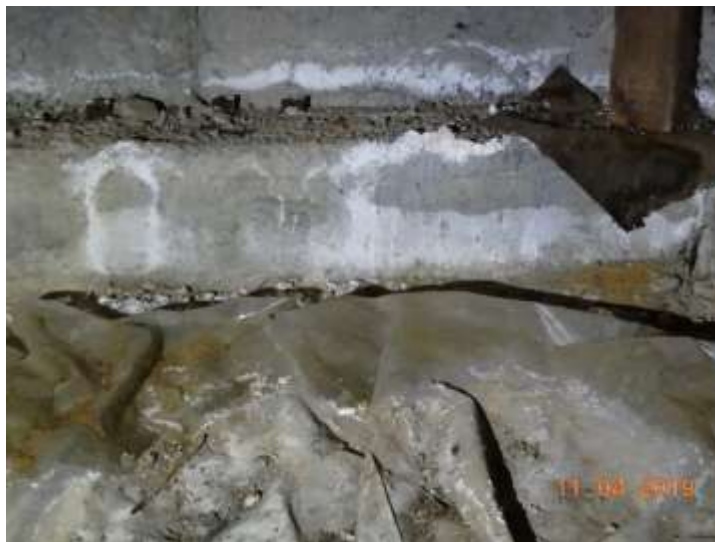
The white is evidence of high moisture, however no moisture intrusion was noted

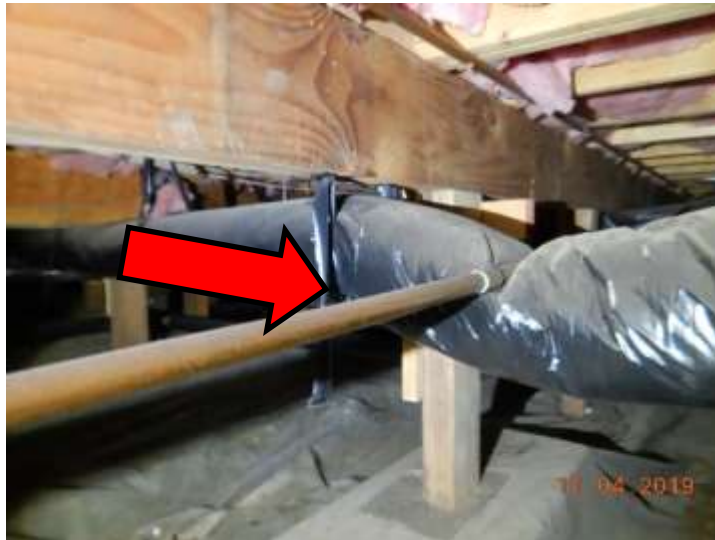
Domestic water lines: - A domestic water supply pipe located below the Kitchen is not adequately secured to the framing. This condition puts excessive stress on the pipe connections

Pipe not secured to the framing

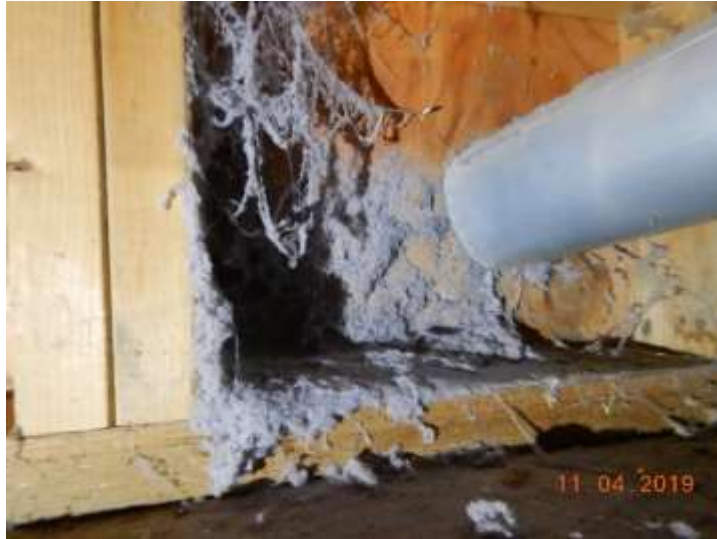
Dryer vent: - There is substantial air and lint leakage at the dryer vent connection to the exterior

Evidence of lint leakage

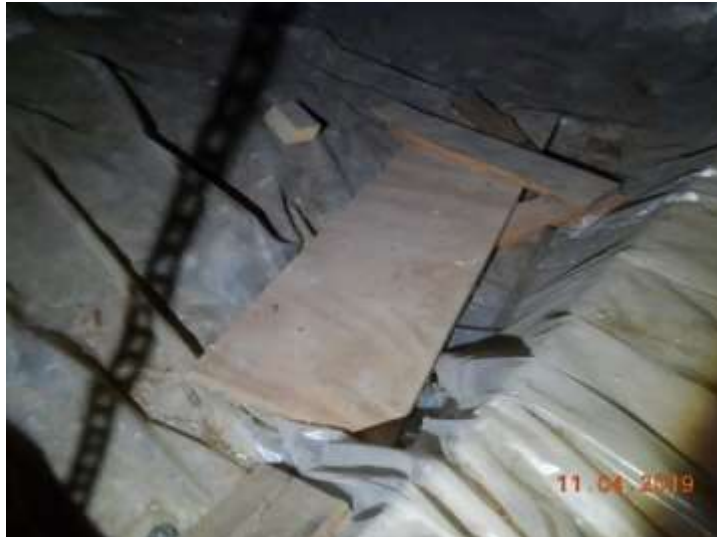
Debris in the crawlspace (typ)

Conducive conditions: - All wood and cardboard debris should be removed from the crawlspace (WDO conducive condition)

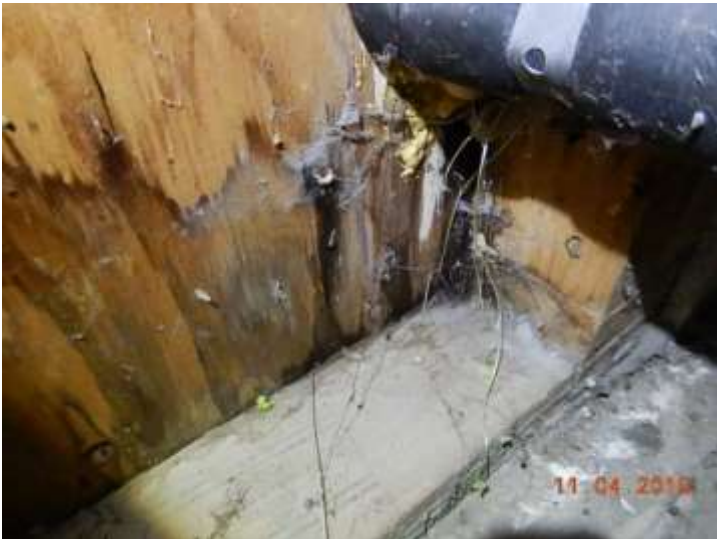
Moisture Intrusion: - There is evidence of an active leak in the vicinity of the furnace condensate drain/water tank pressure relief valve. The leak may be at the connections of the pipe fittings (elbow). Minor wood rot is visible at this area

Evidence of wood rot

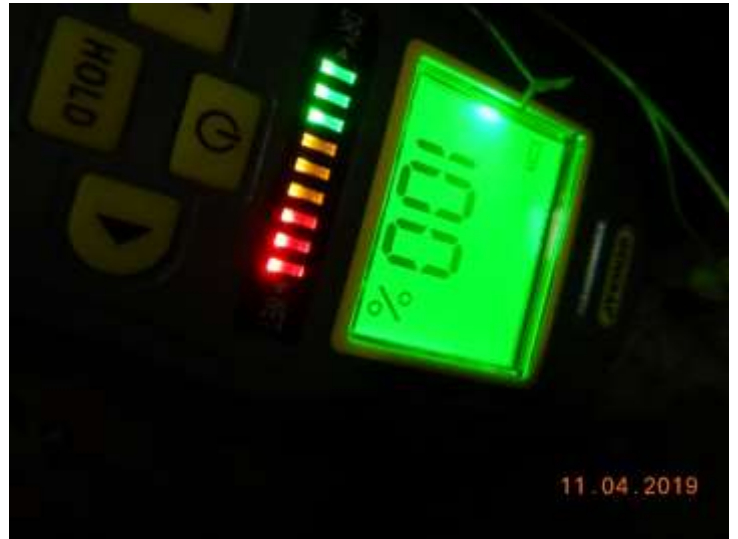
High moisture reading

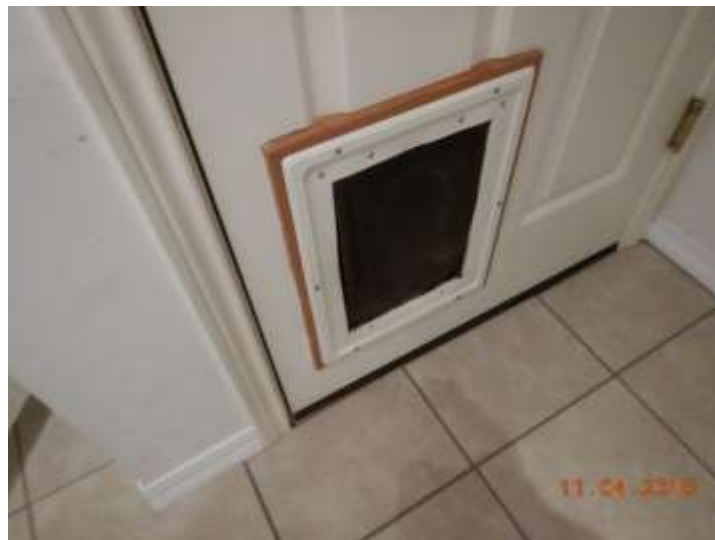
Fire separation: - The pet door cut into the garage to house door is a breach in the 1 hour fire separation from the garage to the living spaces

Pet door cut into the door to the house

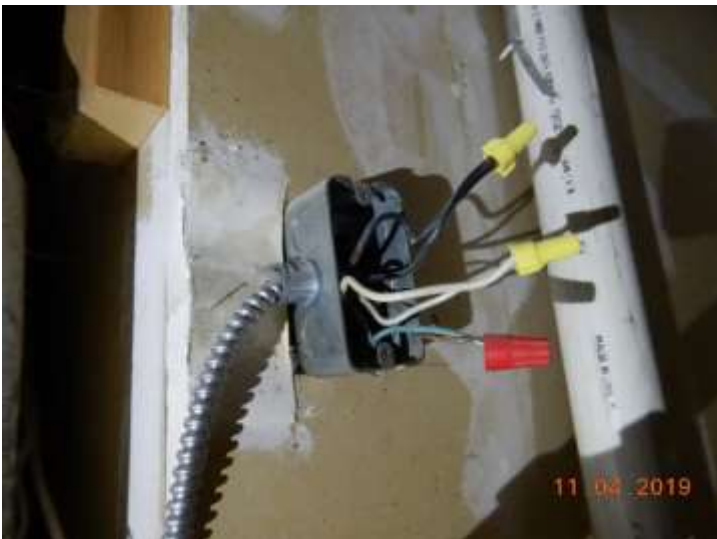
Open electrical wires

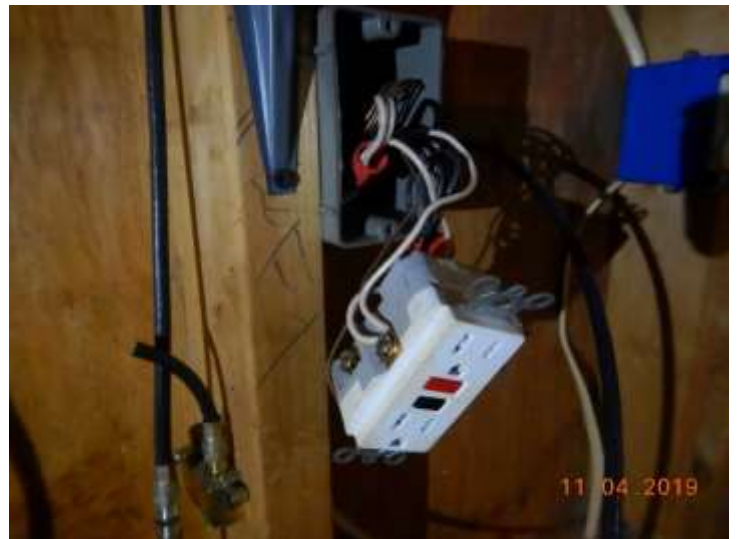
- Switches/Lights: All visible tested
- Outlets: All visible and accessible outlets were tested for proper polarity and grounding
- Recommend GFCI protection for all of the garage electrical outlets
- Tip: it is not recommended to plug a freezer into a GFCI electrical outlet as the motor may trip the GFCI circuit*
- Plate covers should be installed at all electrical boxes/outlets were missing. The GFCI outlet should be properly secured in the box

Unsecured GFCI outlet

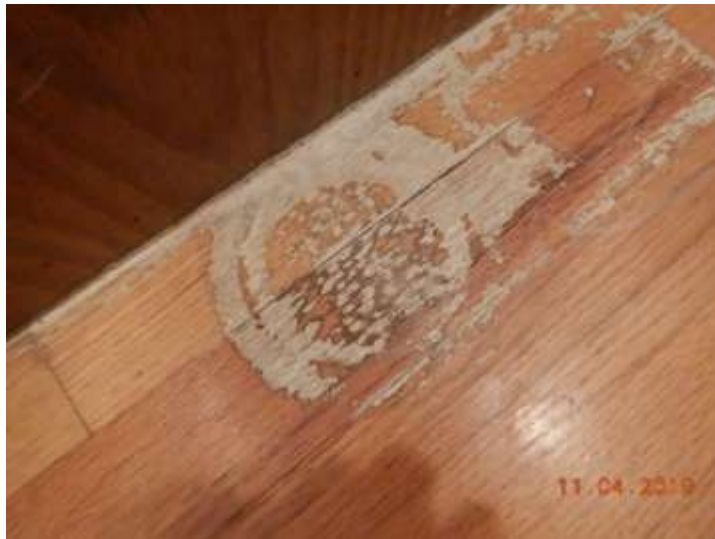
Prior surface damage to the hardwood flooring.
Appears to be from a prior pet dish

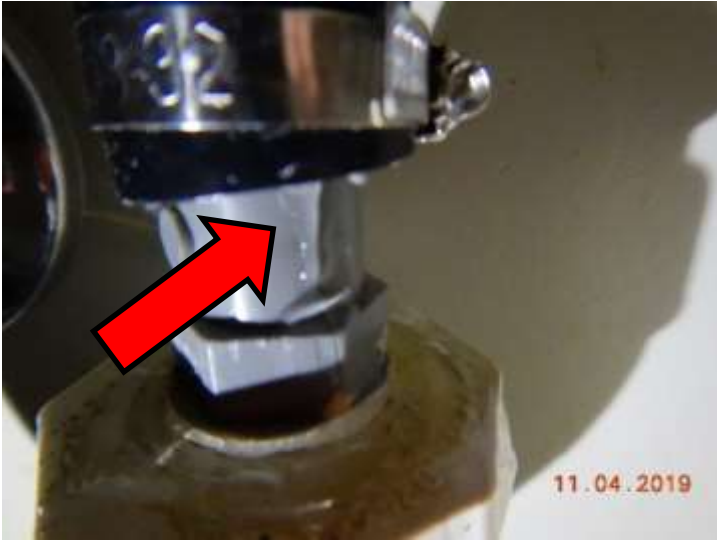
- Dishwasher: Tested a full cycle. Not all functions and settings are tested
Dishwasher drainage: Sink area air gap
- There is active leakage from the dishwasher drain hose when the appliance is draining

Leakage from the dishwasher drain

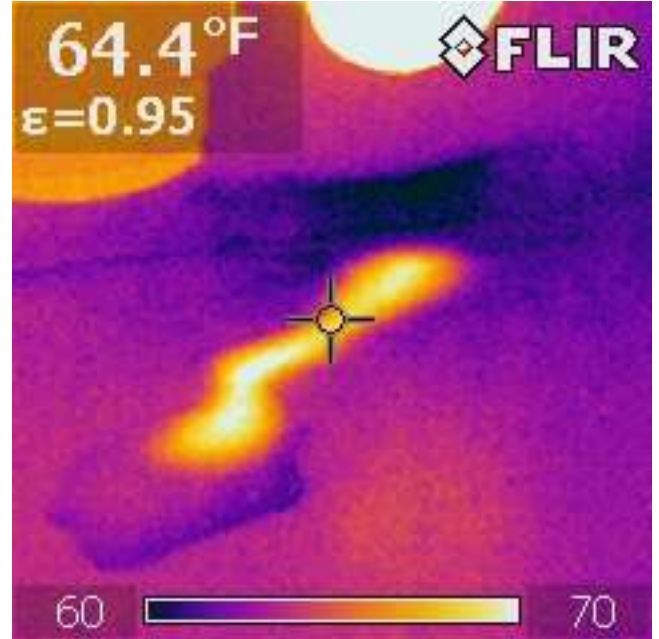
Moisture in the sink base cabinet from the leakage noted in the image to the left

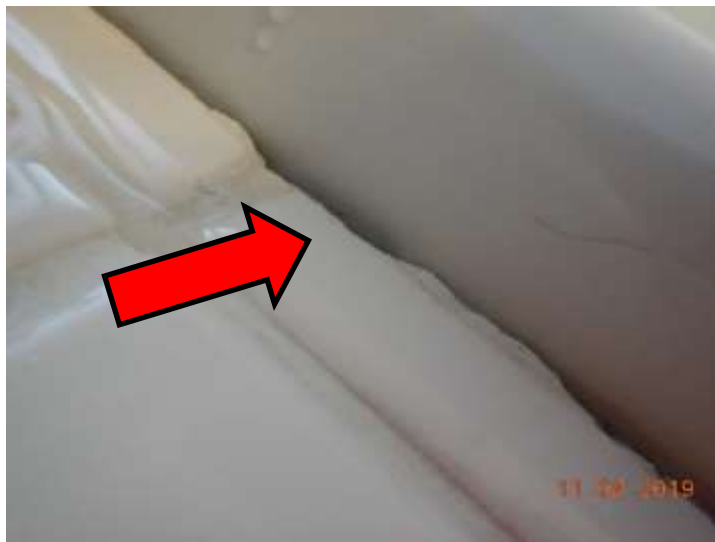
Overall functional flow: Appears adequate
Sink(s): No visible defects or leakage identified
Bathtub-Shower: No visible defects or leakage identified
- The gaps between the tub and tub deck should be caulked
Shower Door: The shower door is in satisfactory condition
Comment: shower pans and shower doors within the house are not tested with a person inside, therefore actual conditions for usage are not tested
Toilet: No visible defects or leakage identified
Comment: plumbing fixture valves within the house are not tested. Some valves may leak once turned on and off or to another position

Gaps surrounding the bathtub

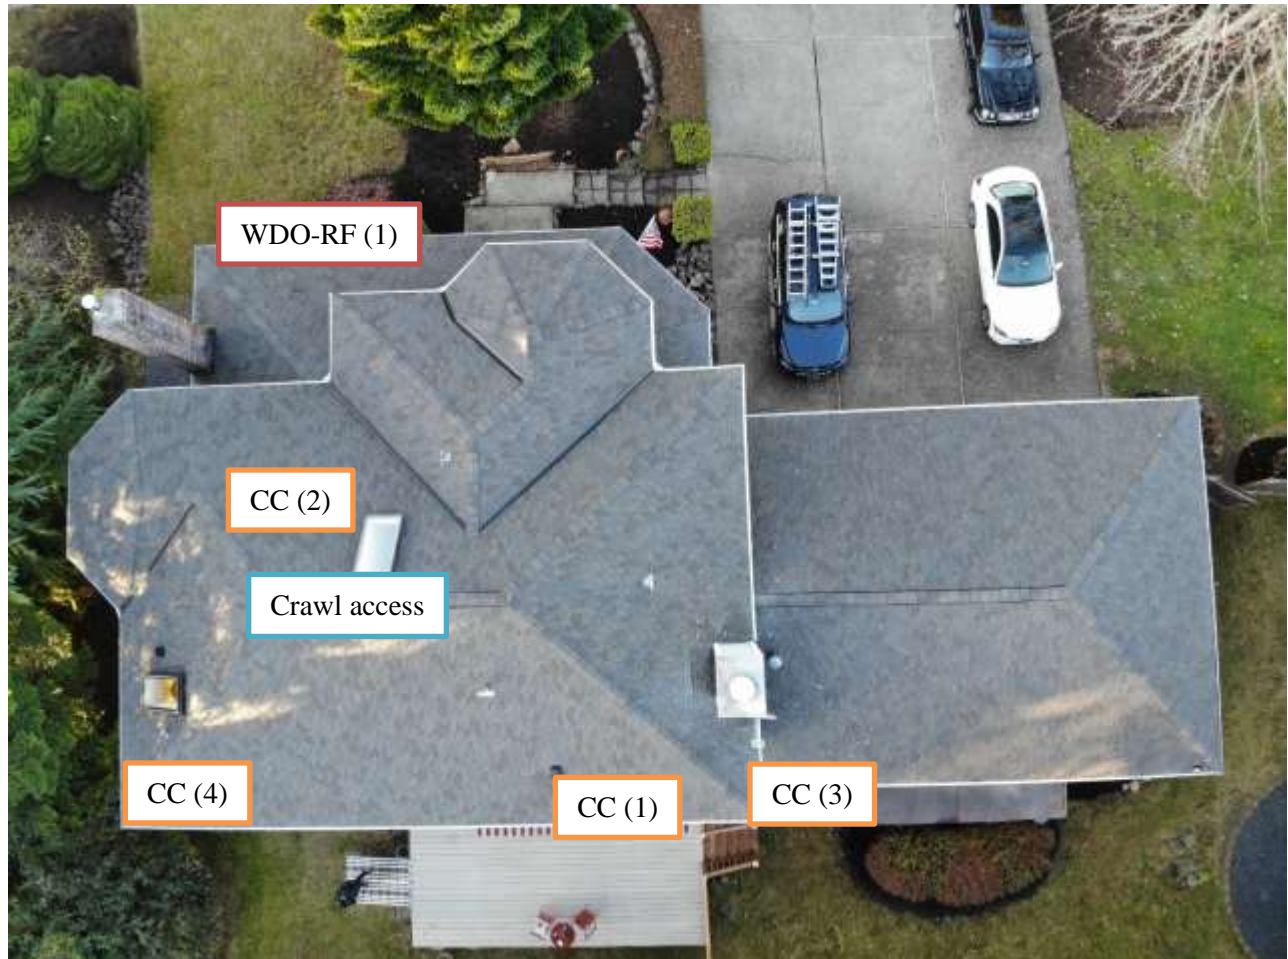
CC (1): Dryer vent connection in crawlspace
CC (2): Debris in crawlspace (typ)
CC (3): Leak at the furnace condensate line; minor rot is visible
CC (4): Dishwasher drain leak
