Client:
Address: Seattle, WA 98144

Property Description: Townhouse style
Estimated property age: Built 2020
Occupancy Status: Under construction

Inspection Date: 06/26/2020
Inspection Time: 11:30 A.M. - 1:30 P.M. +-
Weather Conditions: Clear, 75 deg f +-

Summary of Inspection

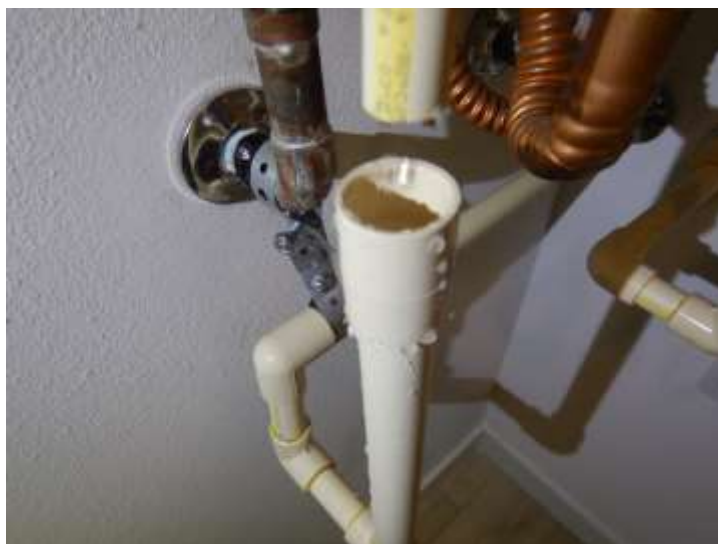
- The age of the water heater is approximately 0 years. The remaining anticipated useful life expectancy is 20 years
- The condensate drain is not properly discharging into the drain line. As a result, there is water (condensate) leakage onto the Laundry room floor.

Flue secure: Inspected
Clearances: As required where visible
Draft Hood: not applicable; direct vent
Water connection: Inspected
Condensate line: - The condensate drain is not properly discharging into the drain line. As a result, there is water (condensate) leakage onto the Laundry room floor.

The condensate discharge pipe is missing the drain pipe

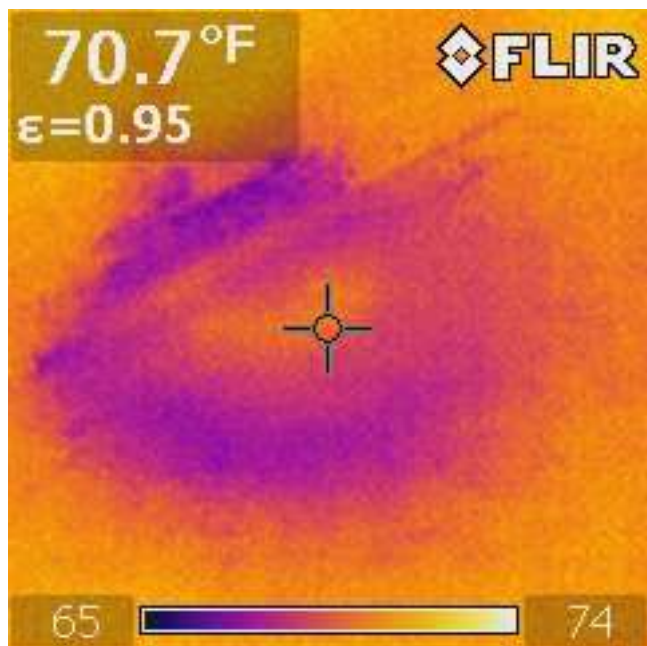
Condensate on the laundry room floor

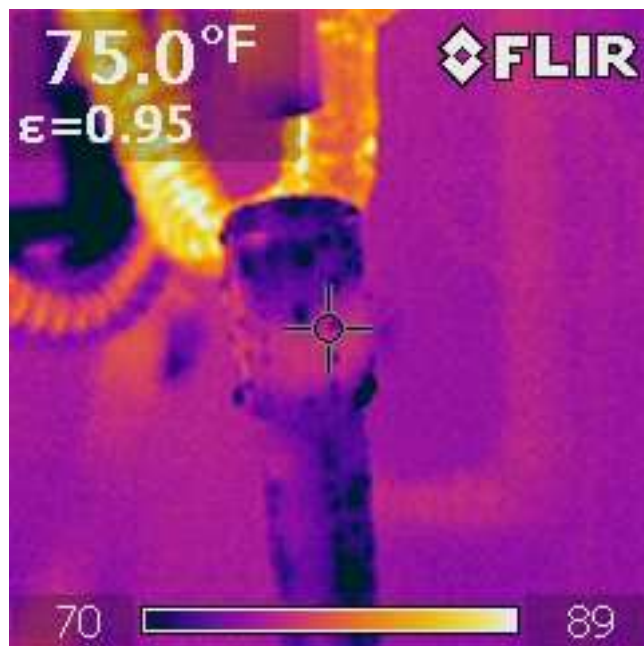
Condensate at the outside of the drain pipe

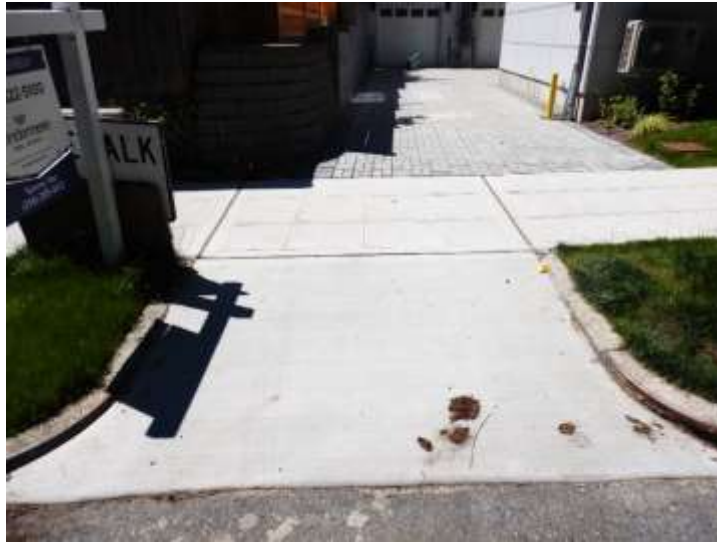
Type: Concrete
Condition: Satisfactory
Trip Hazard: None
Other: - The driveway apron is substantially out of alignment with the driveway

The driveway apron is not in alignment with the driveway

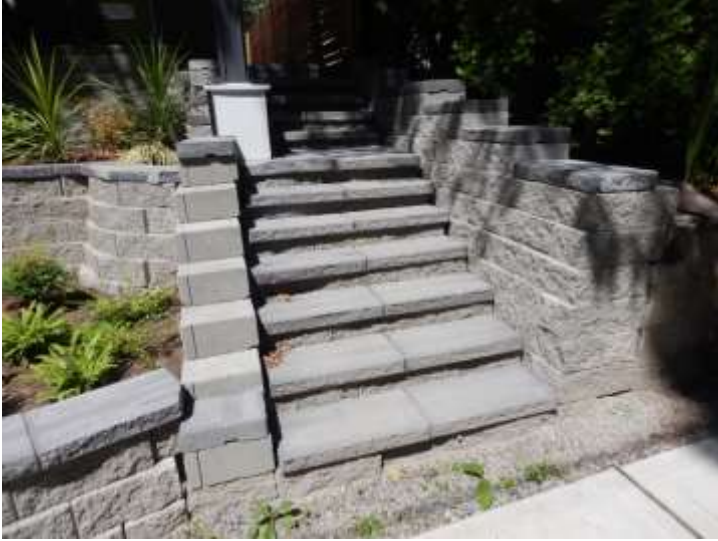
A graspable handrail is not installed

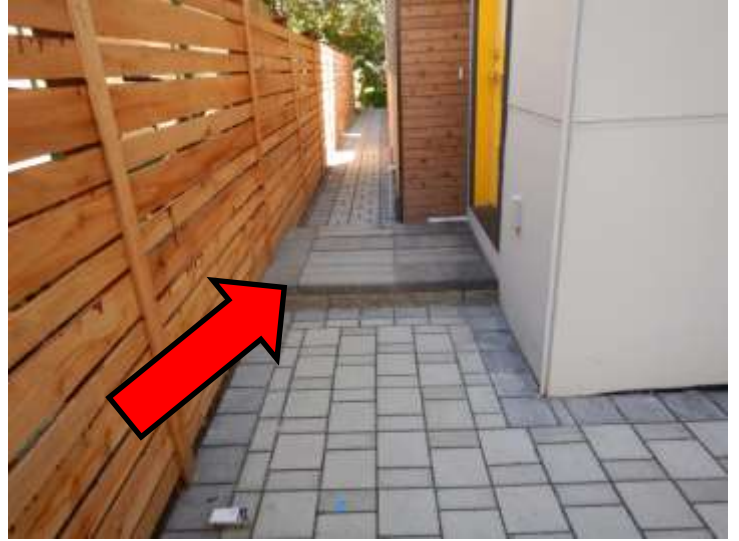
Type: Concrete
Condition: Satisfactory
Trip Hazard: - A substantive trip hazard exists at the raised are of the walkway where adjacent to the neighboring unit. Walkway illumination is not installed as would typically be required.
Handrails: - A graspable handrail is not installed at the front steps as would typically be required

Trip hazard, no common area walkway illumination is provided

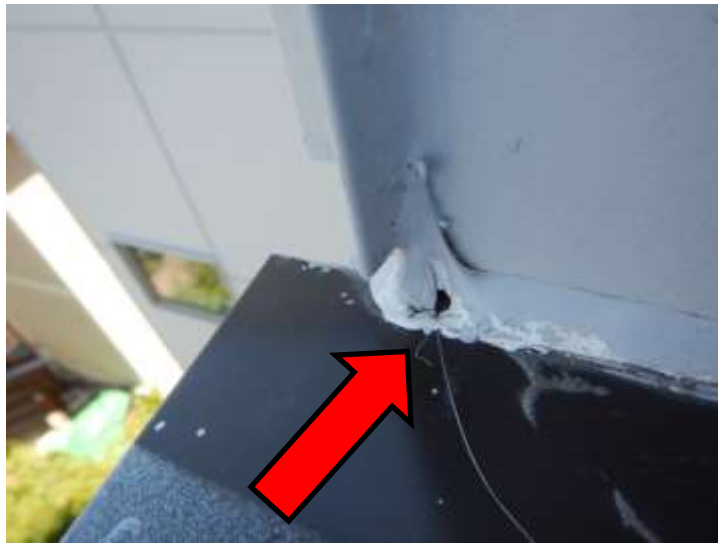
Type (primary): Fiber cement board
Condition: Overall satisfactory
Window/Door Flashing: Satisfactory
Paint and caulking: - The gaps at the deck cap-wall should be sealed. There are gaps at the existing caulking.
Exterior vents: Satisfactory

Gap at the wall cap caulking

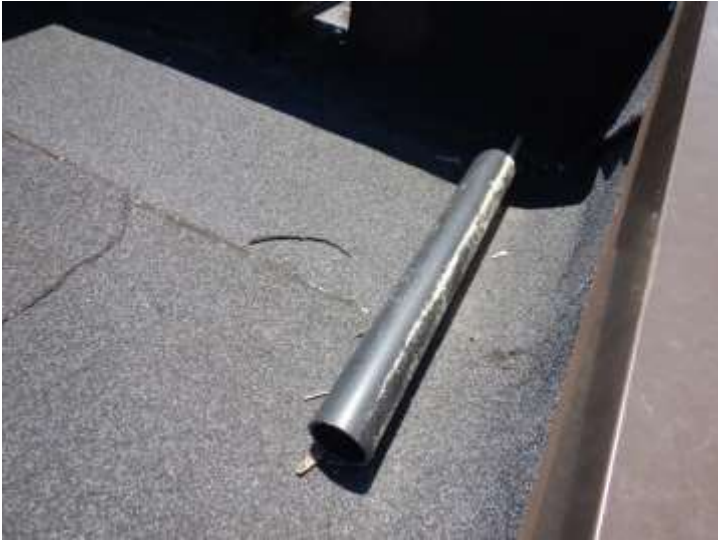
Debris on the roof

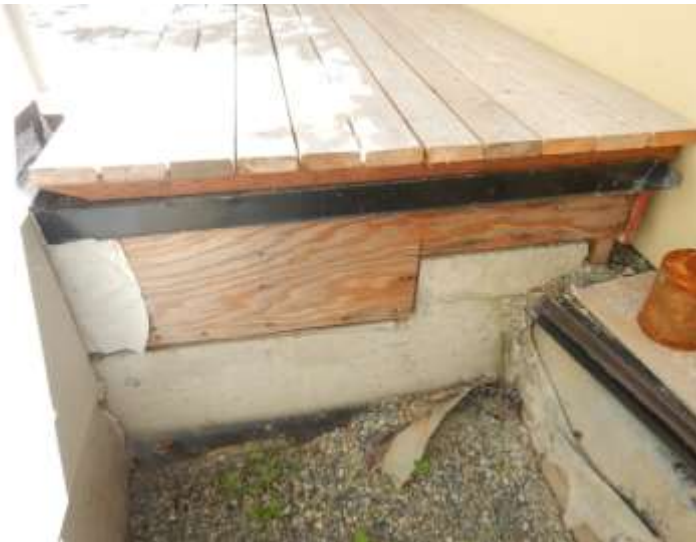
Missing barricade - exposed non weather rated wood

- Recommend installing a safety barricade at the lower deck where the surface to surface vertical height is 30" or more. There is exposed wood at the side of the lower deck that is not rated for weather exposure.

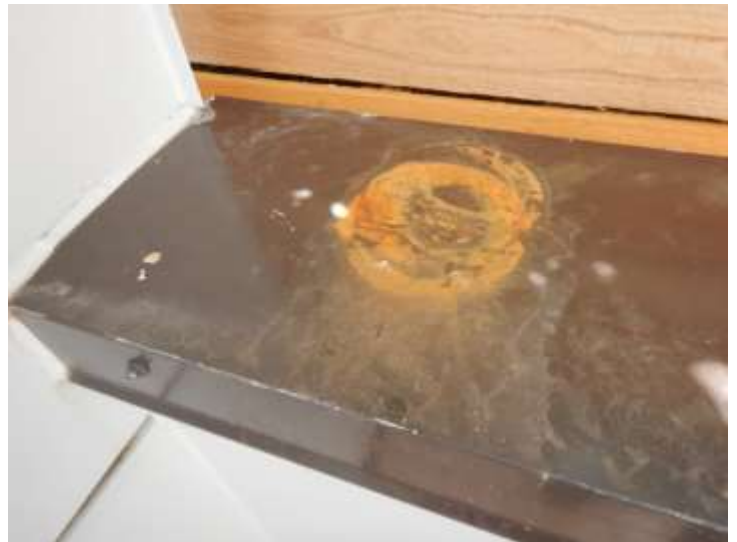
- There are rust stains at the wall cap of the lower deck.

Rust stains at the wall cap

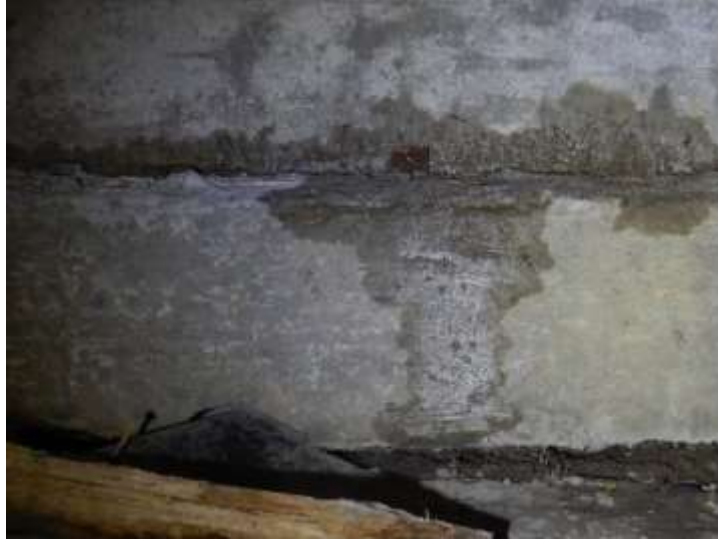
Moisture Intrusion: - There is evidence of active moisture intrusion at the crawlspace. Recommend further review by a qualified contractor.

Evidence of moisture intrusion

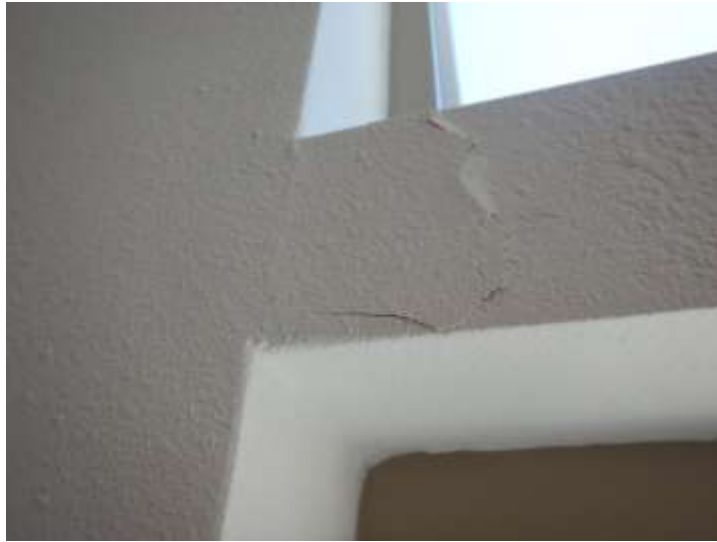
- Visibility: Rooms are staged
- Structural Movement: No visible evidence of substantive structural movement
- Moisture Intrusion: No visible evidence
- Walls: - There is a substantive drywall imperfection at the mullion between the sliding glass door and window above.
- Ceiling: Satisfactory
- Flooring: Satisfactory

Drywall imperfection

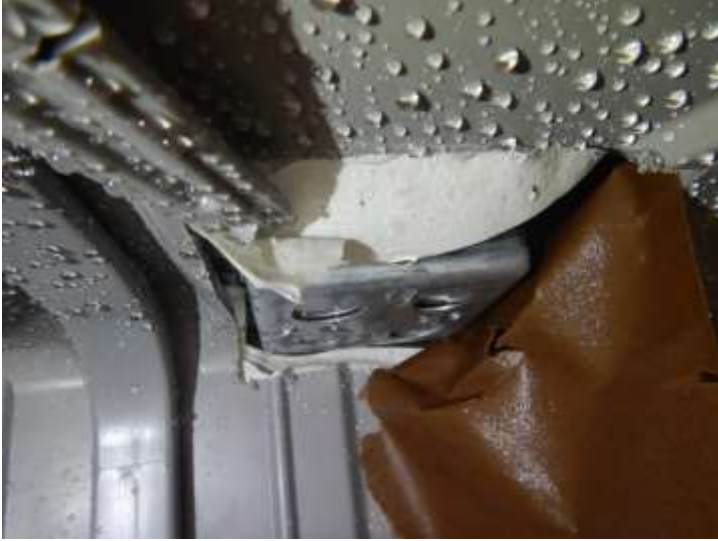
Dishwasher: Tested a full cycle. Not all functions and settings are tested
- The dishwasher is not secured in place
- The shell of the dishwasher has been cut open to provide space for the countertop electrical outlet. Full replacement of the dishwasher will be needed. The electrical outlet will likely need to be abandoned or relocated. A new countertop will be needed to seal the hole of the electric outlet box.
Dishwasher drainage: Sink area air gap
Cooktop: Tested all burners
Oven: Tested. Not all functions and settings are tested
Microwave (door): The door of the microwave was tested for operation
Ventilation: Tested
Refrigerator: The refrigerator appears to be operative. Not all functions and settings are tested

The shell of the dishwasher has been cut open

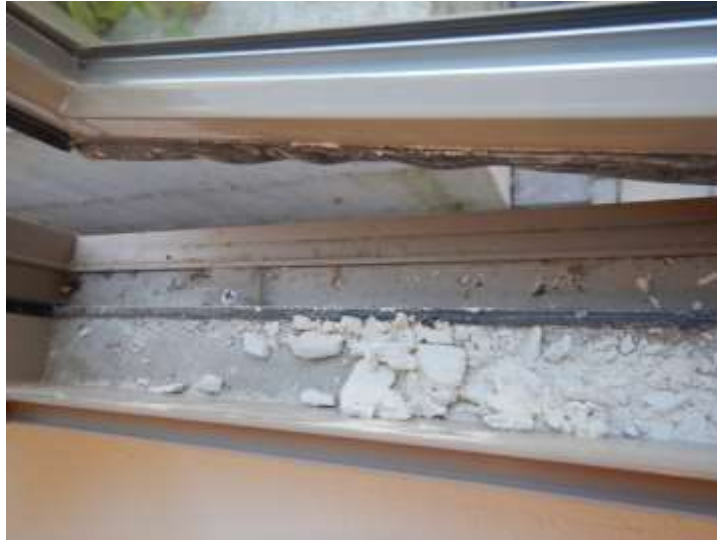
- Glazing: No visible defects
Operation: Fixed
- Window screens are not installed throughout the home. Screens are typically included with new construction.
 - All windows and tracks should be properly final cleaned.

Debris in a window track

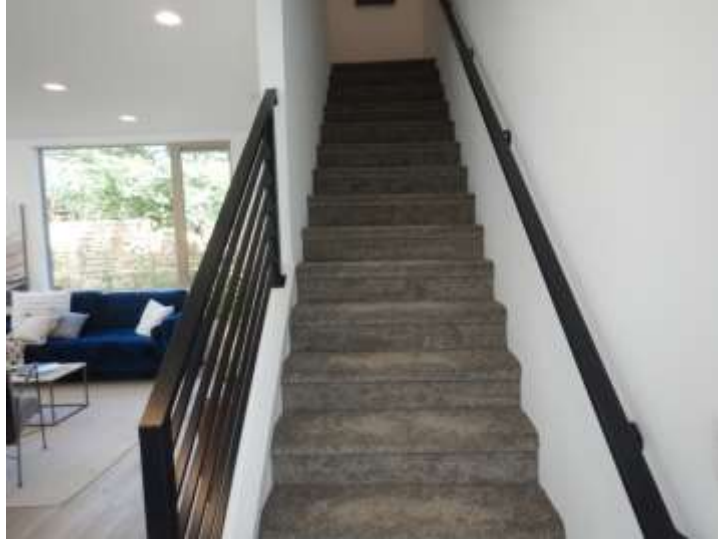
- Graspable handrails: A reasonable graspable handrail is installed
Barricades: A reasonable safety barricade is installed
Trip hazard: Satisfactory
- There is a slight lean (east-west) to the stairwell from floor 1 to 2, however this item serves its intended purpose.

There is a slight West-East lean to the stairs

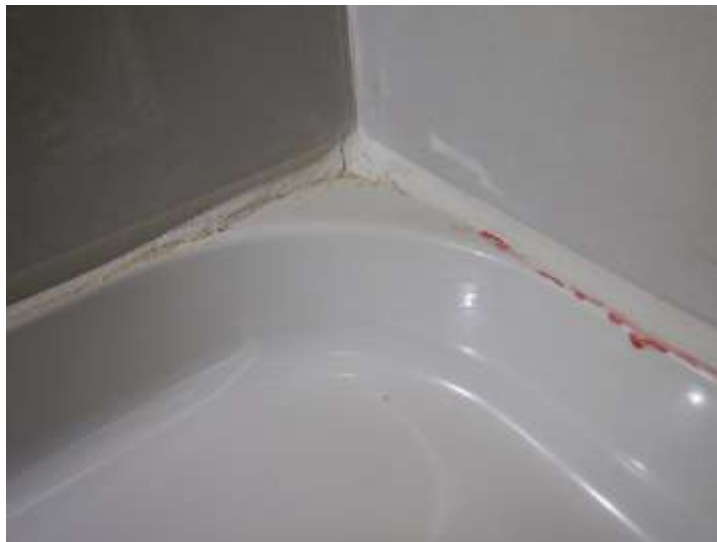
Overall functional flow: Appears adequate
Sink(s): No visible defects or leakage identified
Bathtub-Shower: *No visible defects or leakage identified. The tub was tested to the overflow
- The debris should be cleaned from the lower edge of the tile tub surround*
Toilet: No visible defects or leakage identified

Debris/ marks at the tub surround

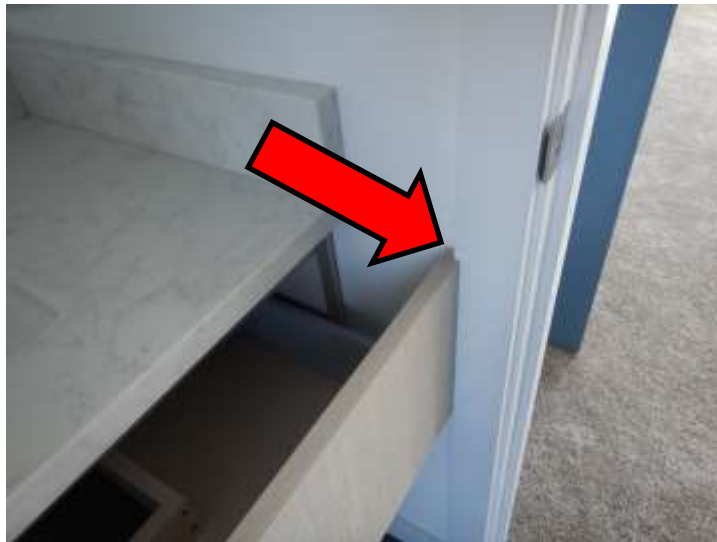
- The upper drawer at the right sink cabinet intermittently strikes the adjacent door casing.
- The window glass stop at the bedroom window is loose

Drawer strikes the door casing

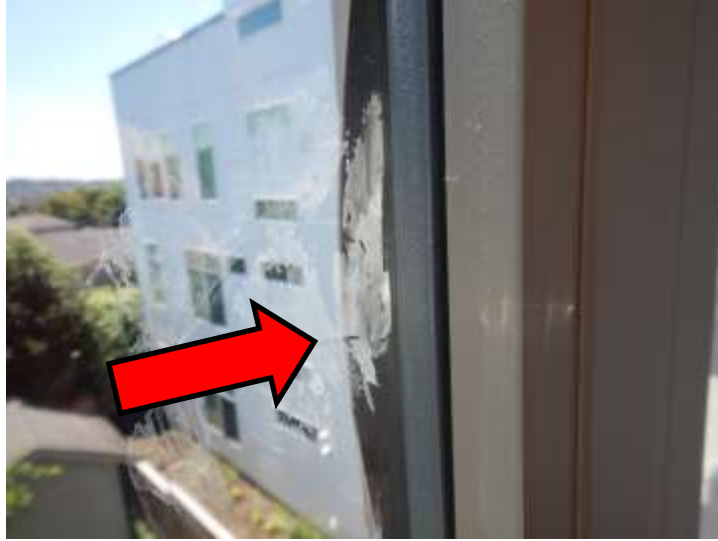
- The window glass stop at the bedroom window is loose

Loose glass stop

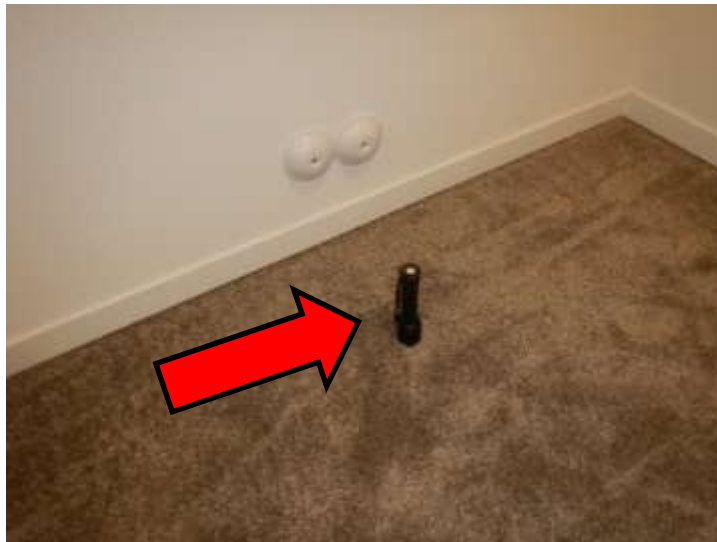
- There is a large bump at the floor. The bump appears to be a waste line (sewer) cleanout.

Location of the bump at the floor
