(425) 652-6515
www.Hergert.com
Kevin @ Hergert.com
Wa. Home Inspector 619
WSDA Inspector 79988
WSDA Control # 11207AQ-03

Client:
Address: Everett, Wa

Property Description: (1) story single family home
Estimated property age: Built 1949 per info on the web
Occupancy Status: Vacant

Inspection Date: 12/12/2019
Inspection Time: 9:30 A.M. - 11:15 A.M. +-
Weather Conditions: Rain, 50 deg f +-

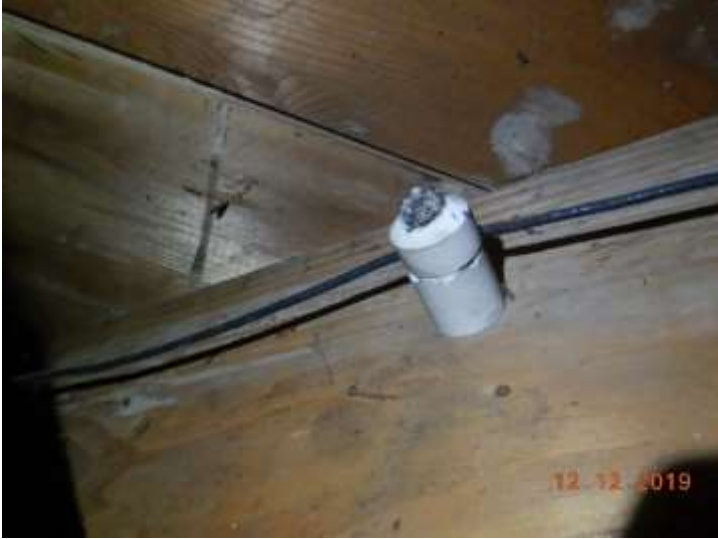
- The home contains knob and tube wiring. This type of wiring is a known defect. Recommend further review by a licensed electrician. See the comments in the Attic section

Knob and tube wiring

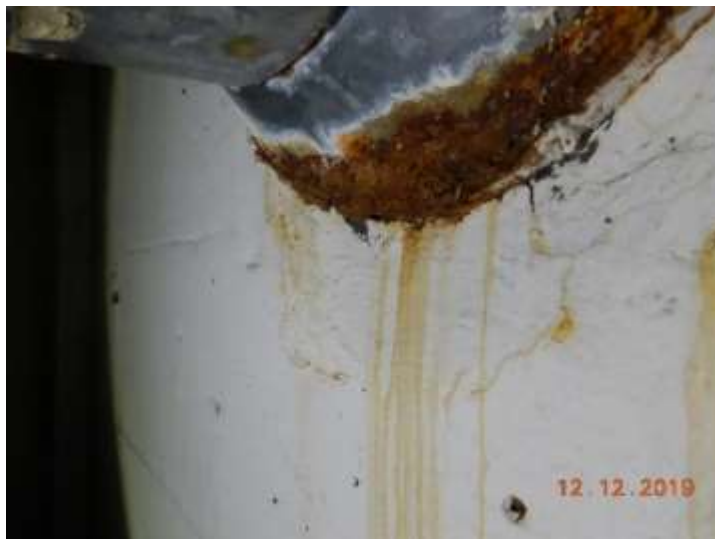
Flue condition: - There is evidence of substantive corrosion of the furnace flue where it enters the chimney. Recommend further review by a qualified technician

Corrosion of the furnace flue

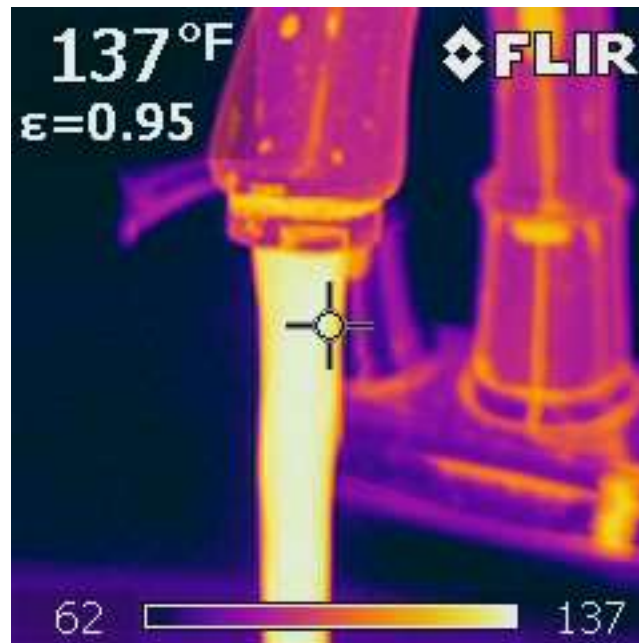
Measured temperature: - The water temperature was measured at 137 deg F; substantially above the recommended setting of 120 deg F. This adjustment is typically a simple adjustment to the water heater thermostat

Hot water temperature

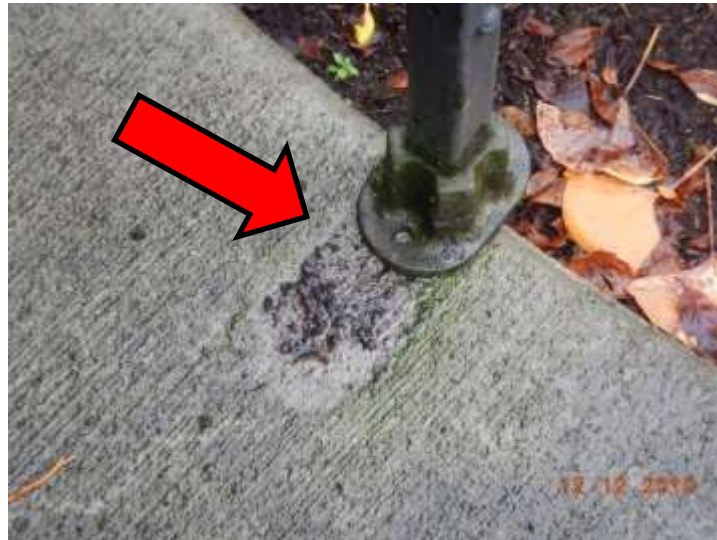
Type: Concrete
Condition: Satisfactory
Trip Hazard: None
Handrails: - The graspable handrail located at the front porch is not required, however is a safety hazard as it is not secured in place

Unsecured handrail

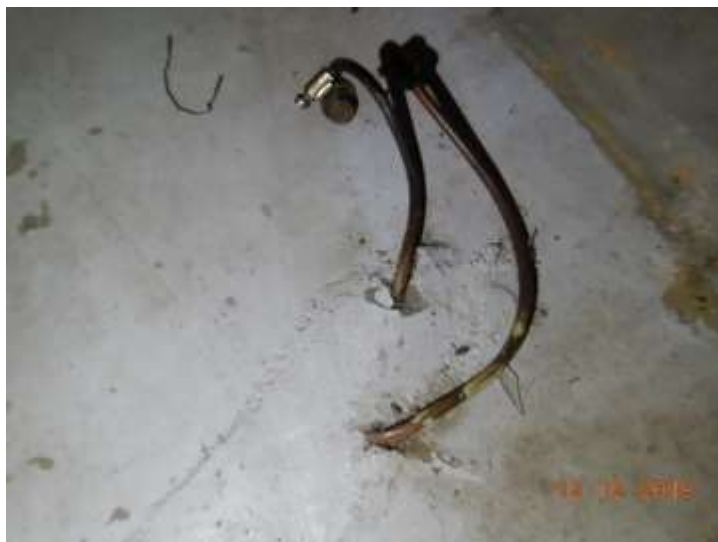
Underground Oil Tank: - There is evidence of a buried underground oil tank as abandoned oil lines are visible in the basement. Recommend verification with the local fire department that the tank has been properly decommissioned or removed

Oil tank lines

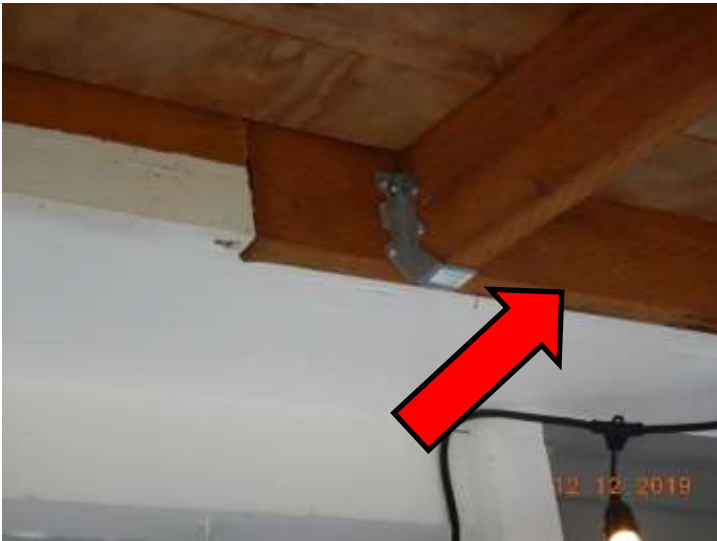
The ledger of the rear roof does not appear to be lag bolted to the home

- Recommend lag bolting the patio roof ledger to the home

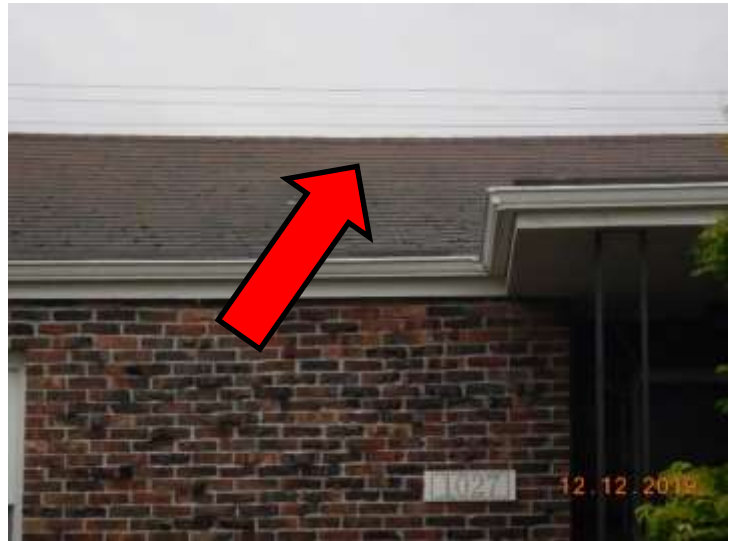
Sag in the high ridge

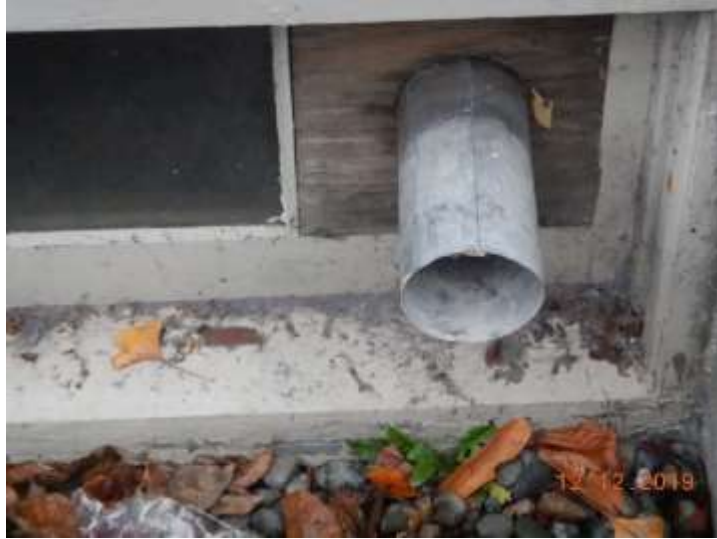
Exterior vents: - A proper dryer vent flap is not installed. This could result in pest intrusion. Do not install a screen type vent cover as this will trap lint which can result in a fire

Dryer vent

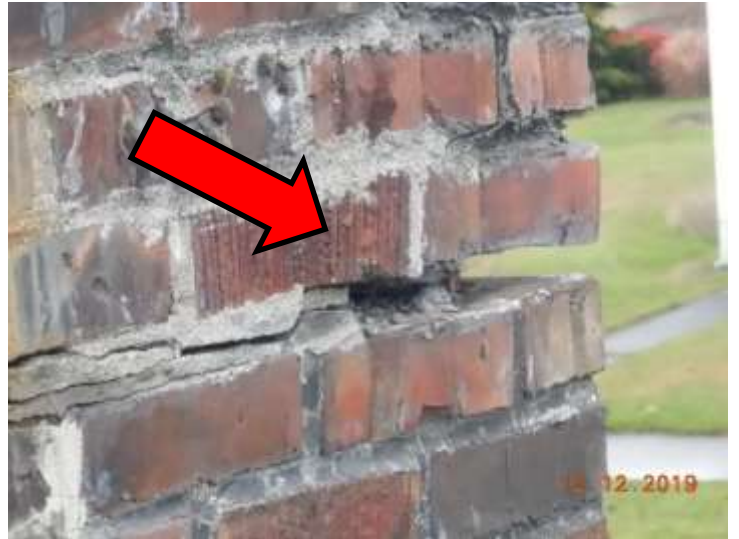
- There is evidence of substantial deterioration (spalling) of the chimney. Recommend repair (AKA tuck pointing) as needed. All cracks at the chimney cap should be properly sealed to prevent moisture intrusion and related damage

Gaps at the mortar

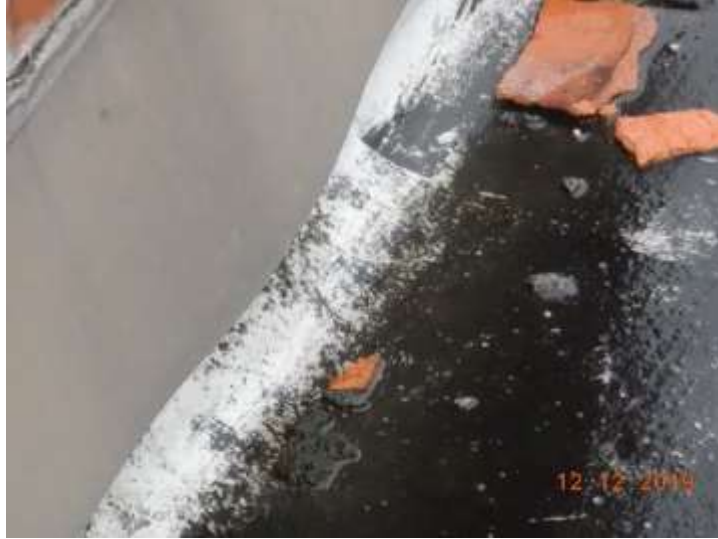
Masonry debris on the roof

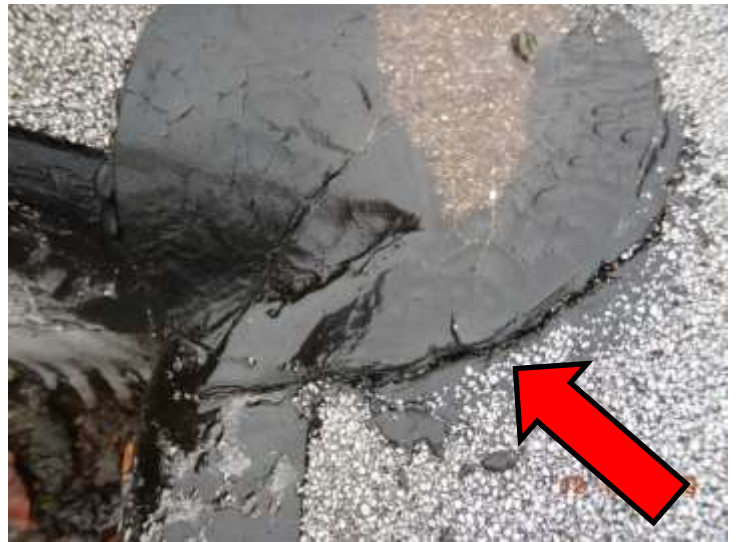
Cracking of the patch

CC (3): Crack at roofing patch

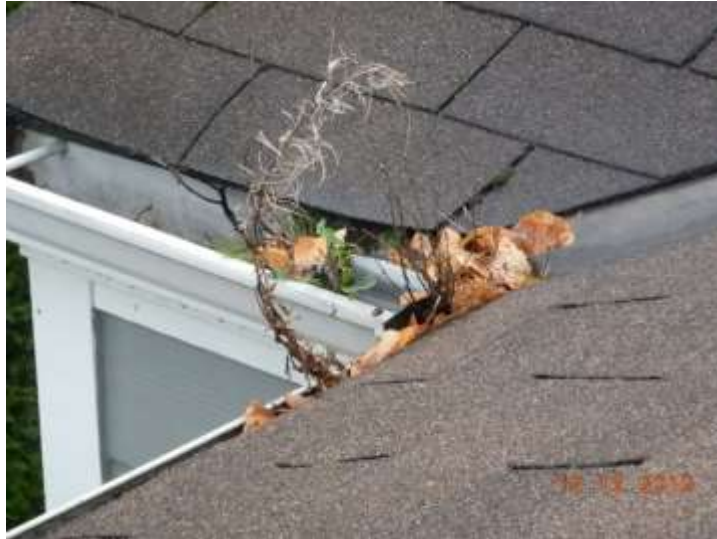
Condition: - The gutters should be cleaned of debris

Gutter full of debris and vegetation

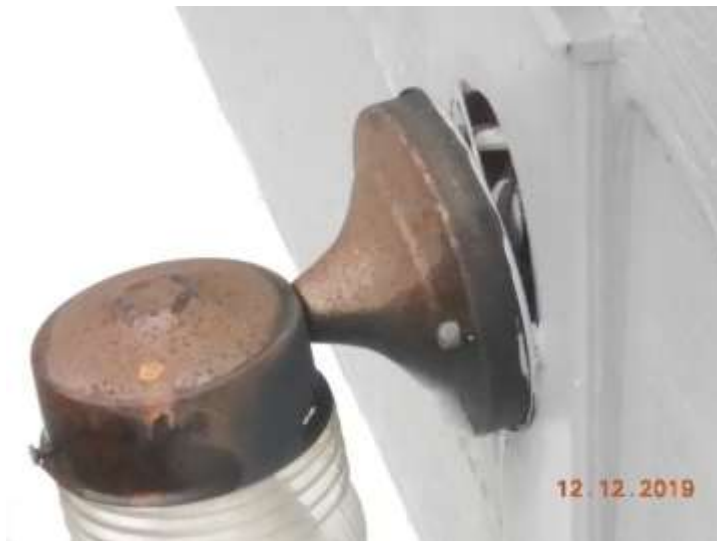
Loose light fixture

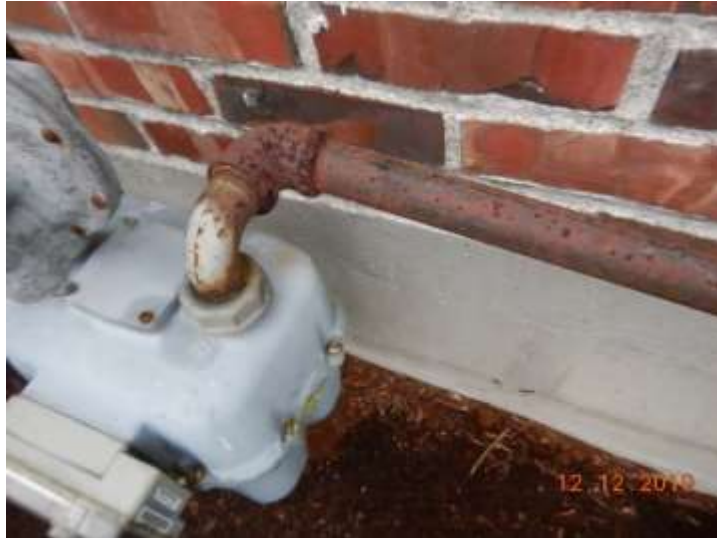
- Hose Bibs: - The rear hose bib drips when in the Off position
Gas Piping: - The exterior gas pipes should be coated with rust proof paint

Rusting gas pipes

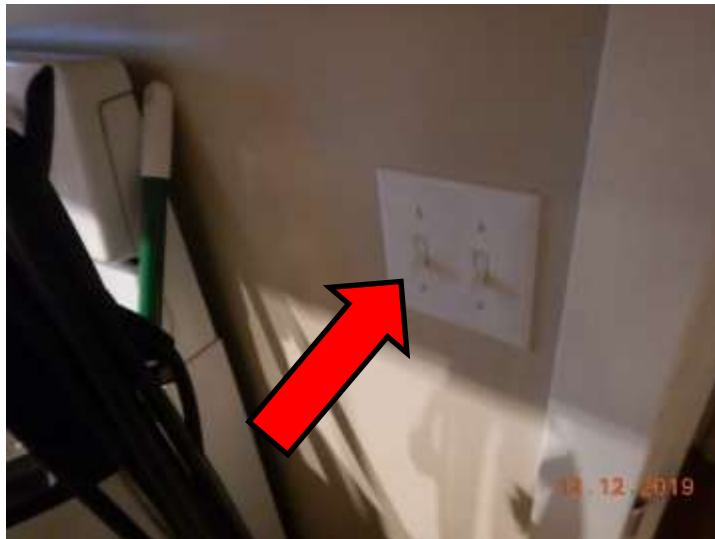
Unknown function of a wall switch

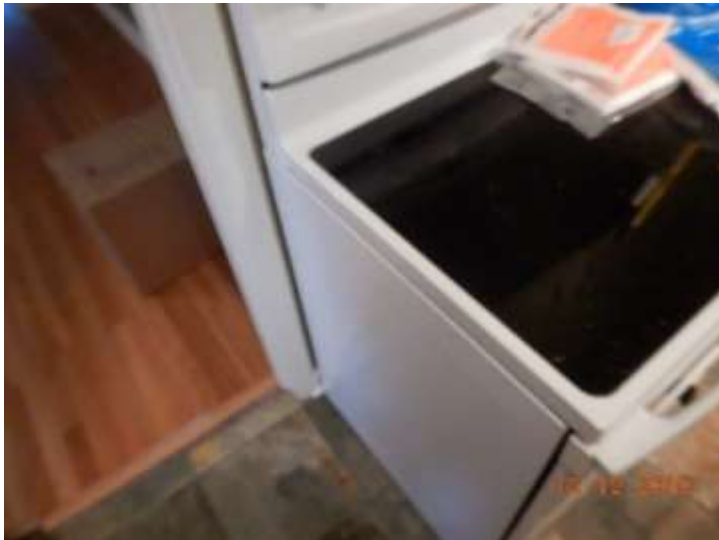
No cabinet or countertop at the side of the range

- Recommend installing a countertop surface at both sides of the range to provide a working surface and to protect the handles of cooking pans from being hit and/or pulled from below resulting in spillage of hot materials

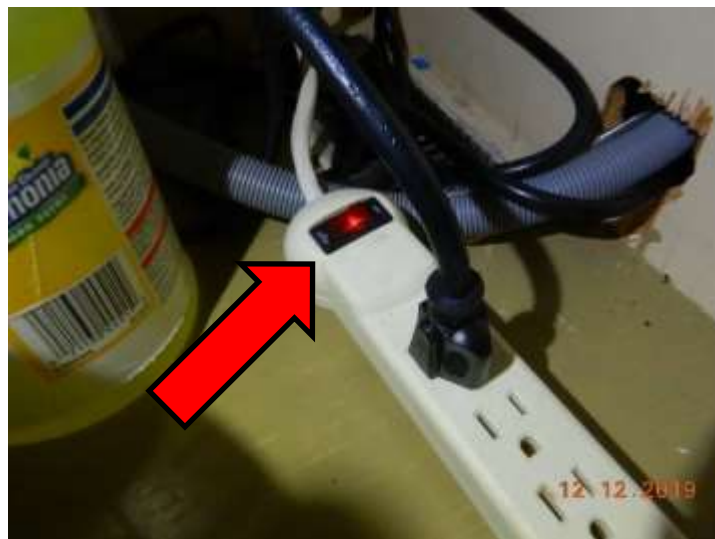
- The garbage disposal is controlled by a switch on a plug strip. An air switch would be a better option

Control switch for the disposal

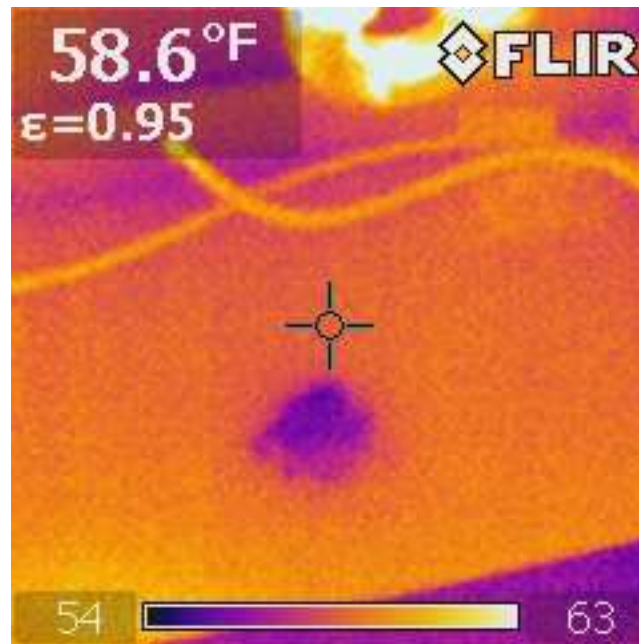
Sink(s): - There is visible leakage beneath the sink

Leakage into the sink base cabinet

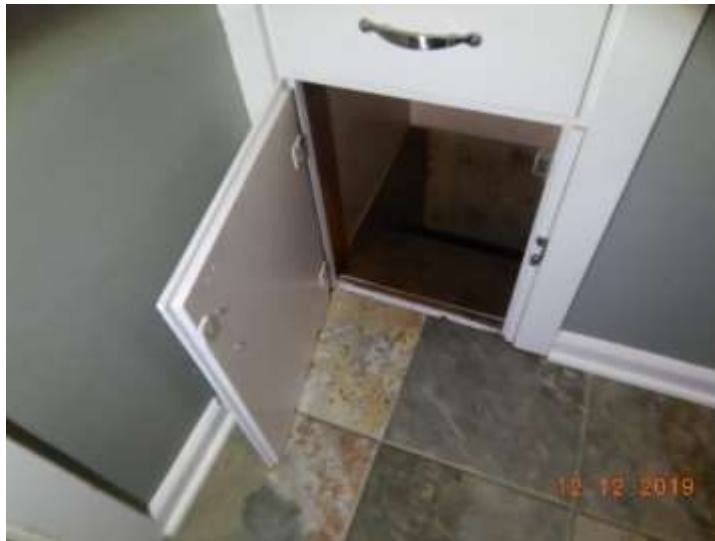
- The access door to the Laundry chute is located within 3' of the floor surface.
This low access is a fall-safety hazard. Recommend providing a lock at the door or modify the access to 3' above the floor surface

Laundry chute at floor level

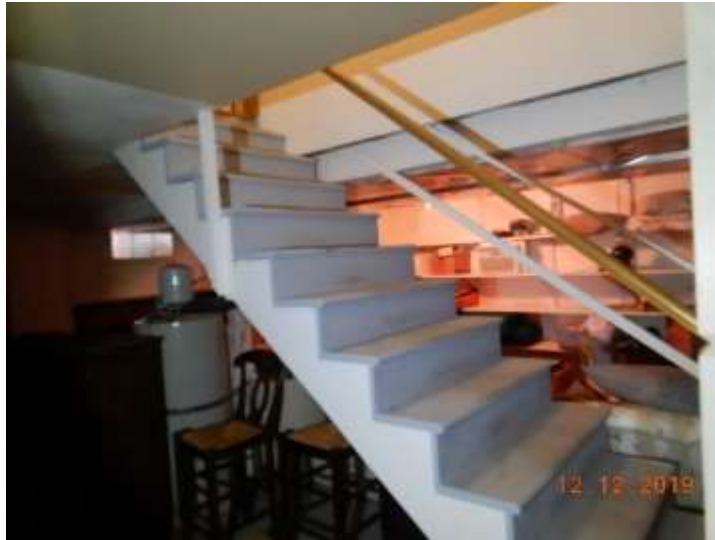
A proper safety barricade is not installed

Barricades: - Recommend installing a proper safety barricade at the stairwell to the basement.
The baluster spacing should be a maximum of 4".

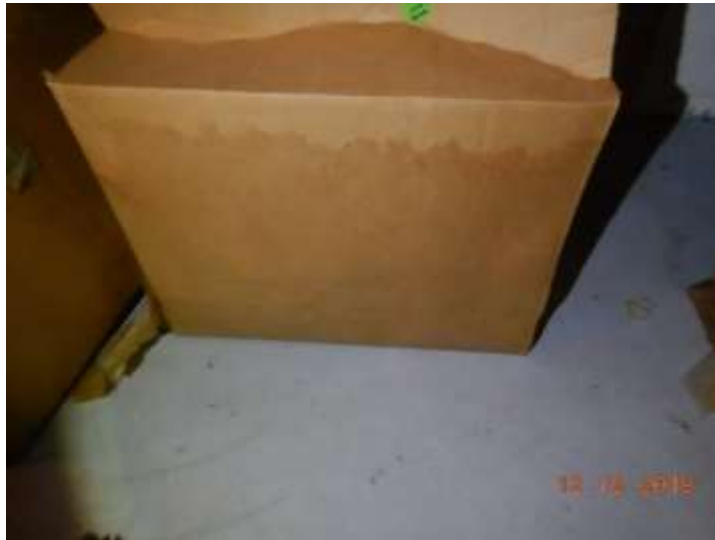
- Visibility: Room is occupied
- Structural Movement: No visible evidence of substantive structural movement
- Moisture Intrusion: - There is evidence of prior moisture intrusion into this room and per Sellers disclosure. Recommend keeping all materials, including a future washer and dryer, elevated. A backflow device for the storm sewer (which may be connected with the sanitary system) may resolve this issue
- Walls: *Unfinished*
- Ceiling: *Unfinished*
- Flooring: *Unfinished*

Moisture stains at a box

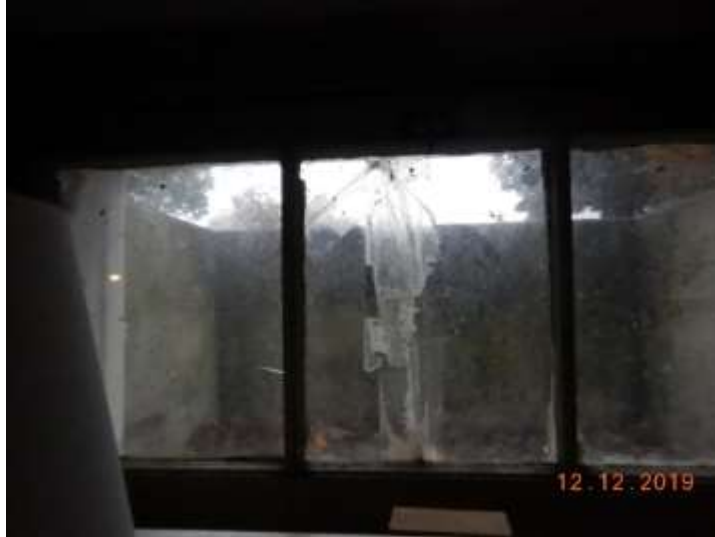
- Glazing: - A window pane is broken
Operation: - Unable to open the windows with reasonable force applied
Screen: No

Broken/ taped window

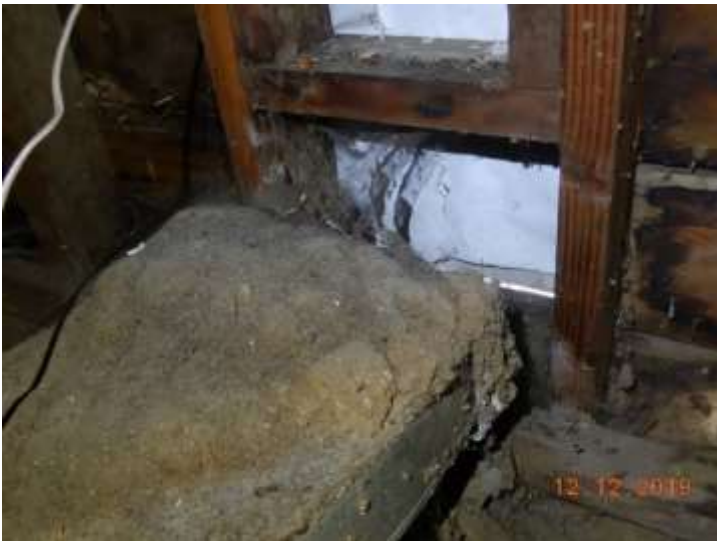
The kitchen vent does not extend to the exterior

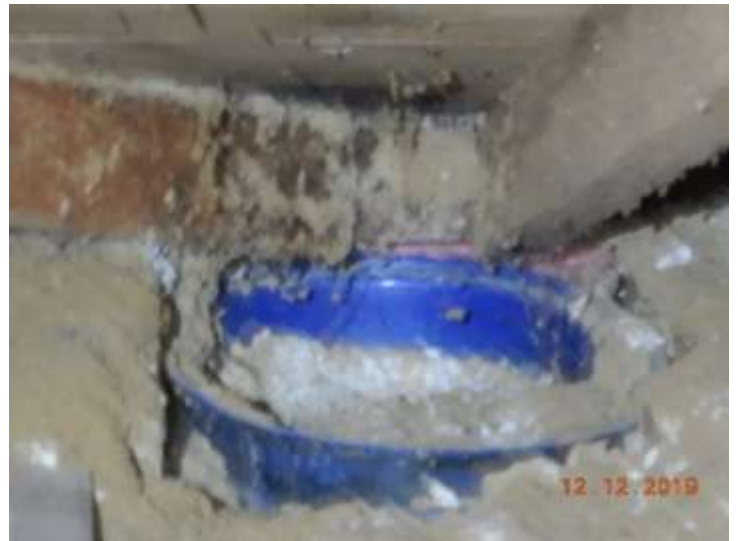
Bucket located in the attic above the North area of the kitchen

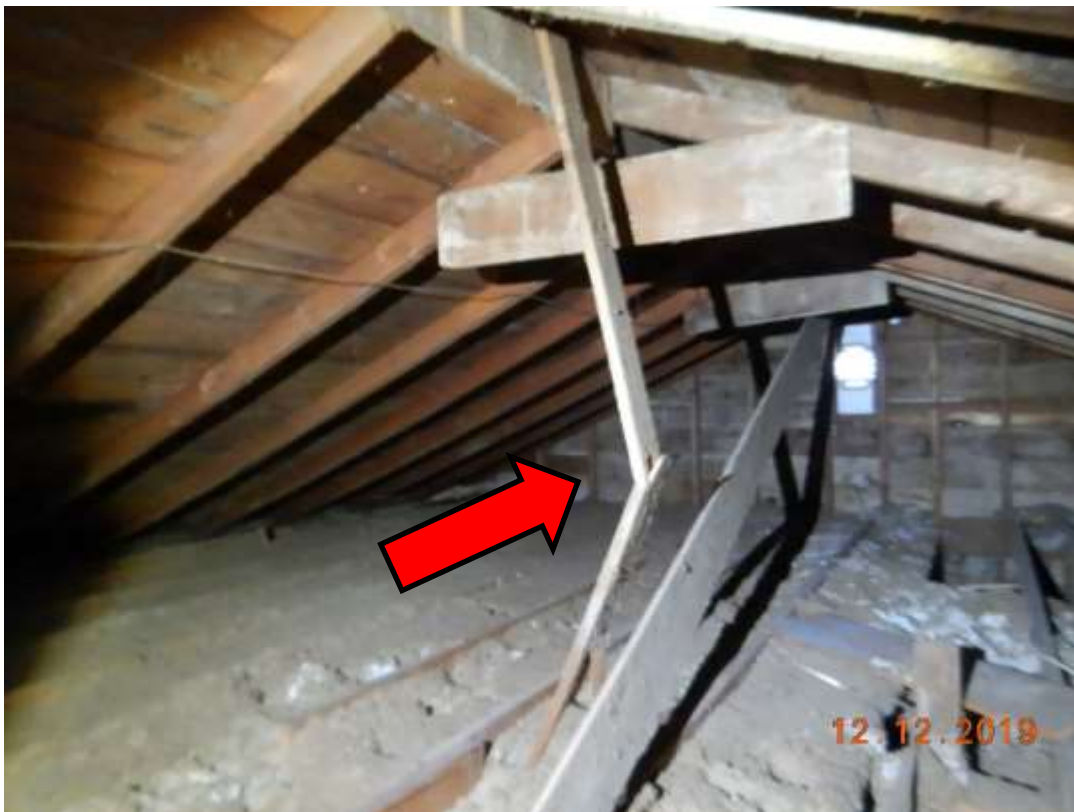
Structural Movement: - The support post for the high ridge is cracked resulting in a structural sag

Cracked ridge post

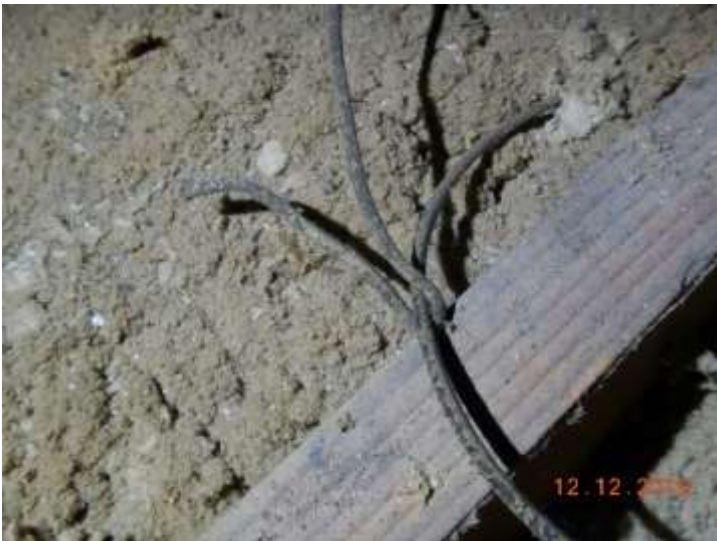
Outlets: None visible
Wiring/ junction boxes: - There is live knob and tube electrical wiring in the attic. Knob and tube wiring is a known fire hazard. A loose and uncapped wire was located near the attic access. Additionally, this type of wiring should not be buried in insulation. Recommend further review by a licensed electrician

Loose and uncapped wire (live)

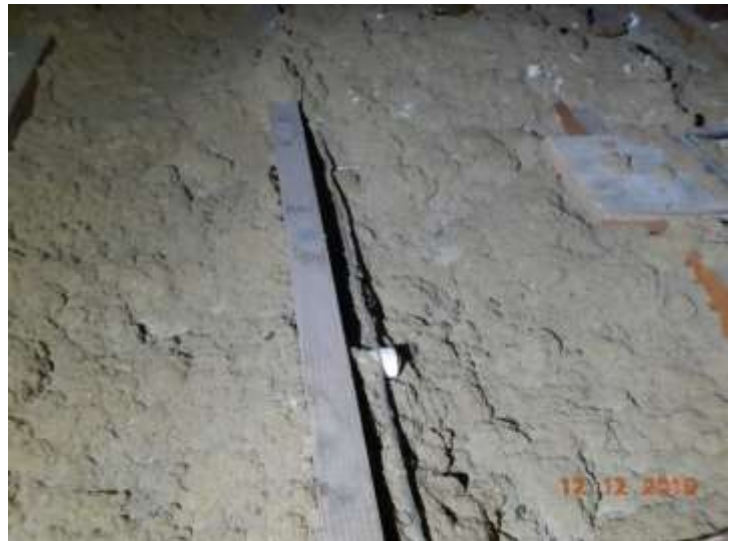
Knob and tube buried in insulation
