Property Description: (2) story townhouse style condominium
Property age/ size: 1,600 s.f., built 2004 per listing
Occupancy Status: Vacant

Inspection Date: 09/07/2011
Inspection Time: 9:30 A.M. – 11:45 A.M.
Weather Conditions: Clear 70 deg F +-

Hergert Inspection LLC

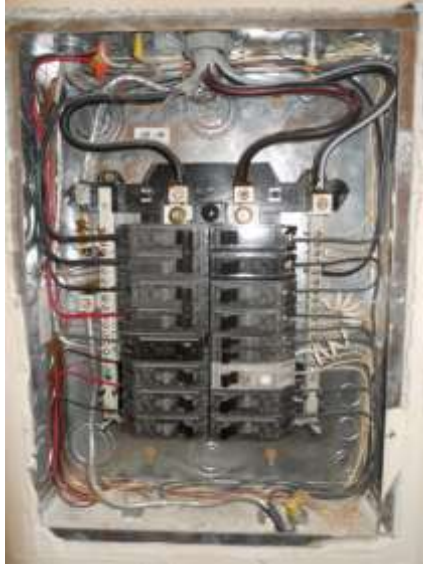
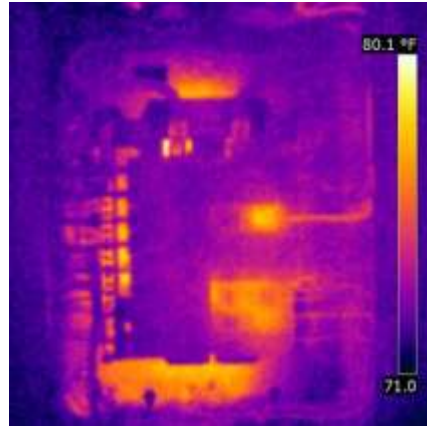
No evidence of over heating

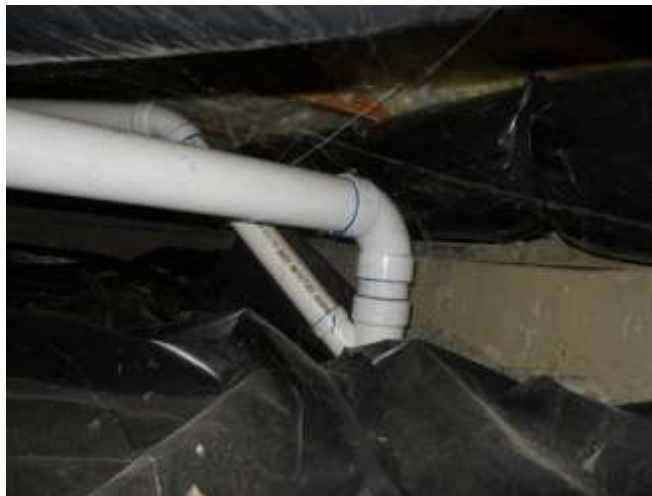
PVC Waste line in crawlspace

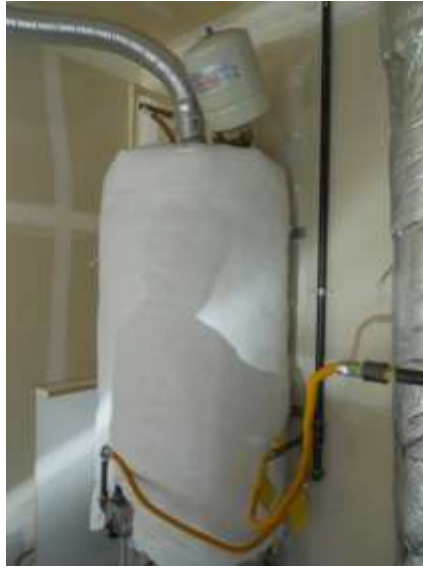
Water Heater

TMP valve: As per required
Earthquake Straps: Installed
Expansion Tank: Installed
Flame Rollout: No visible evidence
- Insulation blanket is not recommended as tank is insulated on inside. May void any applicable warranties

Secure: Inspected
Clearances: As required where visible
Draft Hood: Inspected - *Draft hood was loose and re-attached by inspector*

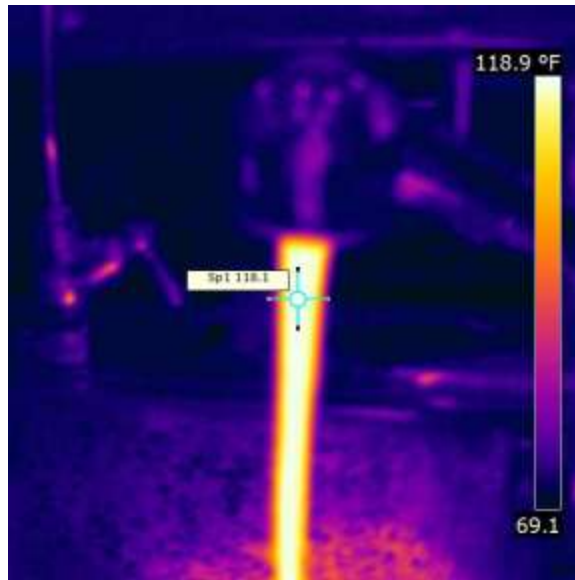
Safe water temperature: 120 deg F per industry standards
Measured temperature: 119 deg F

Hot water temperature @ kitchen faucet

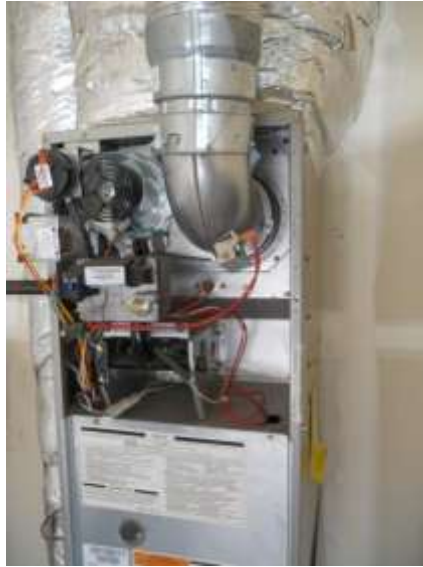
Thermostat: Programmable @ floor 1 hall
Disconnect: Switch on furnace
Combustion Air: Appears adequate
- Furnace filter is very dirty and should be replaced
- No evidence of prior servicing of furnace. Recommend service of furnace every (2) years

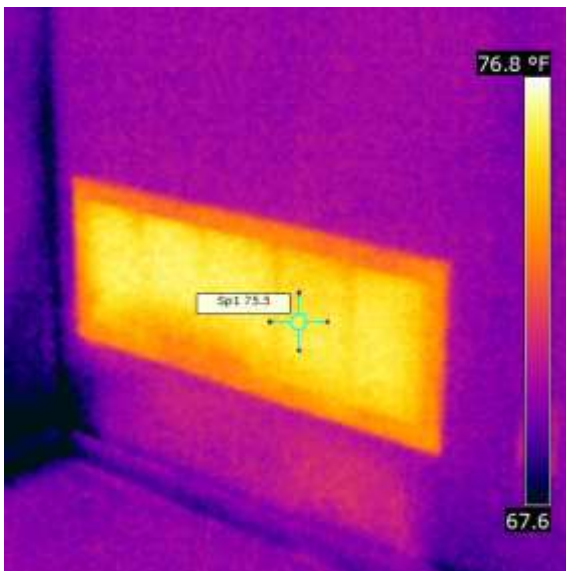
Rating: 20-50 deg F
@ return air: 77 deg F
@ nearest register: 116 deg F
Heat Gain: 39 deg F. Heat gain is within specifications of furnace

Temperature measured at return air

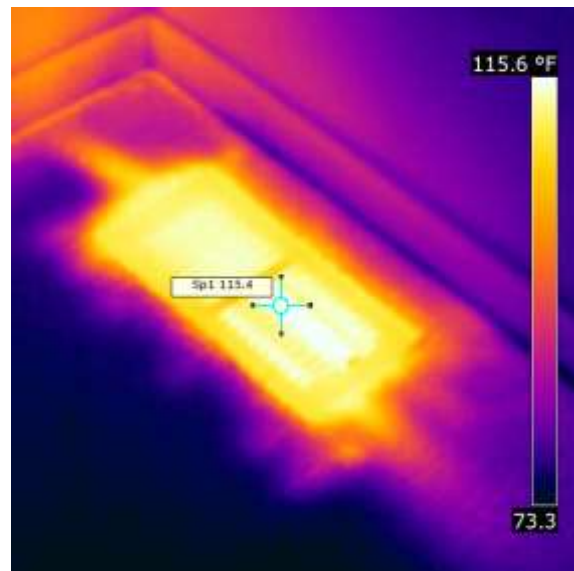
Temperature measured at heat register

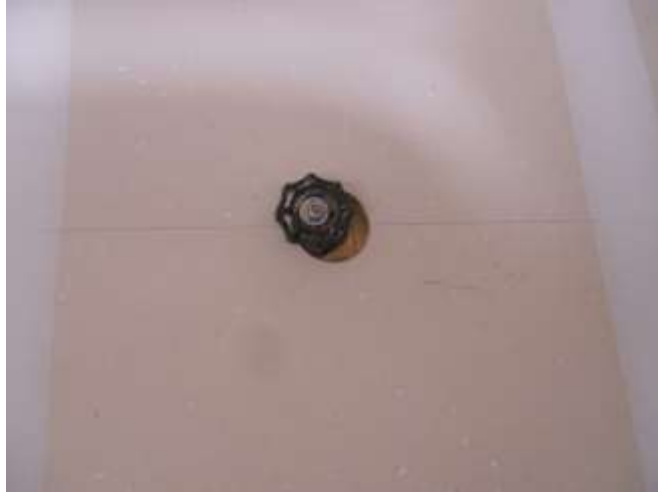
Winter shut off for front hose bib
located in garage

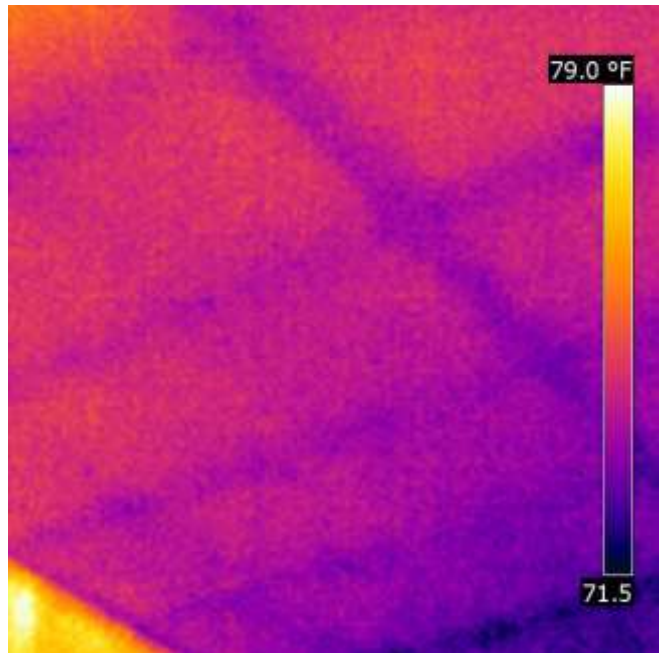
Visibility: Space is vacant
Structural Movement: No visible evidence
Moisture Infiltration: - *Evidence of prior moisture at ceiling. Domestic water was run in all fixtures, including washer drain, were run for at least 30 minutes. No evidence of current moisture intrusion. See Building Exterior section*
Walls: Satisfactory
Ceiling: Satisfactory
Slab: Satisfactory

No evidence of current moisture @ ceiling
