Property Description: (1) story single family home with detached garage w/apt  
above

Property age/ size: 1,942 s.f, built 1999 per listing

Inspection Date: 09/03/2011

Hergert Inspection LLC

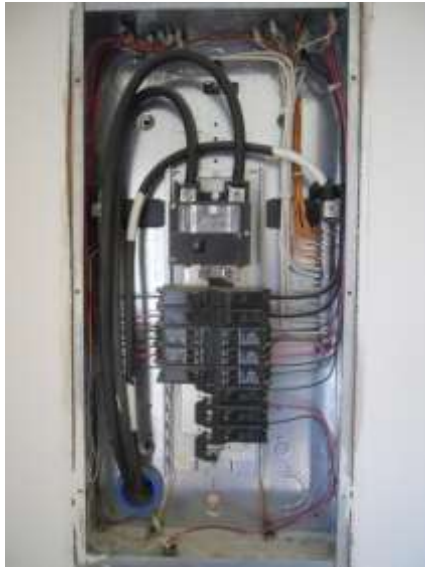
Service panel: House

No evidence of over heating

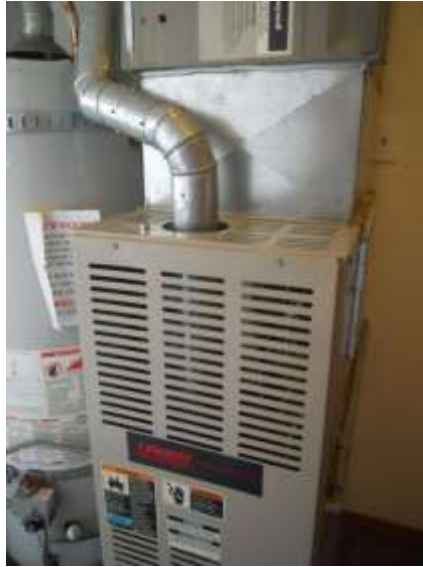
Location: Utility Room  
Make/ Model: Lennox, converted to propane on 04/1999  
Fuel Type: Propane  
- Propane tank not installed for water heater or furnace. No operable heat source or hot water for house  
BTUH: - not noted  
Efficiency Rating: Mid-efficiency

Est. Useful Life new: 25 years  
Est. age of furnace: 12 years +-  
- Furnace not tested due to lack of propane. Blower fan operated and furnace when thru ignition cycle. Furnace is extremely dirty. Recommend service and cleaning by a licensed furnace technician

Dust and lint in burner area

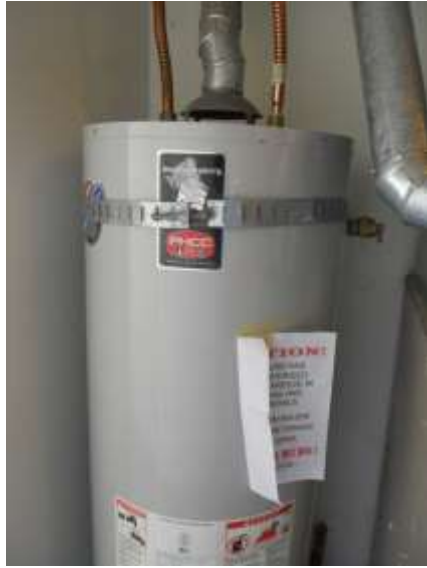
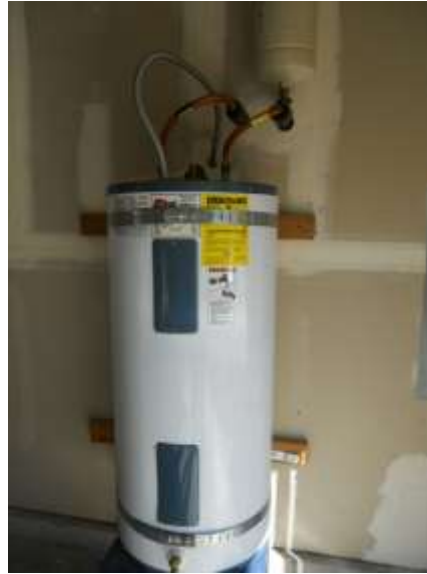
- Water heater not tested due to lack of propane. Substantial rusting inside burner area of tank. Both water heaters are beyond their anticipated useful life expectancy

Rust in burner compartment

Earthquake Straps: Installed  
Expansion Tank: Installed  
Flame Rollout: Yes, burn marks on front of compartment
