Property Description: Split level house  
Property age/ size: Built 1961, 2,100 s.f. per listing  
Occupancy Status: Occupied

Inspection Date: 07/13/2011  
Inspection Time: 3:30 P.M. – 6:30 P.M.  
Weather Conditions: Scattered Clouds, 65 deg F +-

Hergert Inspection LLC

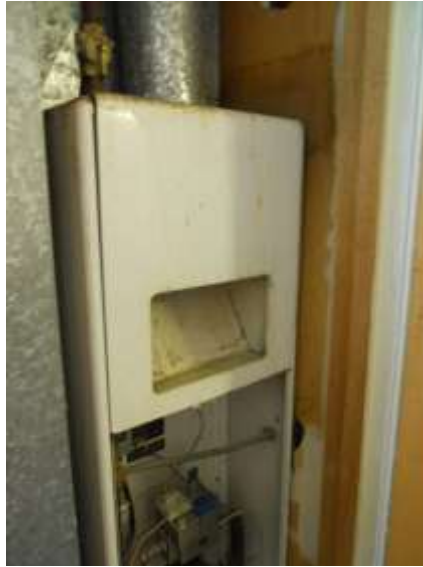
Est. Useful Life new: 25 years  
Est. age of furnace: - Date tag not visible at furnace. Earliest date information is 1990 which would put the age of the furnace at least 21 years. Furnace is likely the original equipment installed during construction  
*- Furnace is far beyond its anticipated useful life expectancy (likely original equipment; 50 years +/-) . Irregular burner patten when blower fan is activated indicates a likely cracked heat exchanger which could result in carbon monoxide poisoning. Extensive rusting a gas pipes, flue, and furnace indicate inadequate drafting of furnace*

Visible Inspection: No visible defects, limited visibility  
Gas detection test: No gas leak detected  
Burner test: *- Irregular burner pattern when blower motor is activated*
