(425) 652-6515  
Kevin@Hergert.com  
Wa. Home Inspector 619  
WSDA Inspector 79988  
WSDA Control # 1336AQ-015

Property Description: Split level house  
Property age/ size: Built 1979, 1,790 s.f. per listing  
Occupancy Status: Occupied

Inspection Date: 12/13/2011  
Inspection Time: 9:00 A.M. – 11:00 A.M. +-  
Weather Conditions: Clear, 35 deg F +-

Hergert Inspection LLC

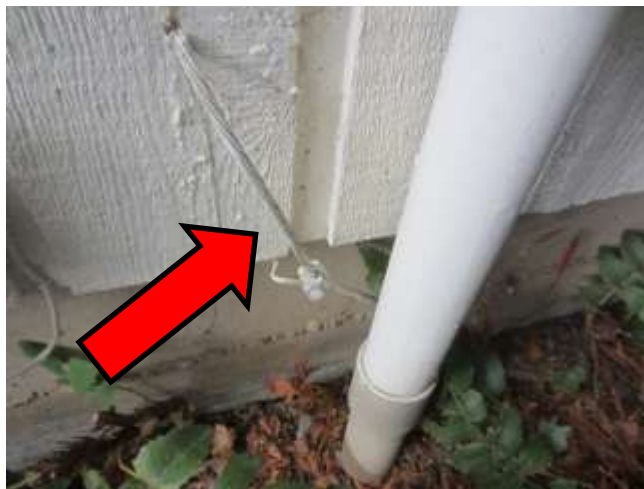
Exterior grounding

Location: Garage  
Manufacturer: Murray  
Type: Split bus bar  
Panel Rating: 200 AMP  
Main Disconnect: n/a  
Serv. wire Size/ Rating: 200 AMP  
Sub-panel: No  
Grounding: Copper to exterior ground rod, limited visibility  
Panel Clearance: 30" wide, 3' in front as required

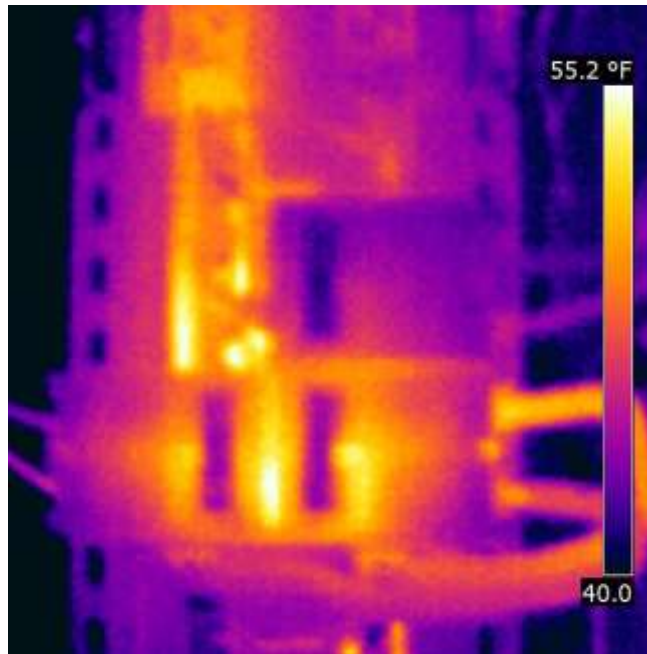
Type: Copper romex  
Breakers: No visible defects

No evidence of over heating

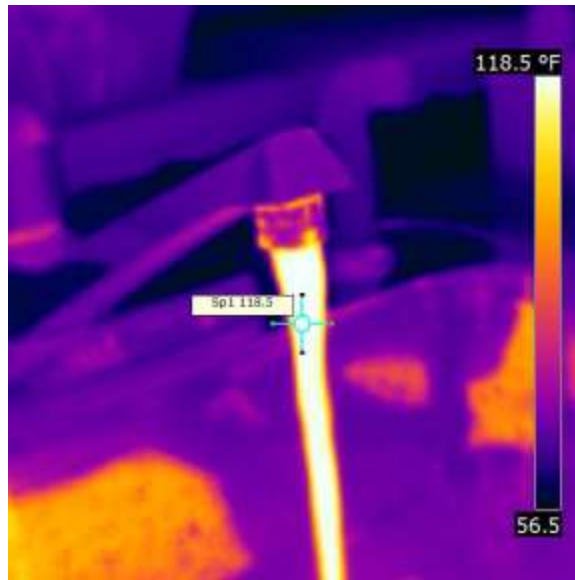
Safe water temperature: 120 deg F per industry standards  
Measured temperature: 119 deg F

Water temperature at basement

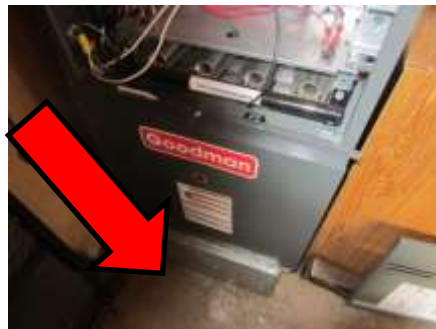
Furnace filter location

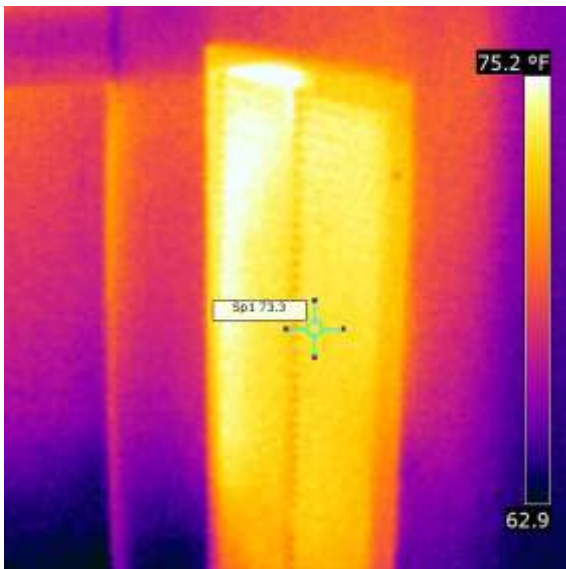
Rating: 35-65 deg F  
@ return air: 75 deg F  
@ nearest register: 124 deg F  
Heat Gain: 49 deg F. Heat gain is within specifications of furnace

Temperature measured at return air

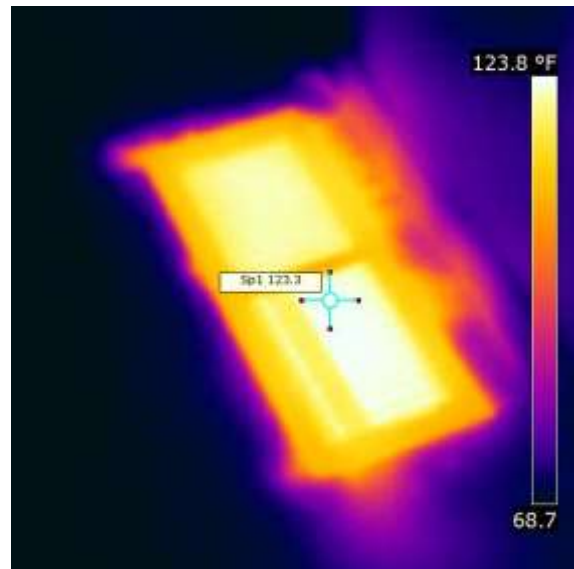
Temperature measured at heat register

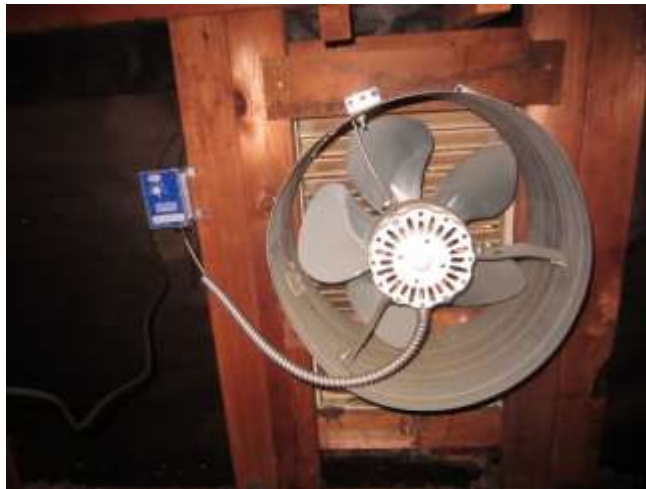
Roof Ventilation: Appears adequate  
Moisture Intrusion: No visible evidence  
Bath/Kitchen fans : All vent to outside

Attic ventilation system
