Property Description: (2) story single family home with daylight basement
Property age/ size: Built 1976, 3,060 s.f. per listing
Occupancy Status: Vacant

Inspection Date: 12/26/2011
Inspection Time: 9:00 A.M. – 12:00 P.M.
Weather Conditions: Overcast, 50 deg F +-

Hergert Inspection LLC

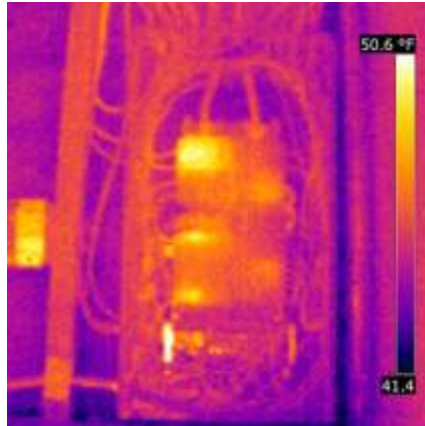
No evidence of over heating

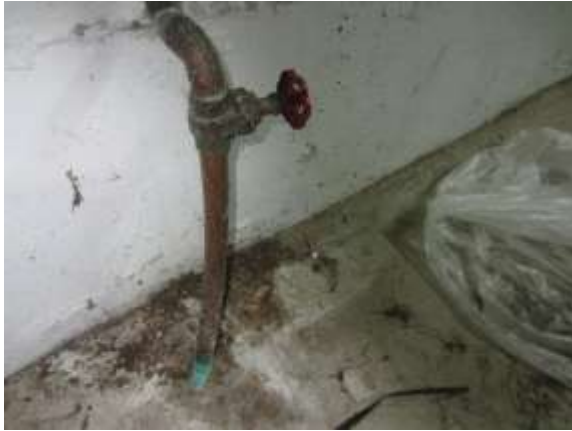
Domestic Water Shut off

Supply: Public water per listing, not included in this inspection
Supply Pipe: Copper pipe where visible
House Piping: Copper and plastic where visible
Pipe Condition: Satisfactory where visible
- Domestic water not active, not tested
Main Water Shut off: @ garage

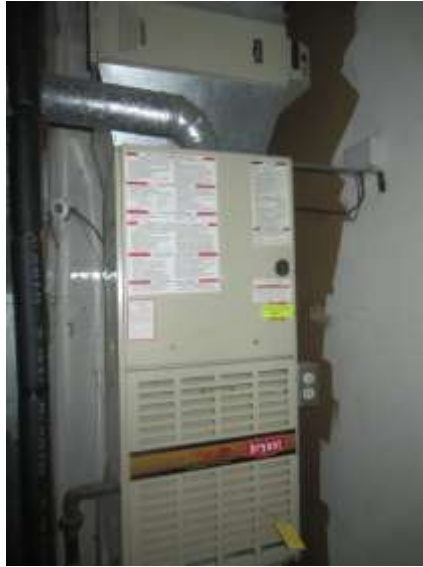
Furnace

Location: Garage
Make/ Model: Bryant plus 80 s/n 4497A11346
Fuel Type: Natural gas
BTUH Input: 115,000
BTUH Output: 93,000
Efficiency Rating: Mid-efficiency

Est. Useful Life new: 25 years
Est. age of furnace: 15 years +-
- Recommend servicing of furnace by a licensed furnace technician and every (2) years thereafter. There is no visible tag that this furnace has ever been serviced

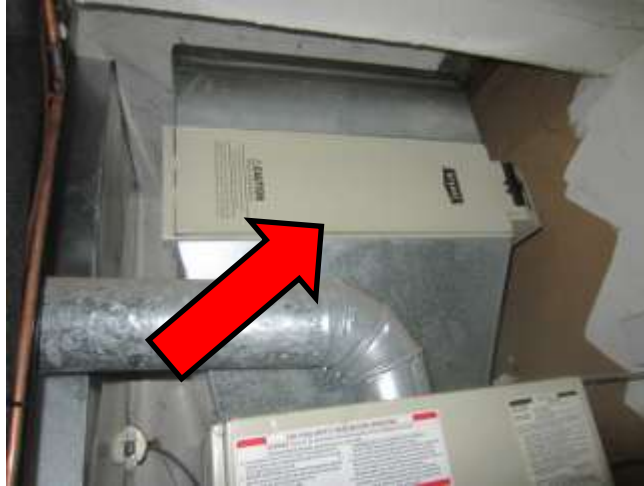
Furnace filter location

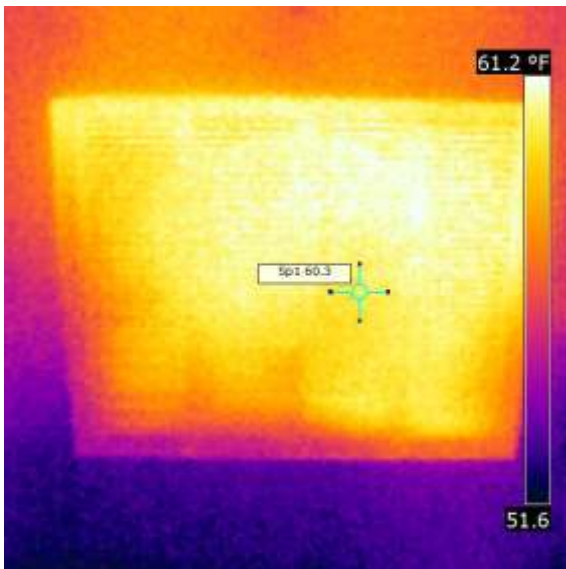
Rating: 50-80 deg F
@ return air: 61 deg F
@ nearest register: 113 deg F
Heat Gain: 52 deg F. Heat gain is within specifications of furnace

Temperature measured at return air

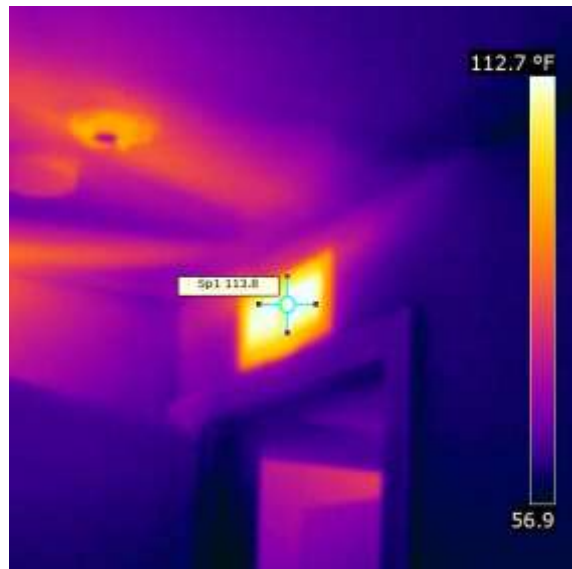
Temperature measured at heat register

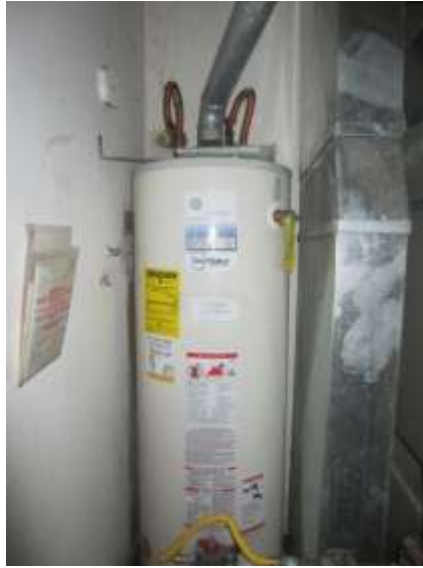
Water Heater

Location: Garage
Make/ Model: General Electric manufactured 12/2003
Fuel Type: Natural gas
Capacity: 50 gallon

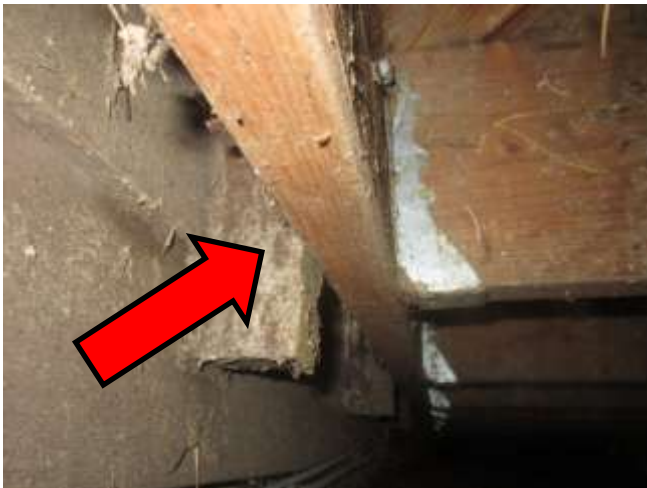
Structure: Pressure treated joists
 Decking: Cedar
 Condition: Satisfactory
 Connection to Structure: Secured to cut cantilevered joists
 Trip Hazard: None
 Handrails: As required
 Barricades: As required

Connection to cut cantilevered joists

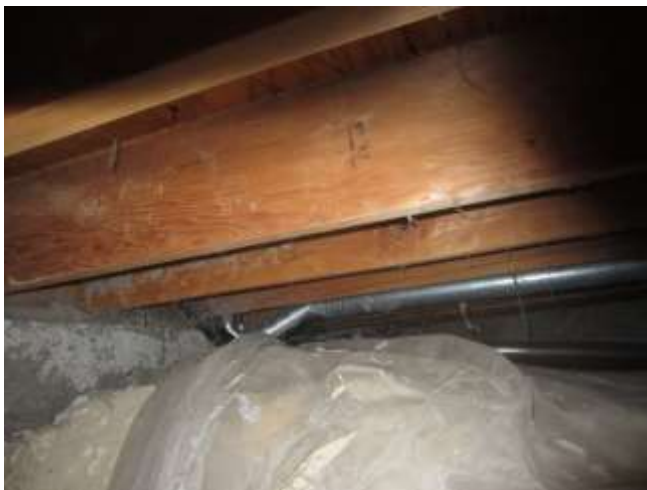
Duct Work: - *Evidence of dryer vent gaps (lint in crawlspace)*
Ventilation Ducts: No visible defects
Gas Piping: No visible defects

Crawlspace (typical)
