Property Description: (2) Story home with basement  
Occupancy Status: Partially occupied

Inspection Date: 07/27/2011  
Inspection Time: 10:00 A.M. – 1:00 P.M.  
Weather Conditions: Scattered clouds, 60 deg F +-

Hergert Inspection LLC

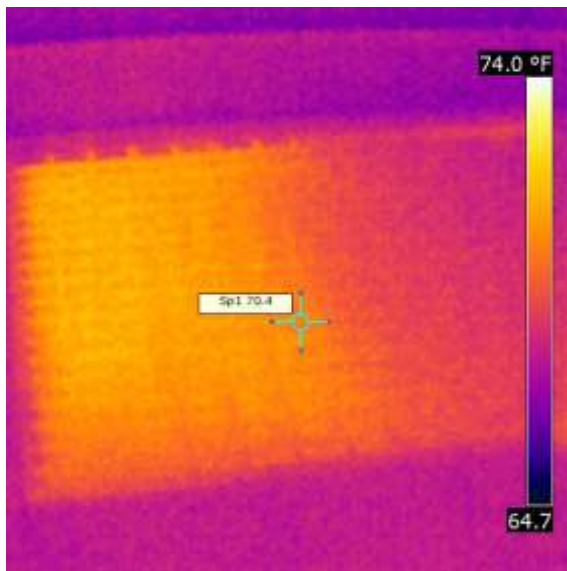
Rating: - Not specified  
@ return air: 74 deg F  
@ nearest register: 118 deg F  
Heat Gain: 44 deg F. Heat gain is within expectations of furnace

Temperature measured at return air

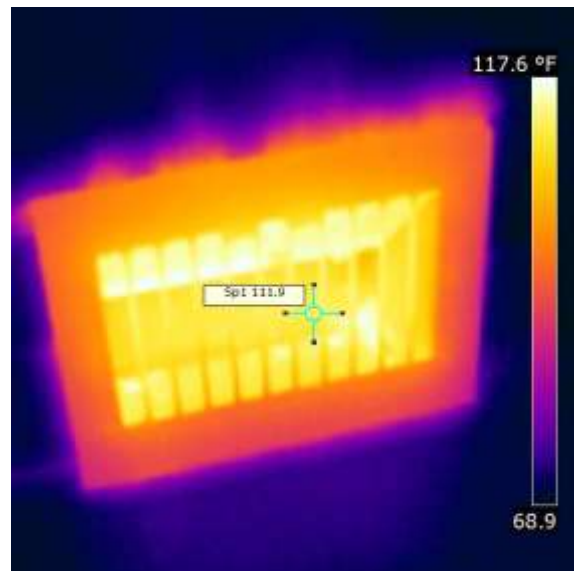
Temperature measured at heat register

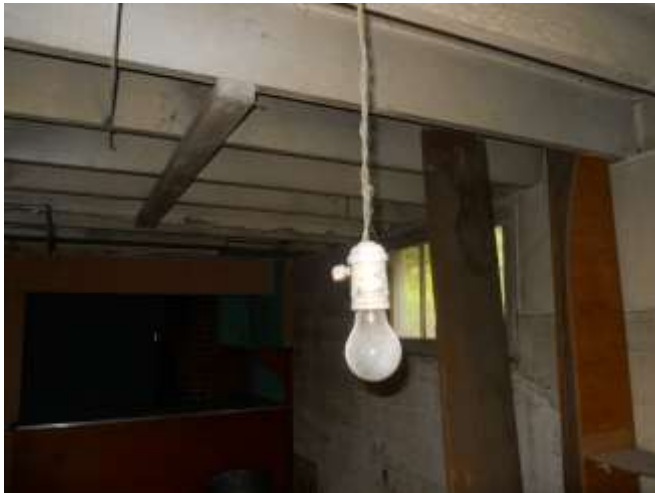
Existing light fixture

- Switches/Lights: - See electrical section  
- Recommend removal of all existing electrical wiring, including knob and tube ceramic parts, when electrical system is upgraded
- Outlets: - See electrical section
- Smoke Detector: - None

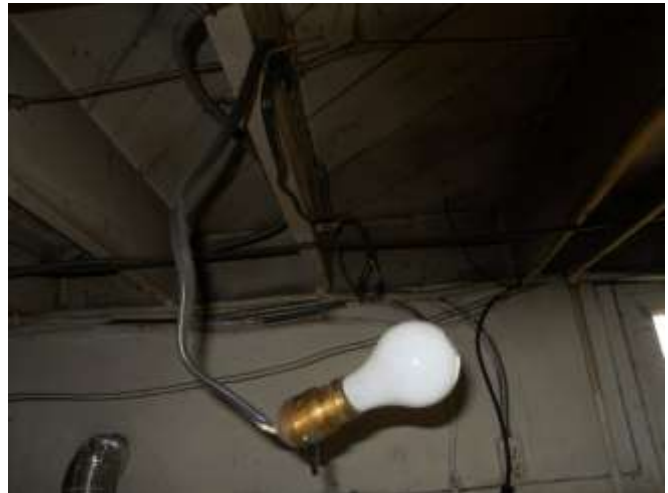
Existing light fixture
