Property Description: (1) story single family home
Property age/ size: 1,024 s.f., built 1944 per listing
Occupancy Status: Occupied

Inspection Date: 09/08/2011
Inspection Time: 11:15 A.M. – 1:45 P.M.
Weather Conditions: Clear, 70 deg F +-

Hergert Inspection LLC

Summary of Inspection

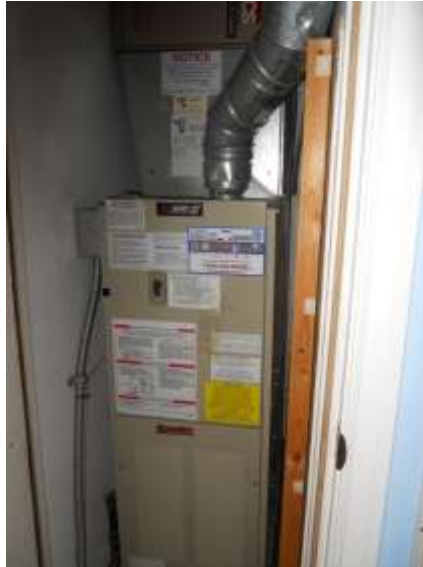
Est. Useful Life new: 25 years
Est. age of furnace: 15 years based on installation tag
- Furnace was last serviced in 2000. Recommend service of furnace and every (2) years thereafter

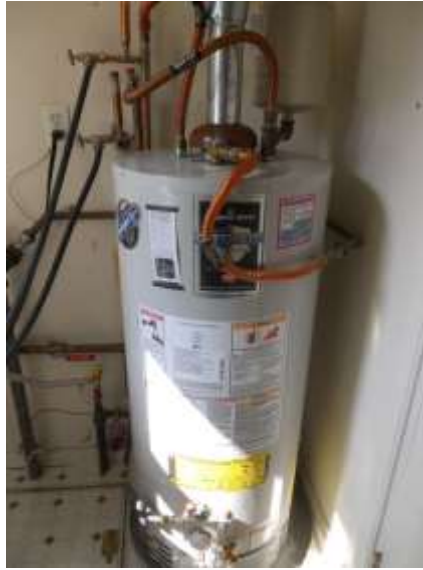
Water Heater

Secure: Inspected
Clearances: As required where visible
Draft Hood: - *Evidence of flue gases not properly venting to the exterior. This condition may be the result of the dryer vent exhausting to the exterior causing negative pressure in the Utility room. The flue gases would then be drawn back into the room. Recommend provide an external source of air (grate to crawlspace) to provide adequate draft of the flue gases*

Evidence of inadequate draft at the water heater flue

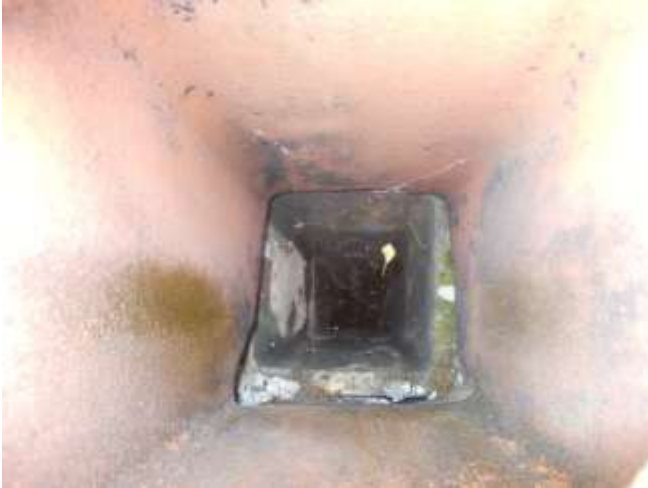
North flue

Mortar deterioration at chimney
