Client:
Address: Seattle, WA 98144

Property Description: Townhouse style
Estimated property age: Built 2020
Occupancy Status: Under construction

Inspection Date: 06/26/2020
Inspection Time: 11:30 A.M. - 1:30 P.M. +-
Weather Conditions: Clear, 75 deg f +-

Summary of Inspection

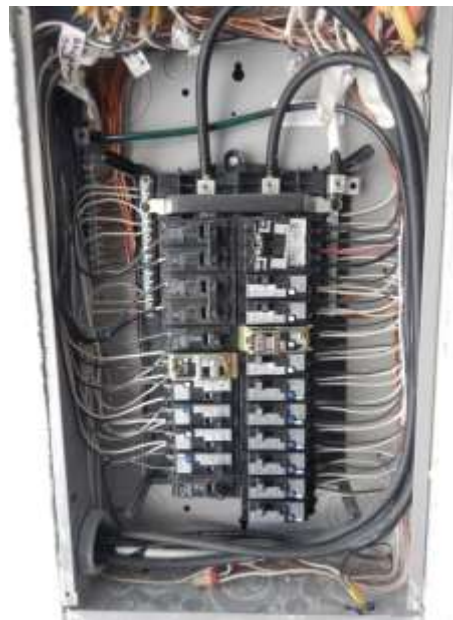
Electrical panel

Location: Garage
Manufacturer: Siemens
Type: Dual bus bar
Panel Rating: Panel rating not visible
Main Disconnect: 125 AMP
Serv. wire Size/ Rating: Estimated 125 AMP
Sub-panel: Yes
Grounding: No visibility
Panel Clearance: 30" wide, 3' in front as required
Panel Cover: Satisfactory

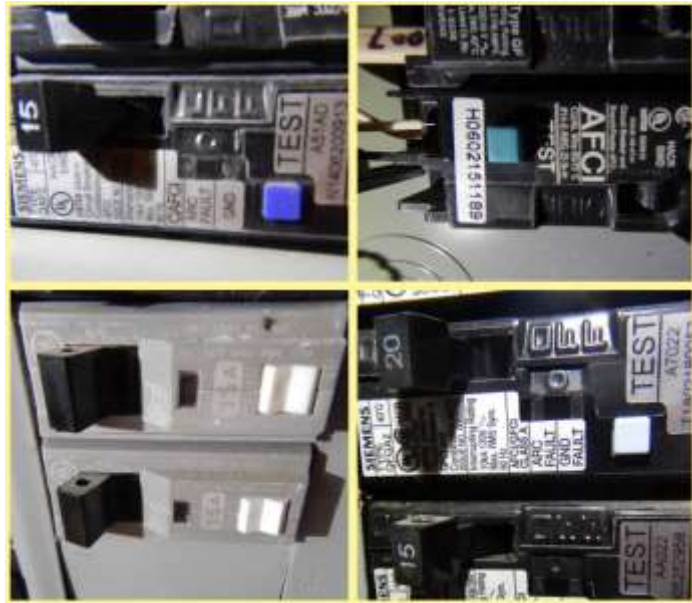
Various arc fault breakers

Type: Copper romex and multi-strand aluminum
Breakers: No visible defects
Circuit breaker legend: Appears proper and complete. Individual circuit breakers are not tested
Arc fault breakers: Tested

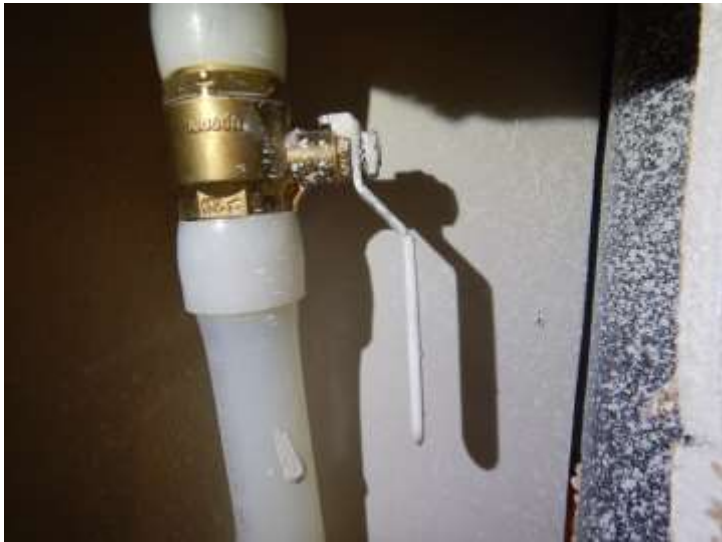
Domestic water shut off

Main Water Shut off: @ basement closet

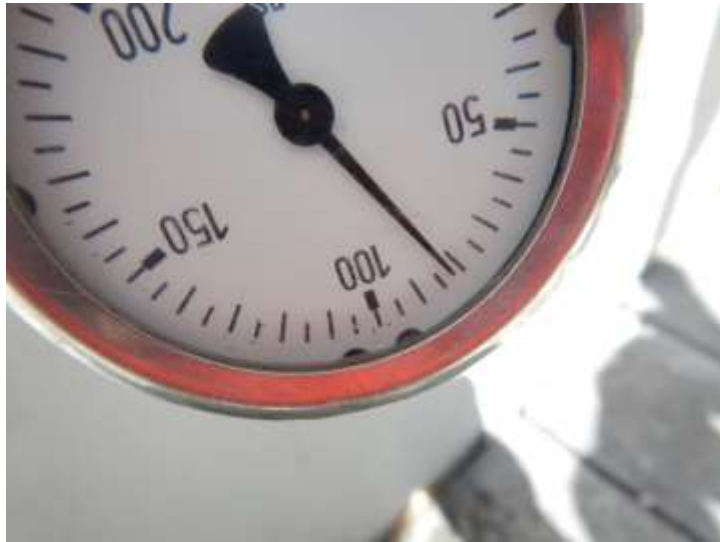
Measured water pressure: 80 P.S.I. Water pressure is adequate and not excessive

Water pressure is adequate and not excessive

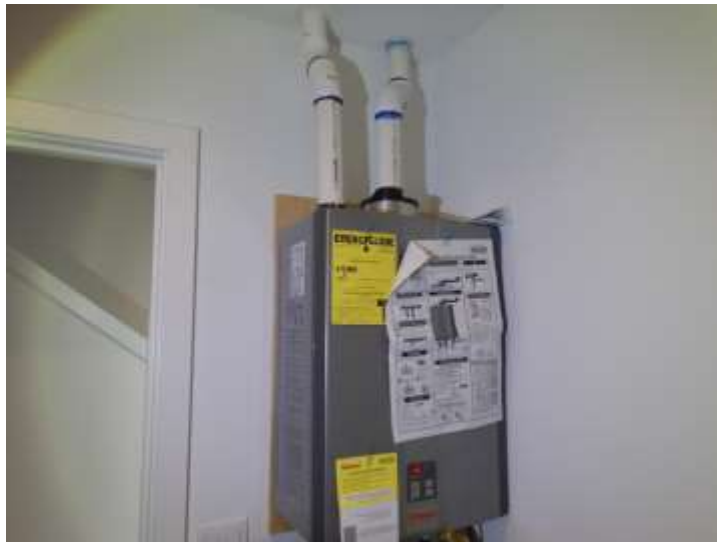
Water Heater

Location: Laundry room
Manufacturer: Rinnai
Fuel Type: Natural gas (electricity is needed for this system to operate)
Capacity: Tankless

Flue secure: Inspected
Clearances: As required where visible
Draft Hood: not applicable; direct vent
Water connection: Inspected
Condensate line: - The condensate drain is not properly discharging into the drain line. As a result, there is water (condensate) leakage onto the Laundry room floor.

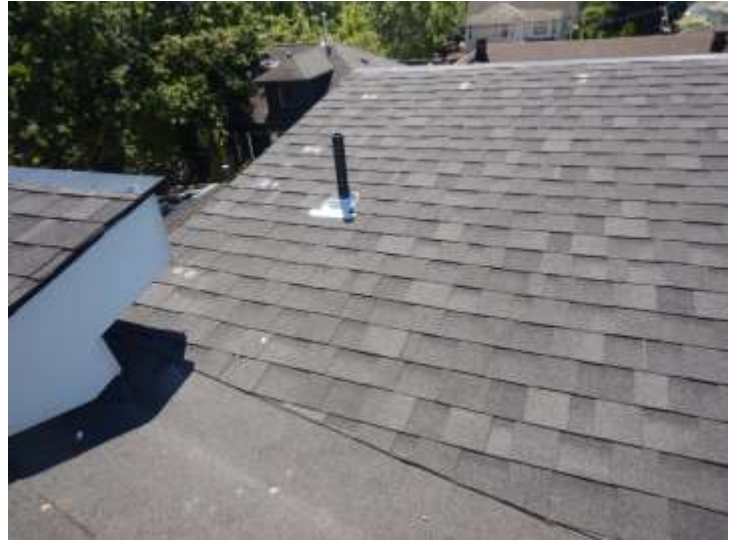
Roof (typical)

Estimated Pitch: 4:12
Material: Composition
Layers: 1+
How Inspected: From the roof deck
Roof access condition: Roof was not traversed as traversing the roof is deemed unsafe by the inspector
Condition: Overall satisfactory
- All construction debris should be removed from the roof.
Plumbing Vents: Satisfactory
Flues: Satisfactory
Flashing: Satisfactory

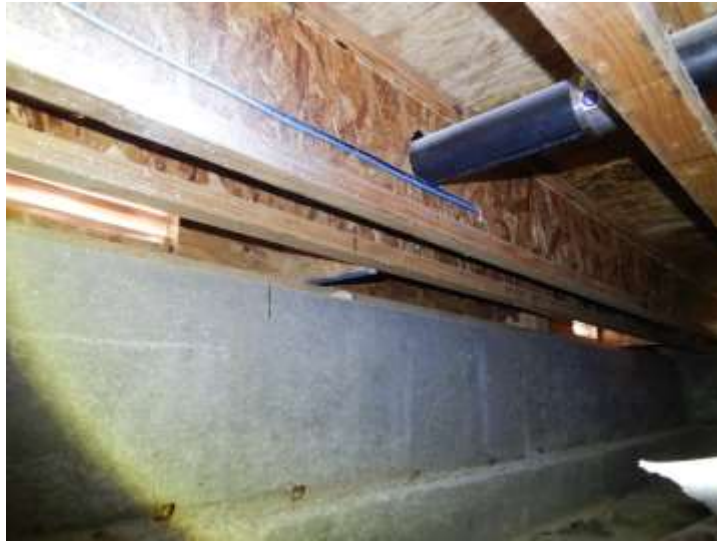
Crawlspace (typical)

How viewed: - The crawlspace was not fully traversed due to restricted access

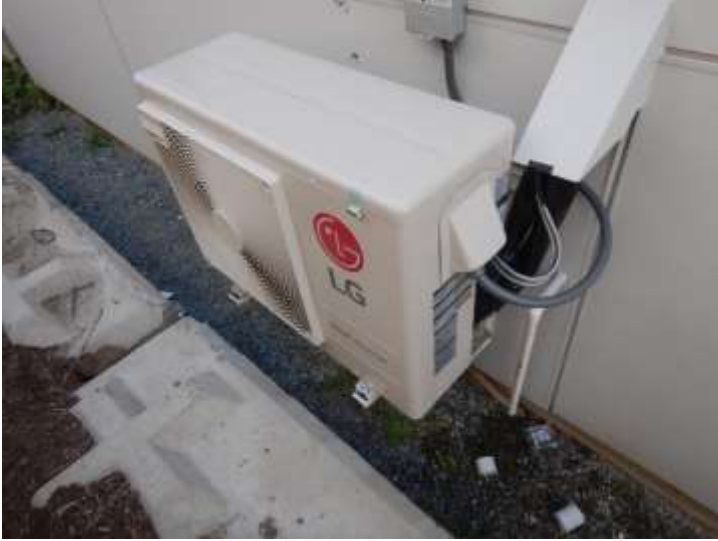
- Source: Ductless heat pump
- Seller should demonstrate that the ductless heat pump system provides heat.
Unable to turn the system to heating mode during the inspection.
- Air Flow/ Heat Gain: Appears to be satisfactory

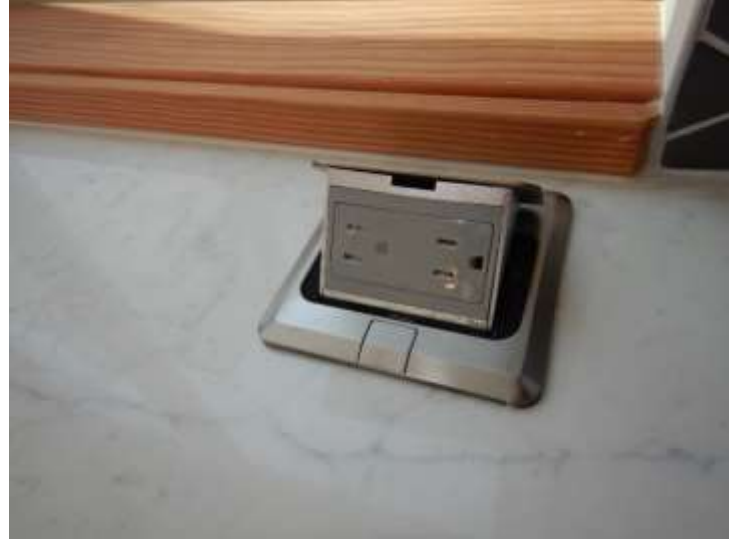
Countertop electrical outlet

- The drywall around the ventilation hood is not completed in a workmanlike manner.
- The dishwasher is not secured in place
- The shell of the dishwasher has been cut open to provide space for the countertop electrical outlet. Full replacement of the dishwasher will be needed. The electrical outlet will likely need to be abandoned or relocated. A new countertop will be needed to seal the hole of the electric outlet box.
- The refrigerator door is dented
- Seller: Is there a water supply to the refrigerator? If so, demonstrate this the supply and ice/water features of the refrigerator function as designed

The shell of the dishwasher has been cut open

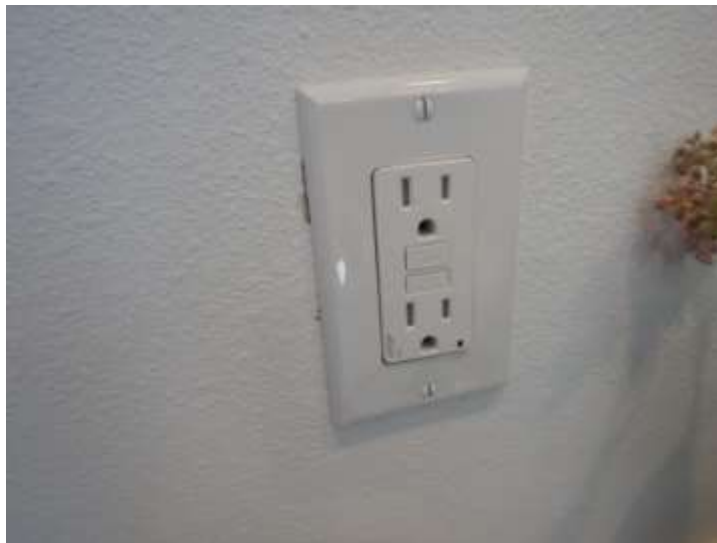
This GFCI reset outlet is the reset outlet for all of the bathroom electrical outlets throughout the home

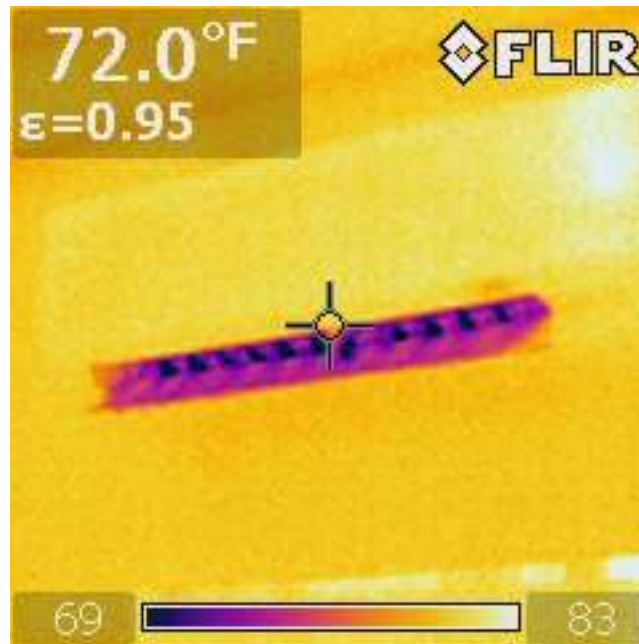
Cooling mode of the ductless heat pump

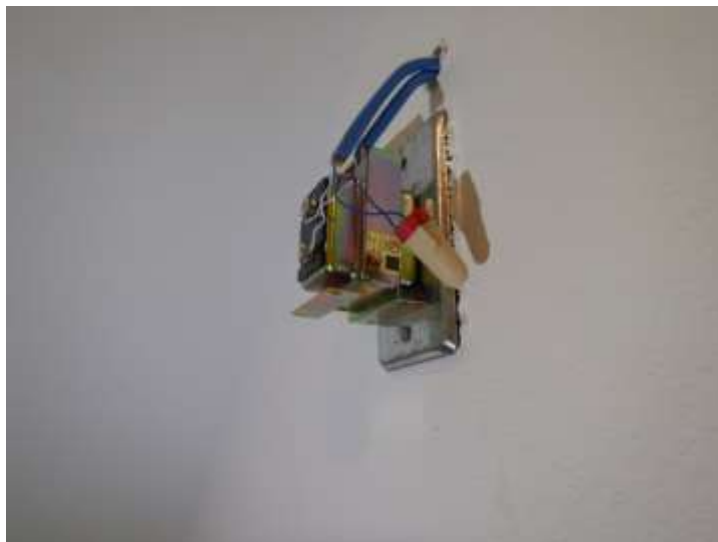
The doorbell transformer is located in the closet

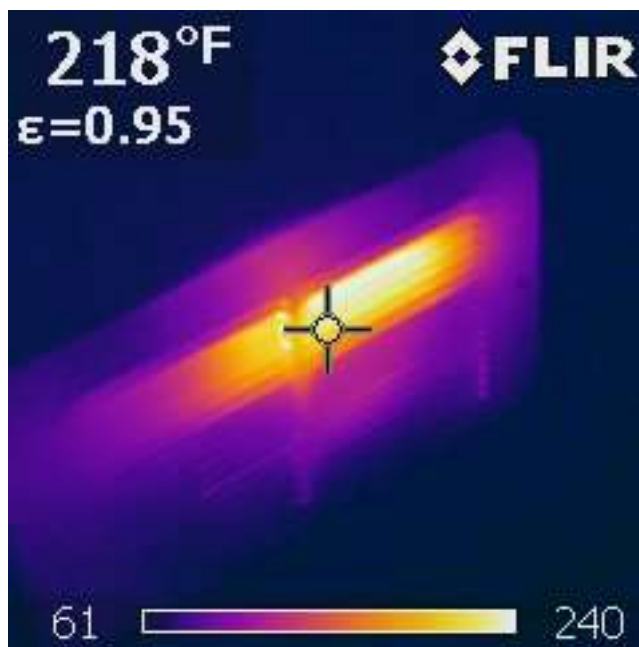
Maintain proper clearances to combustibles
